# **OFFICE OF THE STATE CORONER**

# **FINDINGS OF INVESTIGATION**

CITATION:	Non-inquest findings into the death of Reuben George Kelley
TITLE OF COURT:	Coroner's Court at Cairns
JURISDICTION:	Cairns, Northern Region
DATE:	10 March 2016
FILE NO(s):	2015/1853
FINDINGS OF:	Kevin Priestly, Northern Coroner
CATCHWORDS:	CORONERS: Non-inquest findings, motor vehicle collision, driving at excessive speed, in- experienced driver, driving to conditions of road

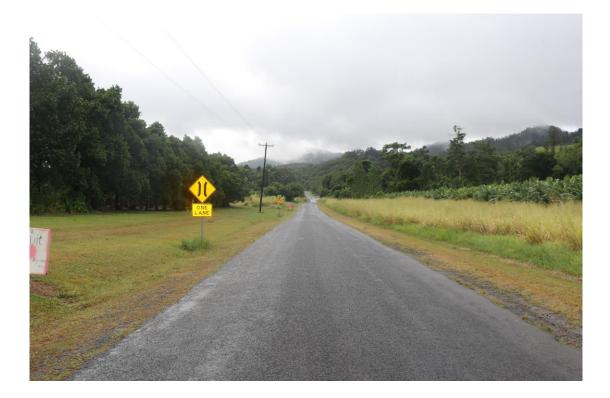
View of the drivers approach to the crossing

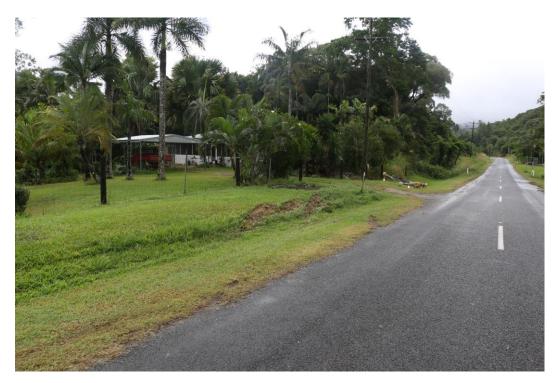
View after incline – house centre left

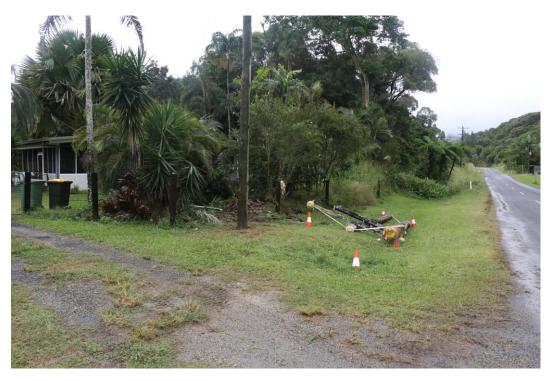
- 6. On either side of the road after the bridge, there are grassed areas. To the western side, there is a slight grass bank which is no more than 300mm high. Two tyre marks were seen leaving the road surface, through the wet grass and up the bank. It was difficult for the investigators to determine whether brakes were applied owing to the furrowing left by the wheels. The tyre marks cease at the top of the bank. The Mazda travelled approximately 20 metres through the air then collided, roof first, with a power pole. The Mazda fell to the ground, landing on its wheels. The power pole broke about 2.5 metres above the ground and fell across the roof of the Mazda, from A pillar to C pillar. As there was no direct impact to the front of the Mazda, the airbags did not deploy. The impact zone was concentrated through the roof.

Tyre marks showing path of Mazda

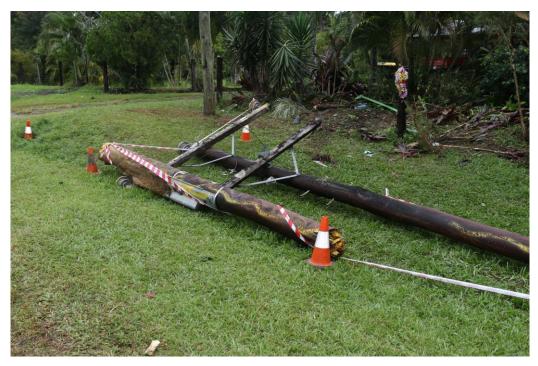
Replacement power pole in position
