OFFICE OF THE STATE CORONER FINDINGS OF INQUEST

CITATION: **Inquest into the death of Michael Earle Auld**

CATCHWORDS: Mining inquest, service crew member crushed between working platform on loader and tray of Landcruiser, safe working procedures, safety awareness.

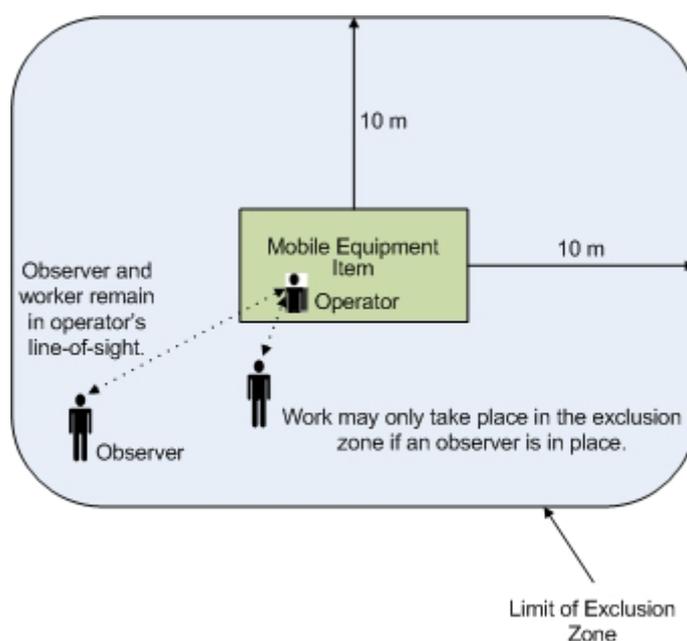
However when mobile equipment is being used to undertake operational tasks (e.g. hanging vent, loading supplies into IT baskets, mucking operations etc) then a 10 metre exclusion zone where practicable (as described below) applies for all pedestrian activity.

An exclusion zone exists for all pedestrians who are not directly involved in the operational activities of mobile equipment.

Where people need to work on foot within the 10 metre exclusion zone and are not in line of site with the operator then a dedicated observer must be in place.

The observer and workers on foot must position themselves so as to not be in the line of travel of the mobile equipment.

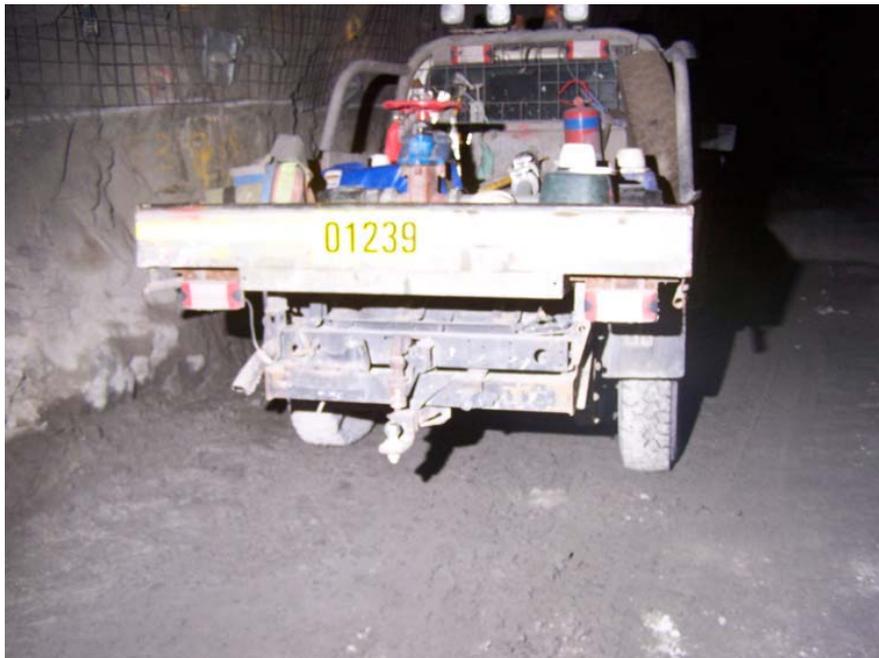
The rear of the Landcruiser

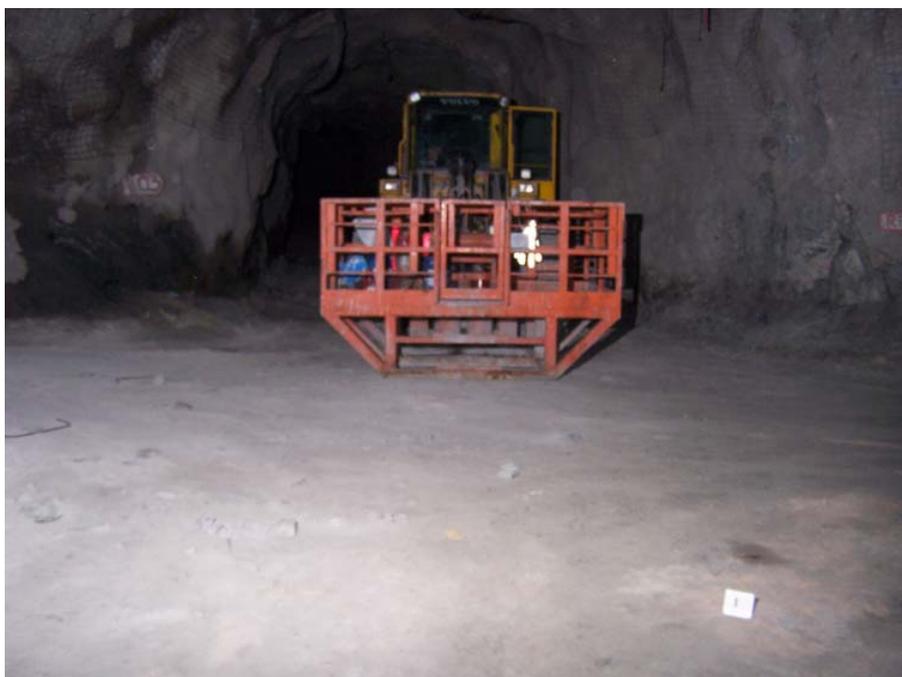
The front of the working platform
attached to the Volvo Loader at the rear

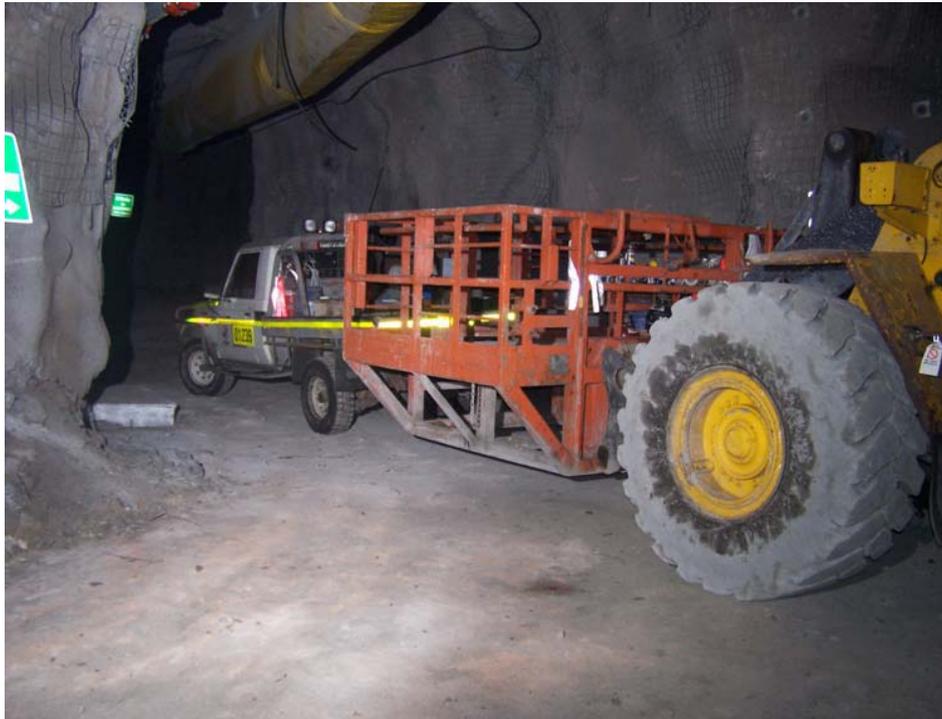
At approximately 11.07am Mr Auld was fatally injured while working underground on the 375 metre level when he was crushed between the rear of a Toyota Landcruiser utility and a basket (working platform) attached to a Volvo L120D loader.

Mr Rabuka saw the hand signal from Mr Box and slowed the Volvo loader. At this point, Mr Rabuka either stopped momentarily and continued or failed to stop. Mr Auld was crushed between the basket and the tray of the Landcruiser. Mr Box escaped injury due to the angle at which basket closed on the Landcruiser or he was just out of the crush zone.

The loader with the attached work platform positioned adjacent to the rear tray of the Landcruiser

Mr Christie reported on the remedial action taken immediately after this death. There were toolbox meetings with employees within 7 days to ensure that the Landcruiser was moved to the IT to facilitate the transfer of equipment. Crews were trained in conducting a Job Safety Analysis (JSA) and directed to complete a JSA for each job. The JSA requirement applied for 3 months. They were collected and reviewed to review all hazards associated with work tasks and to review the adequacy of existing safe working procedures and to identify the need for new ones. Immediate efforts were also made through safety presentations to reinforce the need for greater safety awareness around the operation of mobile equipment.

On 8 February 2008 a risk assessment was undertaken at Cannington into the interaction of pedestrians and vehicular traffic that resulting in a recommendation for a 10m exclusion zone at the front and rear of loaders, a requirement that the Landcruiser be moved to the loader, and the development of a safe working instruction. The recommendations of the risk assessment were ultimately incorporated into BHPB's safety management system.

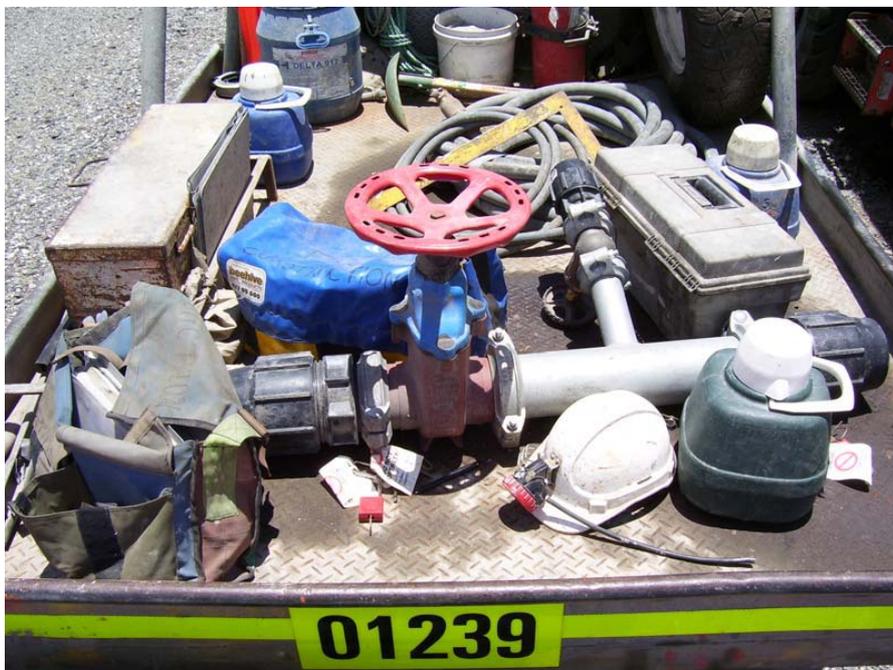
The valves, fitting and tools in the tray of the Landcruiser to be transferred to the work platform
