# **CORONERS COURT OF QUEENSLAND**

## **FINDINGS OF INVESTIGATION**

**CITATION:** **Non-inquest findings into the suspected death of Bradford Zaiser Maisel**

**CATCHWORDS:** CORONERS: Robinson R22 helicopter crash into ocean, night flying, loss of visibility, unapproved modification, Pilot error, helicopter.

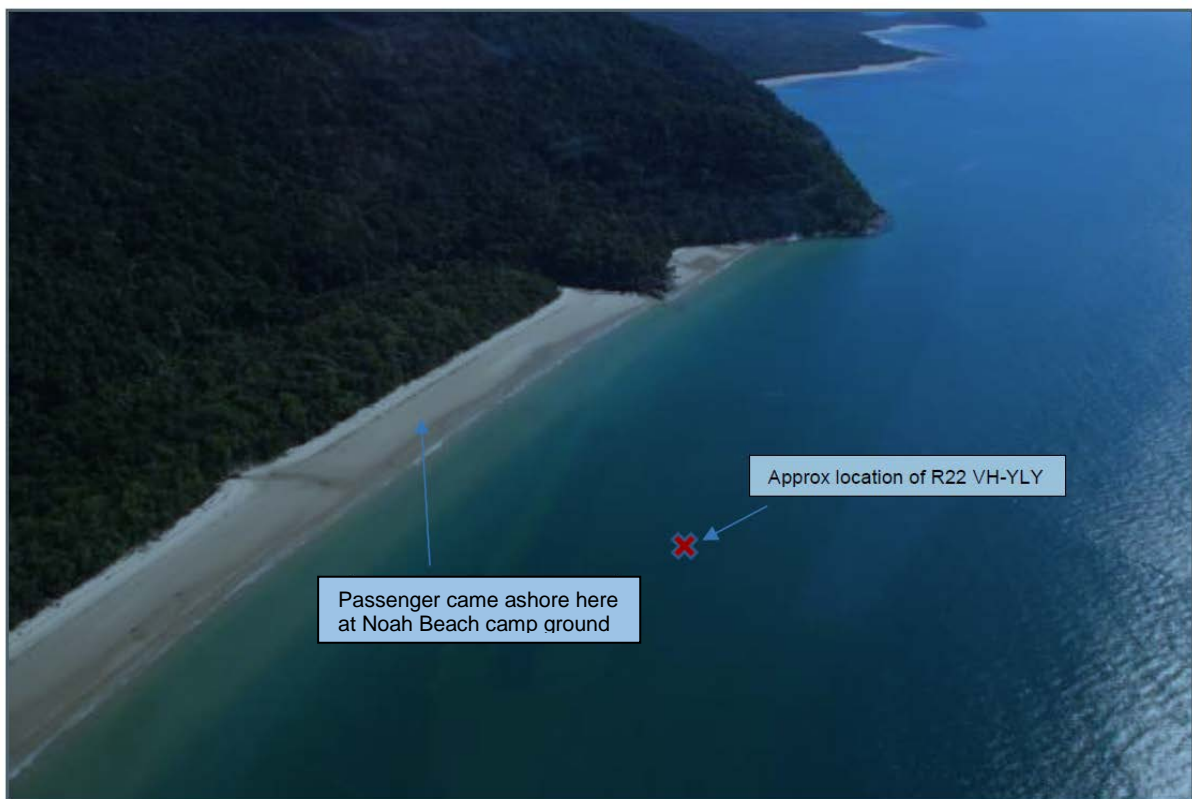
Noah Beach looking north towards Cape Tribulation
