CORONERS COURT OF QUEENSLAND

FINDINGS OF INVESTIGATION

CITATION **Non-inquest findings into the death of:
Martin Sydney CUNNINGHAM**

CATCHWORDS : Collision at sea; fishing vessel (FV) *Cygnat Lass* and
tugboat *Svitzer Nana*; Bowen Harbour; crossing vessel;
give way vessel; stand on vessel; overtaking vessel;
collision course; failure to maintain a proper lookout;
rescue and recovery; *Convention on the International
Regulations for Preventing Collisions at Sea* (COLREGs);
delisted Inquest; published non-Inquest Findings.

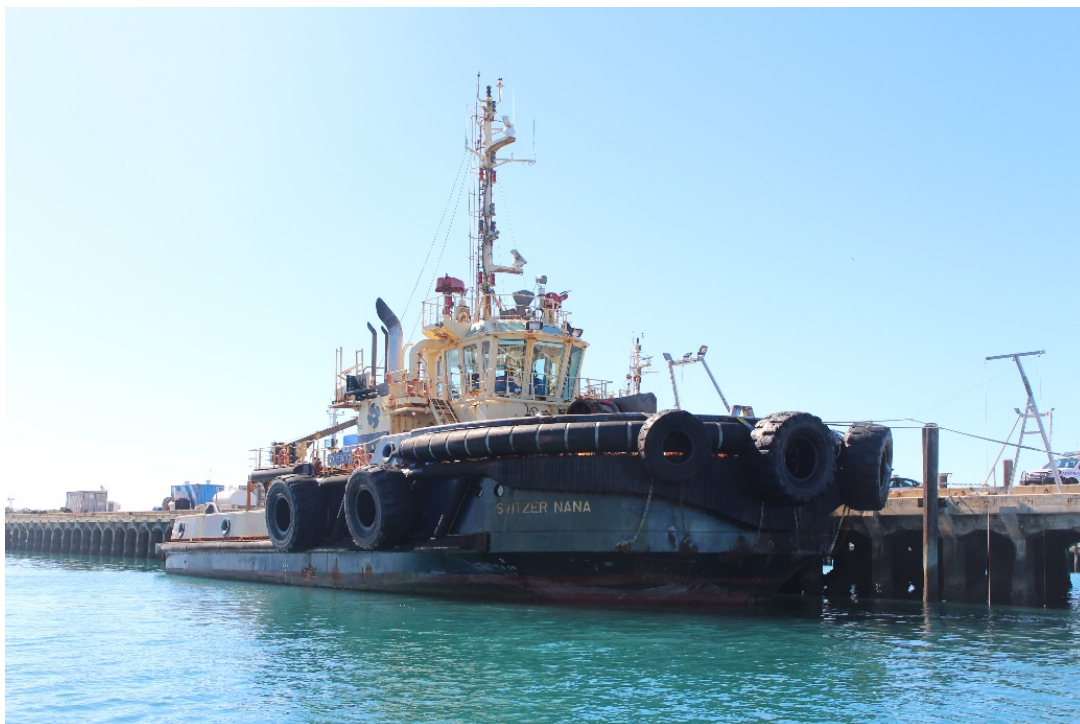
119. Mr Male also accepted there were blind spots resulting from funnel stacks positioned midship on both sides of the helm of the *Svitzer Nana*. The following image depicts the position of those funnels (abeam) and the mullions on the windows:

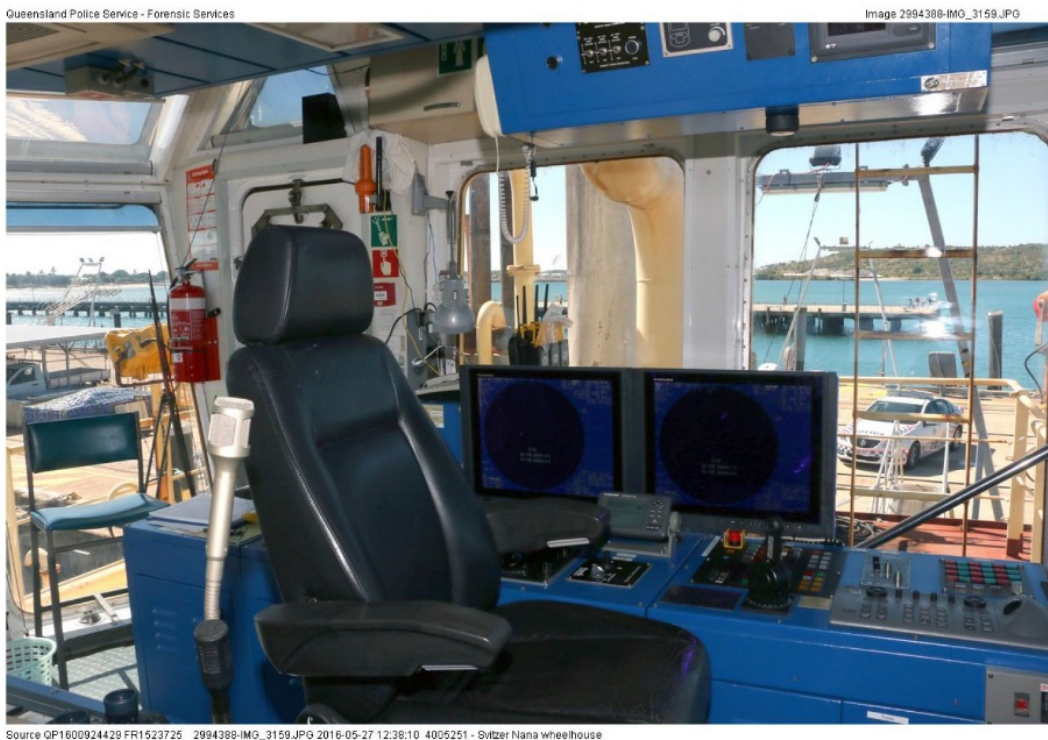
The following image depicts the view from the helm of the *Svitzer Nana* looking abeam and towards the port quarter, as described by MALE:

120. When questioned further about the 'white flash' that he observed Mr Male placed it at three points around on the port bow. There is an appreciable difference between that and the port quarter, with the former position (three points around on the port bow) placing the 'white flash' ahead of any visual obstruction created by the exhaust stacks or mullions.

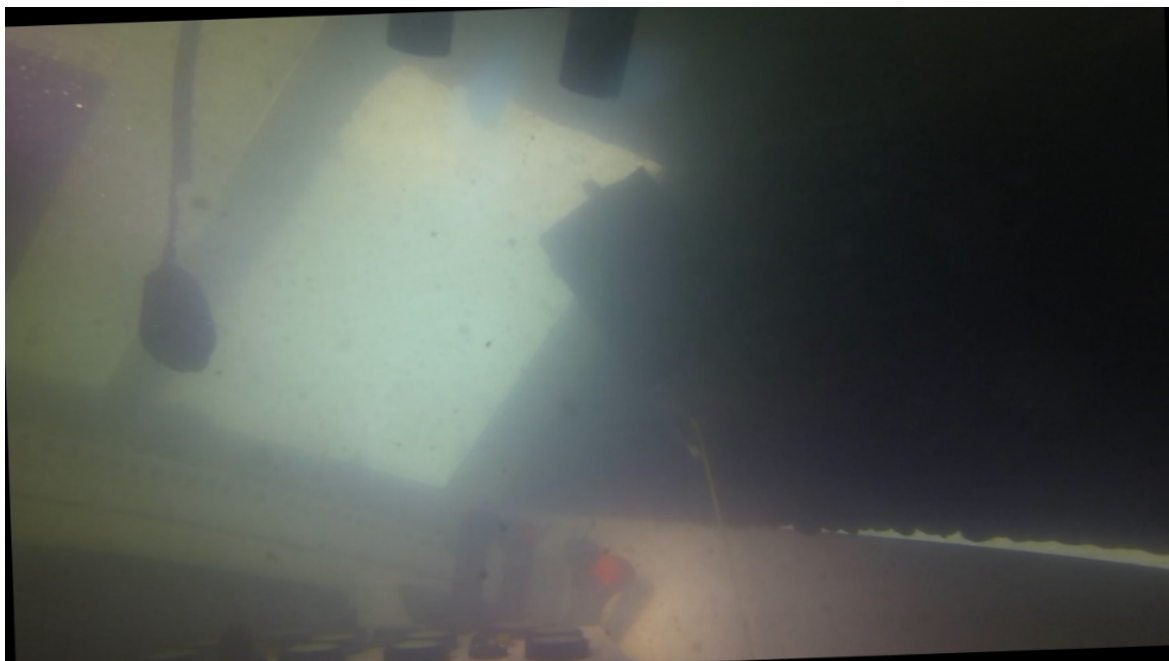
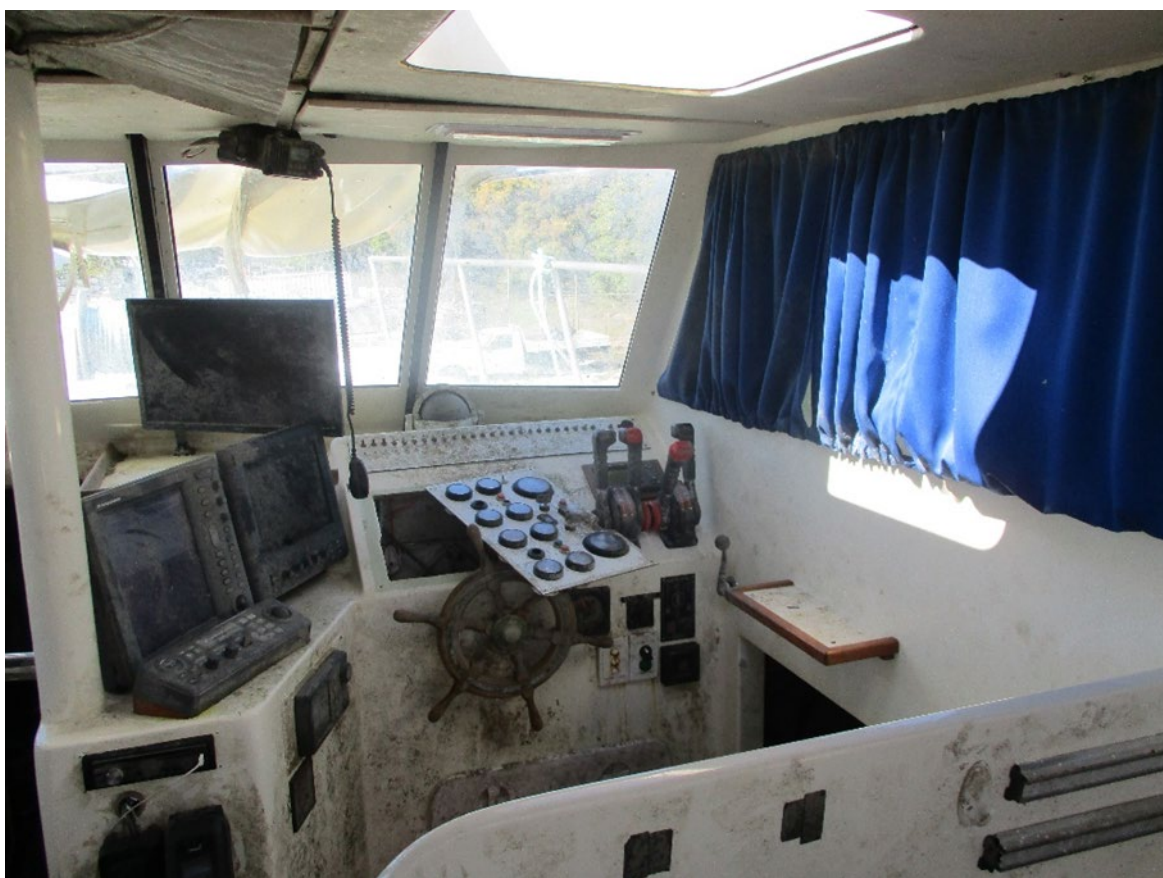
"These curtains were also sighted as closed in the underwater inspection of this section of the vessel by Queensland Police Divers. The design of the

curtains with cable runners top and bottom required some force to open and close due to the friction of the curtain fabric against the cable – I am therefore of the opinion that the curtains would have had to have been closed prior to the time of the incident occurring and were not closed as a result of the incident.”

289. Whilst I accept the evidence that the curtains were not drawn when the *Cygnat Lass* departed Bowen Harbour I am satisfied and find that at some stage after departure, the starboard side curtain was drawn over.

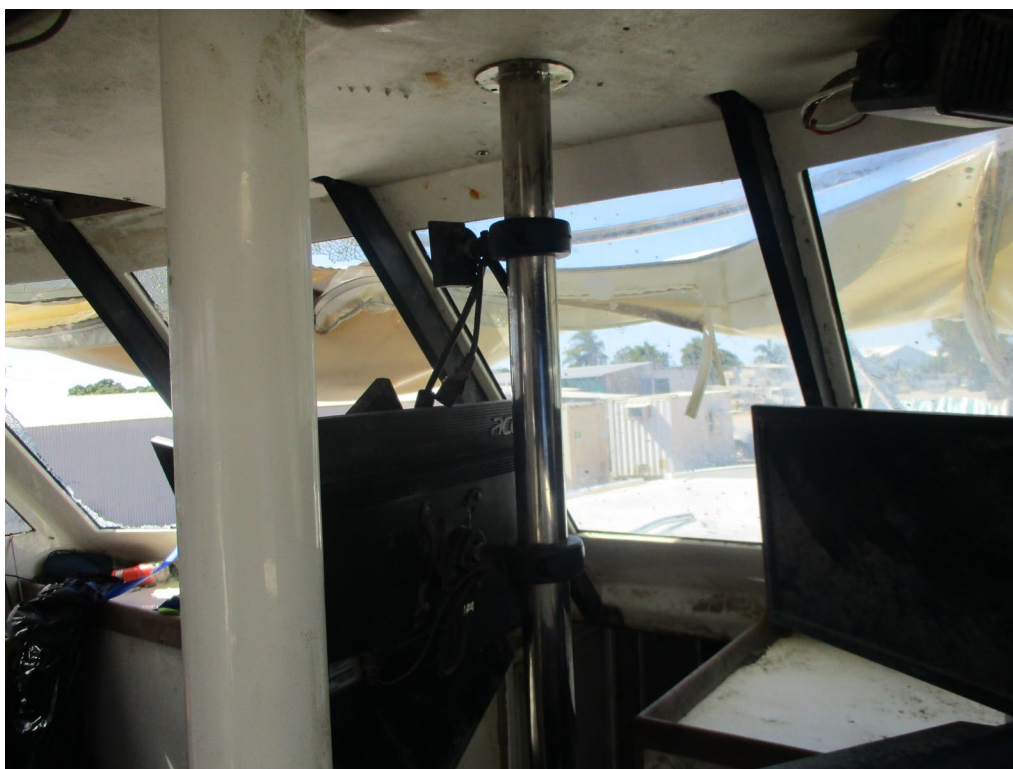
292. Upon review of the photos taken during the examination it is noted that the door leading from the deck onto the bridge of the *Cygnets Lass* had been removed. This is consistent with the version given by Mr McGuire. I also note that two clear view windows on the bridge were shattered. Noting the obstructions that were detected to the door, it seems more likely that Mr Cullen had been able to successfully exit via one of the clear view windows.

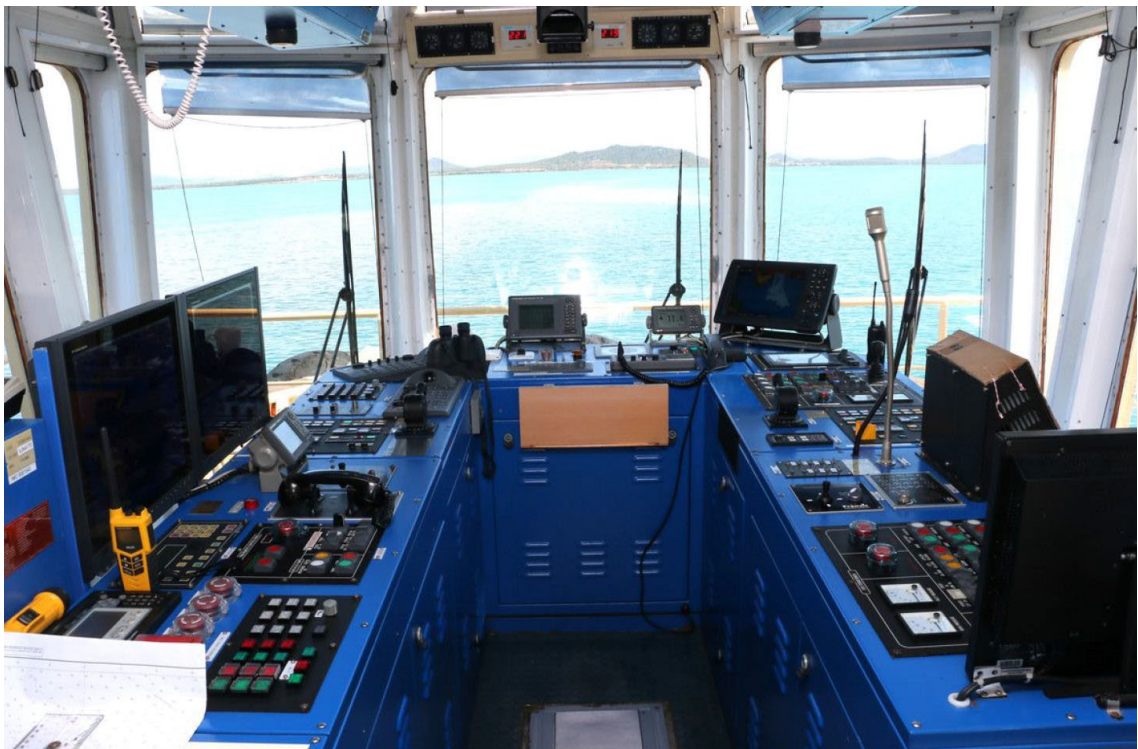
- "the tug and wake from the tug was obscured from vision by a window frame at the forward starboard side of the wheel house".*
300. Mr Matchett, in his inspection of the *Svitzer Nana*, agreed that there were restrictions on visibility, from the controls panel. Mr Matchett also identified issues with the positioning of the radar monitor.

301. The monitors were not in direct view of the helm when the helm is positioned at the forward end of the conning station. They also appeared to be affected by sunlight when the sun is positioned over the starboard side of the vessel. The screens are not visible when viewed side on (i.e. at a viewing angle towards 90 degrees).

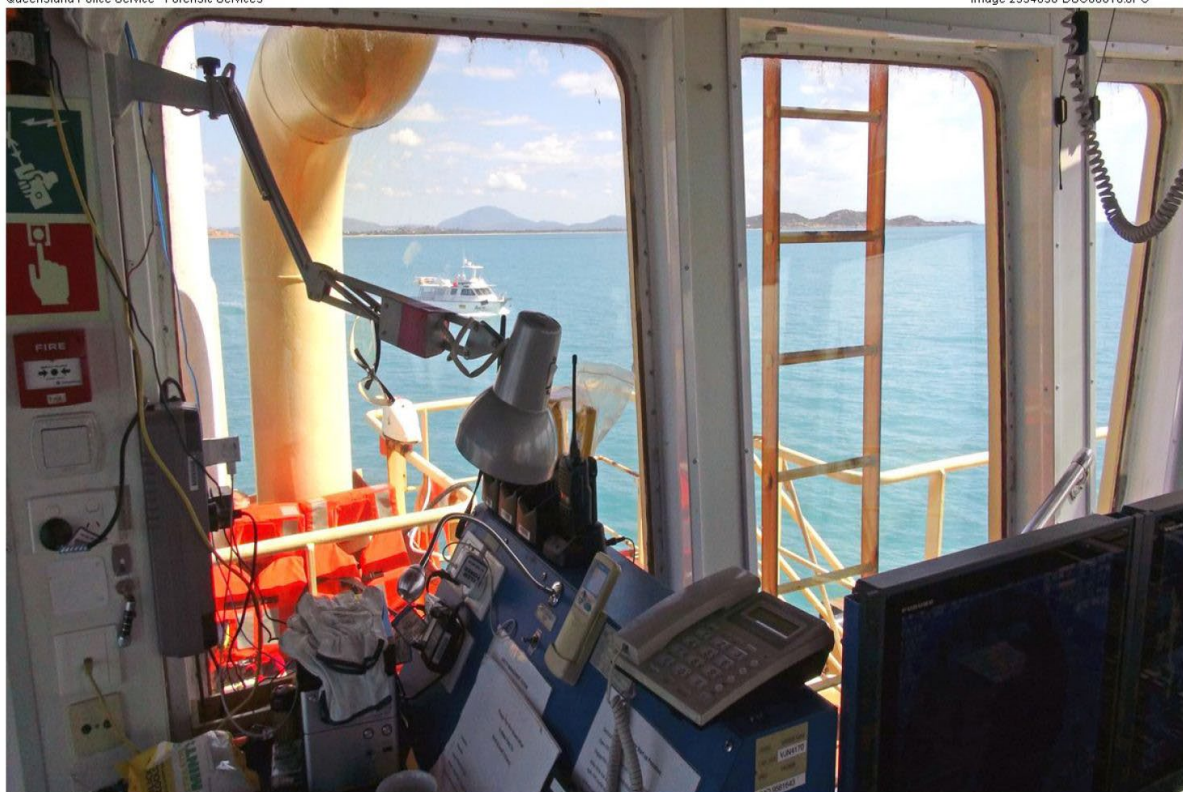
Image 2994838-DSC00018.JPG

304. Video footage was taken from aboard the *Svitzer Nana* by scenes of crime officer Senior Constable Schubert. It was noted during the re-enactment that there was a good radar echo of the vessel Ace IV throughout the trials. It was noted by officers that large window mullions (supporting structure between the glass windows) of the *Svitzer Nana*'s helm could obscure the view of the Ace IV, depending on where the observer was positioned.

Source QP1600924429 FR1523725 2994838-DSC00018.JPG 2016-05-28 11:52:10 4005251 - Svitzer Nana: screen shot from video during runthrough
