OFFICE OF THE STATE CORONER

FINDINGS OF INQUEST

CITATION: Inquest into the death of Samuel John Beresford

CATCHWORDS: Coroners: inquest, gyroplane, investigatory and regulatory responsibility

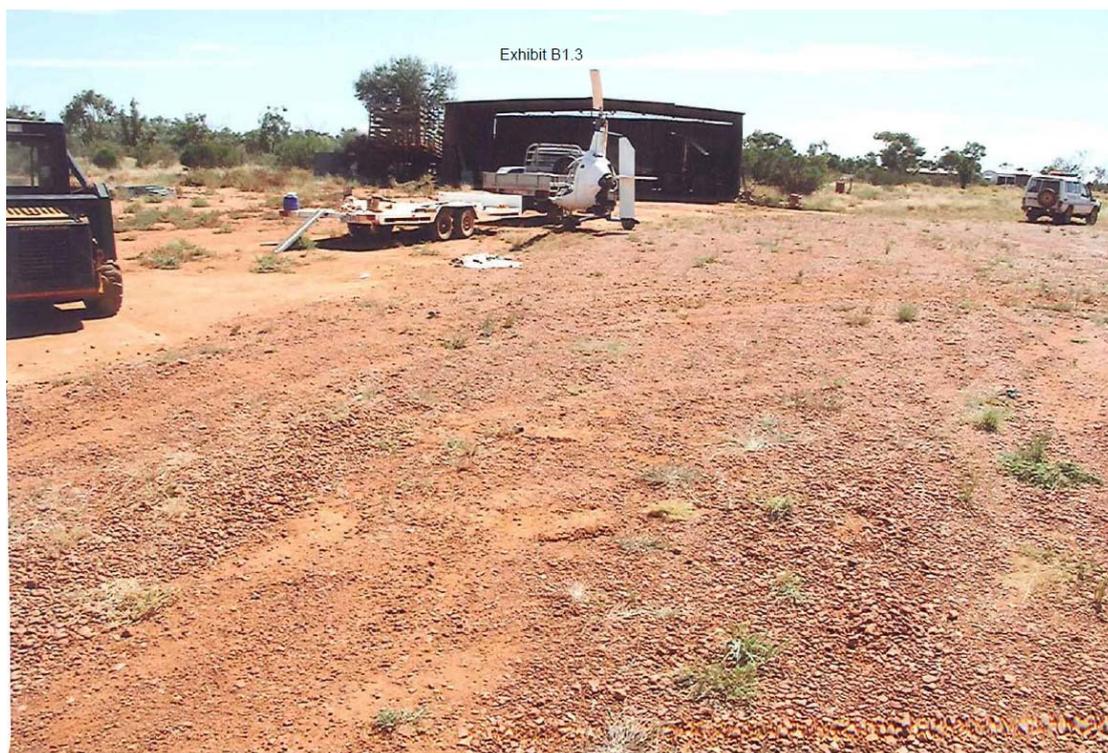
(Photo 1016, Exhibit 1.3)

In oral evidence, Sergeant Relf advised that he determined that the gyroplane would have been pointing towards the shed on the property when it was started. The Toyota utility and trailer used to tow the gyroplane to the property was approximately 16 metres ahead to the left of where the gyroplane was started (when looking from behind the gyroplane). A bob cat, which was used to assist in re-attaching the rotor blades to the gyroplane before it was started, was about 5 – 8 metres adjacent to the gyroplane to the left hand side (when looking from behind the gyroplane).

Based on the drag marks made by the path the gyroplane took, the throttle control lever being on the left hand side of the cockpit, and the blood and tissue also found on the left hand side of the rudder and boom section of the gyroplane, Sergeant Relf determined that Sam would have been standing outside the cockpit on the left hand side of the aircraft when he started the gyroplane.

Sergeant Relf noted that the front lower section of the gyroplane was extensively damaged and the gyroplane's propeller was fractured with sections of the propeller blades located on the ground.

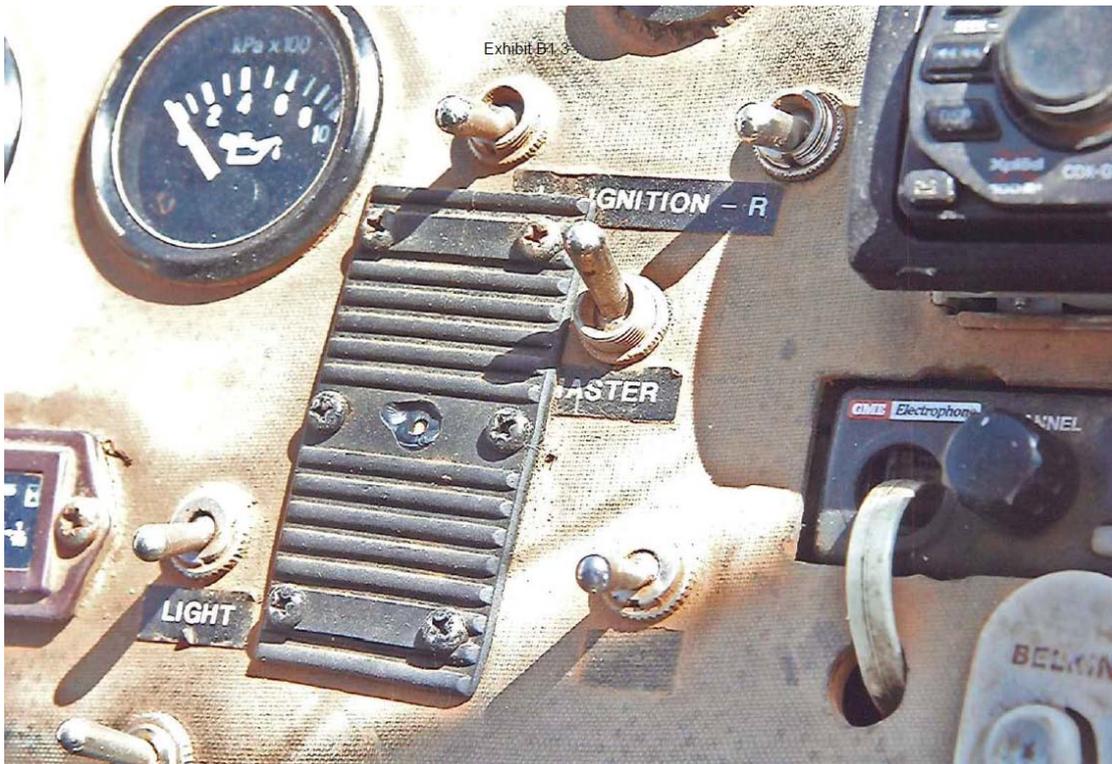
(Photo 1044, Exhibit B1.3)

The police officers observed that the throttle position of the gyroplane was in a 'closed' state, the two magneto (ignition) switches were in the 'on' position and the master switch was in the 'on' position. The photograph below shows the ignition switches in the 'off' position, however Sergeant Relf had moved them down for safety reasons.

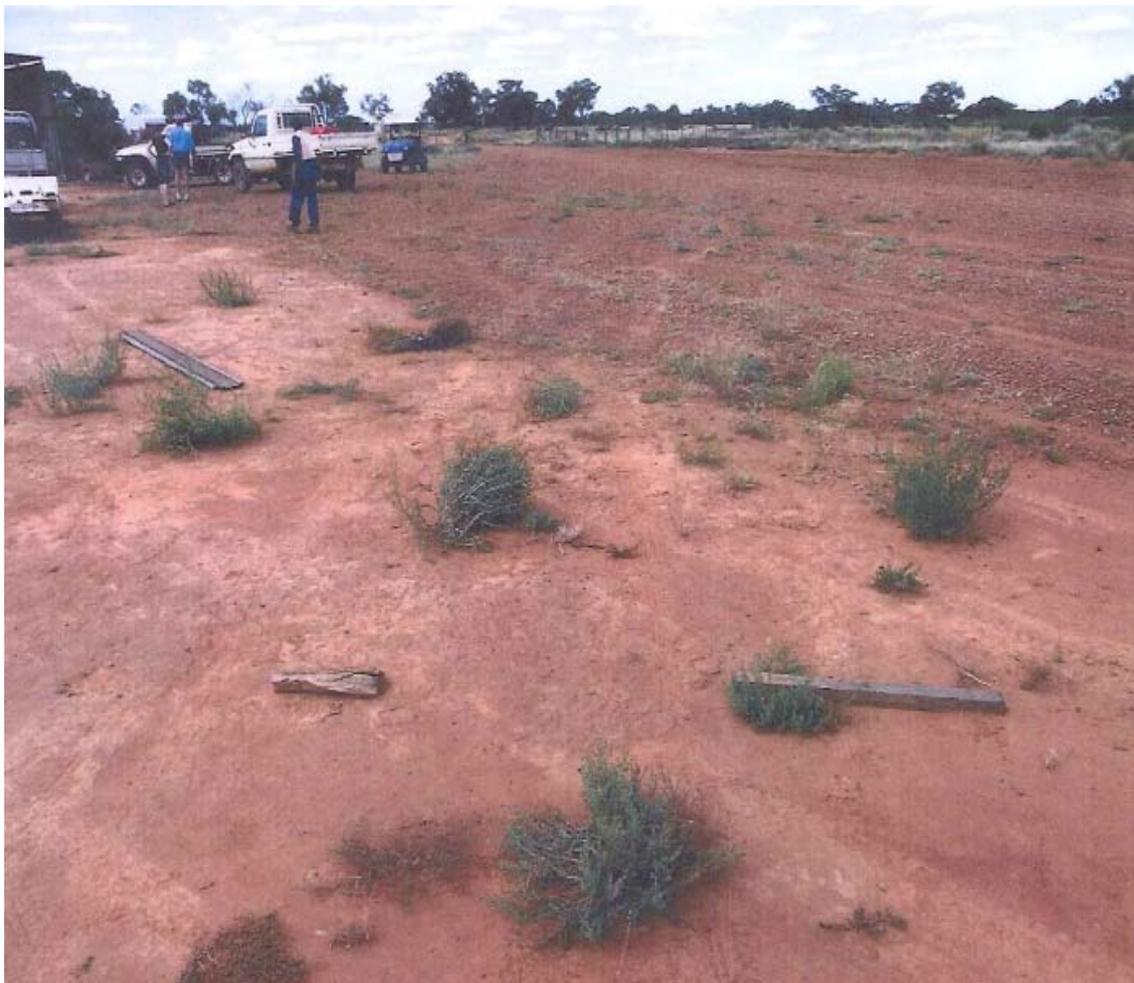
The next day Eric took a drive to the incident scene. He found two lengths of timber approximately 30 metres to the south of where the impact had occurred. He thought it was important enough to take photographs and he later produced them to WHSQ.

Given Sergeant Relf's evidence about the scene, I consider it unlikely that the pieces of wood found were utilised as chocks. If they had been used they were clearly unsuitable for that purpose and would have provided little resistance in the event of a high revolution start.

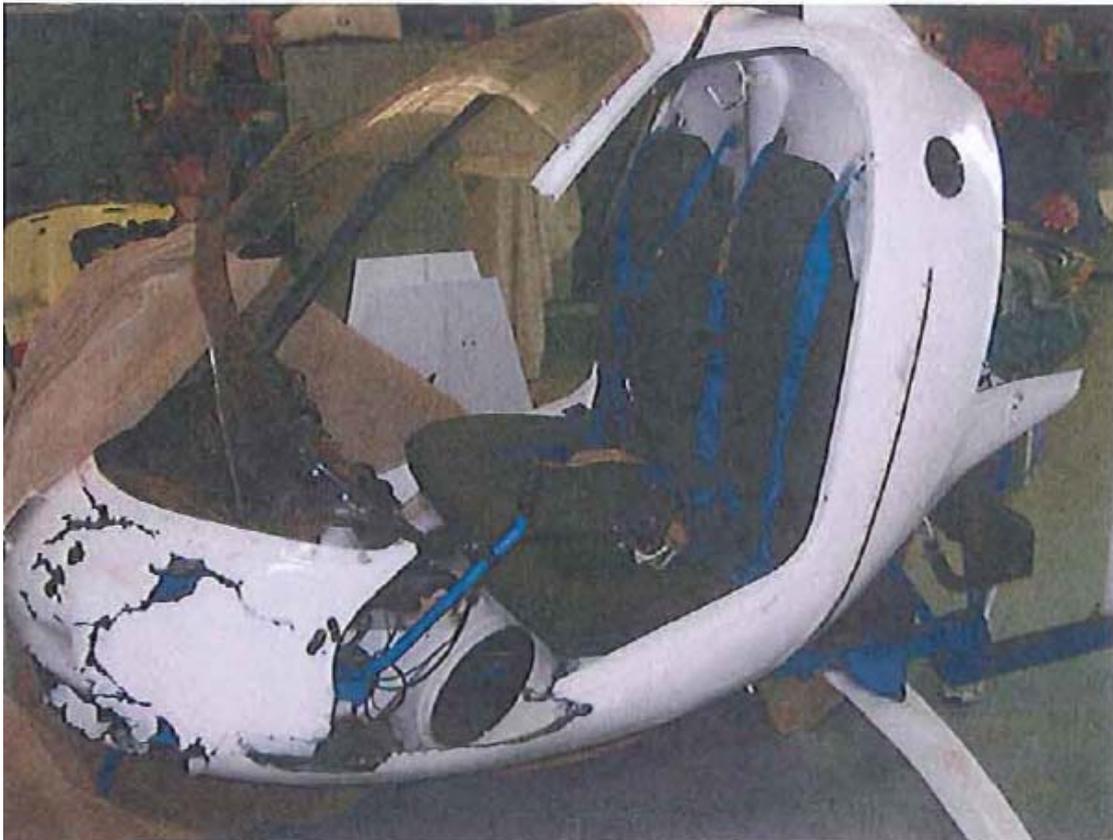
Photograph 1. Front damage to the body of the Gyrocopter.
