## **CORONERS COURT OF QUEENSLAND FINDINGS OF INQUEST**

**CITATION:** **Inquest into the death of Dale Kennedy**

**CATCHWORDS:** Apprentice, non-electrical work, ceiling space, electrocution, interference with wiring by unknown persons, adequacy of ESO investigation, missed opportunities, level of electrical safety assurance under current standards and regulatory regime, prospect of greater use of RCD's

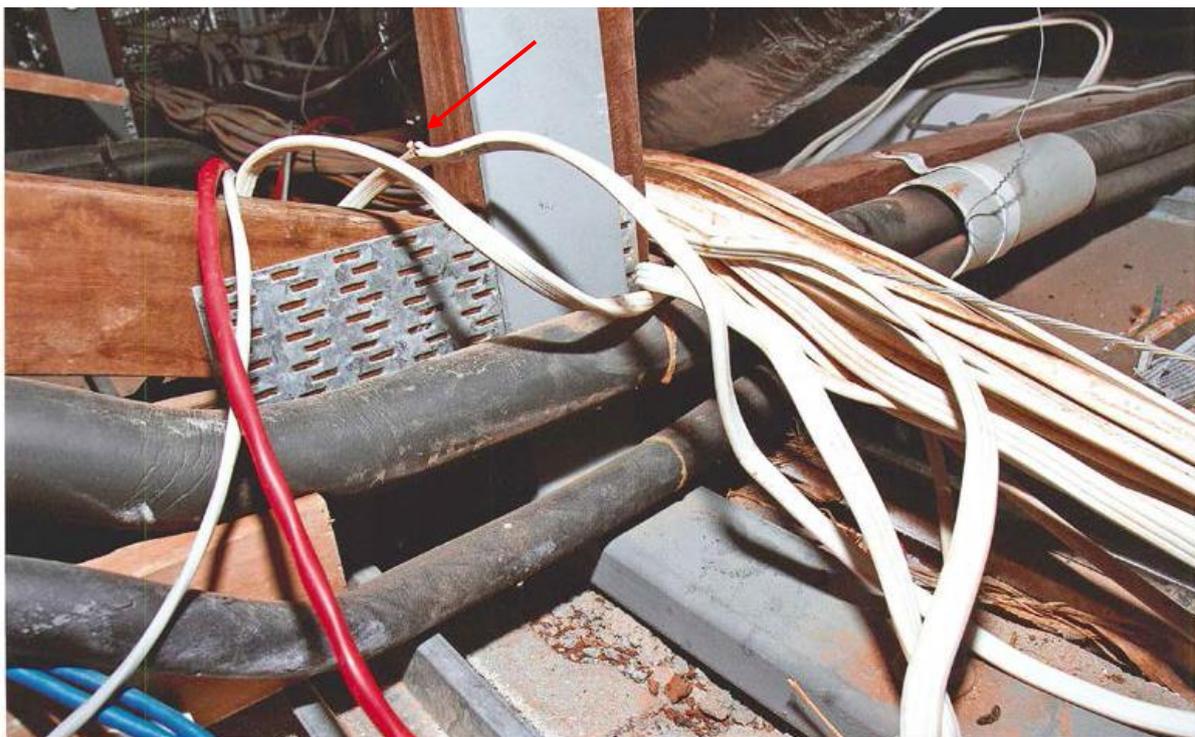
The Inspectors concluded the cable, to become known as circuit 22, was recently damaged. The cable had a fresh contact blow mark with carbonisation soot from contact and a clean insulation tear<sup>3</sup>. The truss gang nail plate also had a clear blow mark where contact was made with the live part.

Inspector Stattmann reported <sup>12</sup> that if wiring to the fan in room G117 wired along the face of the truss to the catenary, it would have been protected from mechanical damage. Instead, the wiring ran across the top of the metallic gang nail plate of the roof truss and then into the catenary.

Mr Browne reported that circuit 22, lying across the gang nail plate, was not mechanically protected and was an area likely to be disturbed, namely within less than 2 meters from a man hole and in a space greater than 600mms from the ceiling<sup>13</sup>. Mr Browne was of the opinion that this was a major noncompliance<sup>14</sup>, and circuit 22 ought to have been "located over the ceiling member or supported above the ceiling member but so that it was not likely to be subject to mechanical movement, not likely to be disturbed"<sup>15</sup>.

Photograph depicting circuit 22 cable positioned above the gang nail plate

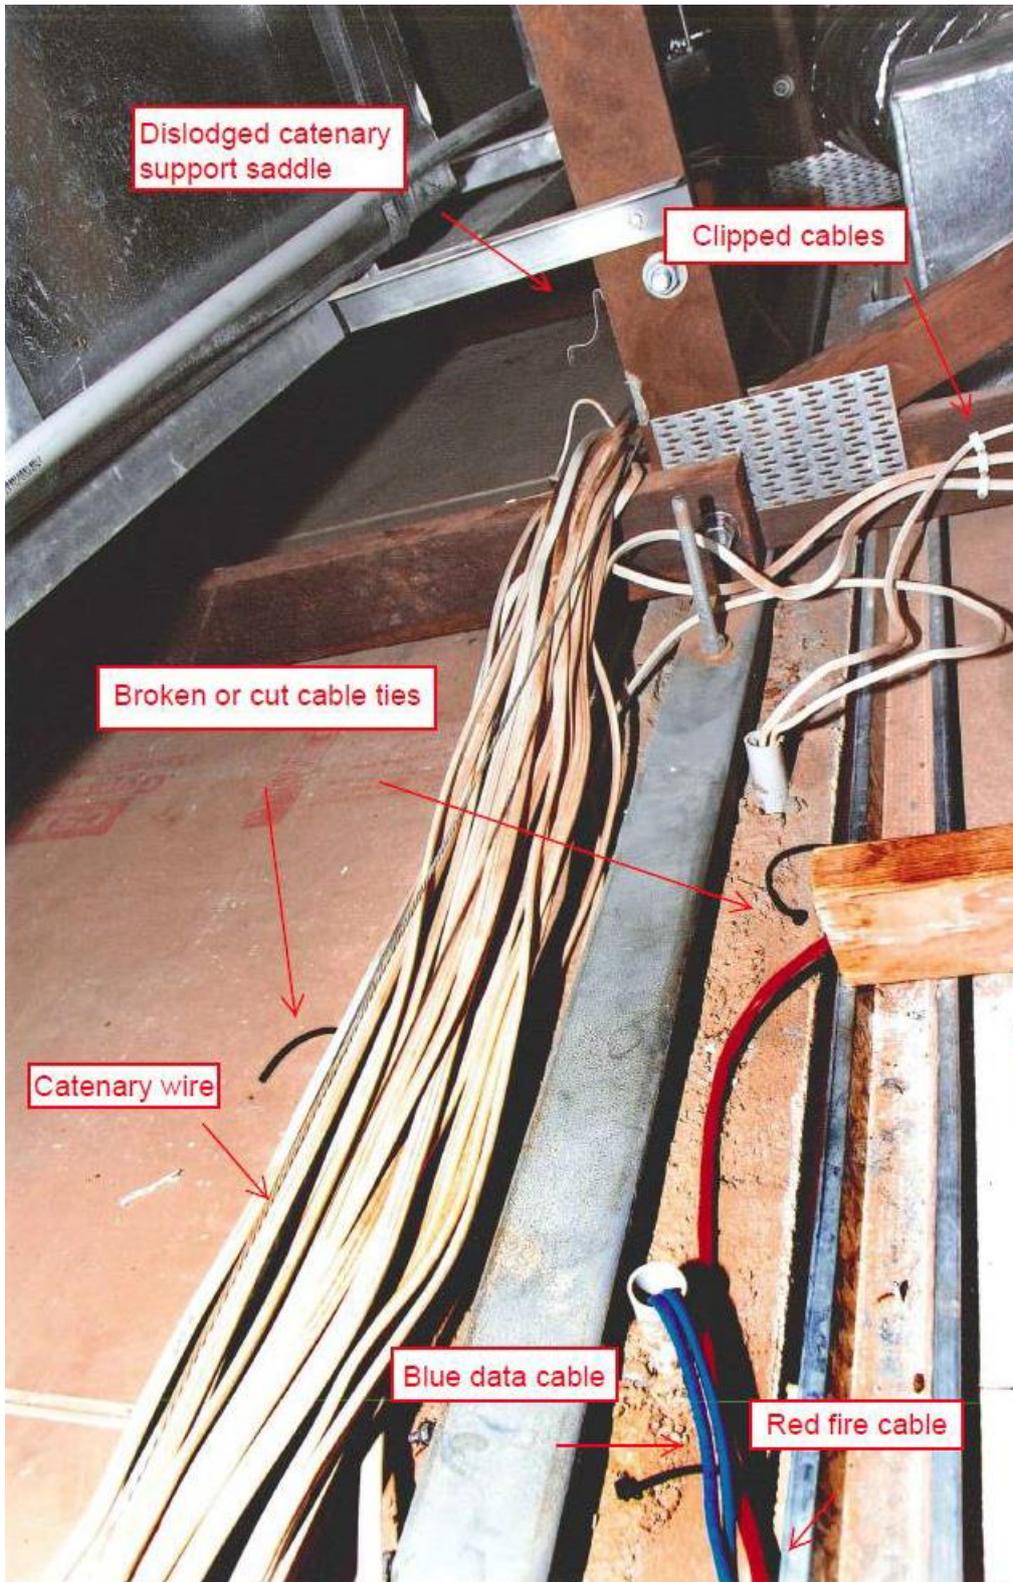
The coronial team and I studied the photographs that police took at the scene to try and understand the general layout of the wiring, including where and how circuit 22 left the catenary. It became apparent from studying the photographs that circuit 22, at the point where it rested on the gang nail plate, was NOT in its 'as installed' position. The catenary (steel wire) was constructed to support a bundle of cables for the length of that building (eye bolts at each end), running adjacent to air-conditioning plant. The span of the catenary was supported at regular intervals with support saddles fixed to trusses to prevent the steel wire sagging. From the photographs, it was apparent that the catenary was lower than expected near where circuit 22 left the bundle of cables. On closer investigation, it was discovered that a support saddle nearest where circuit 22 contacted the gang nail plate was not supporting the catenary. The catenary hung lower under the weight of the cables, lowering circuit 22 from its original position above and clear of the gang nail plate.

Mr Browne reported that it is unlikely that the catenary wire would pull down on the saddle causing the top to become loose without human intervention and it would take an intentional act to remove the top screw, open the saddle and release the catenary wire<sup>68</sup>. It may have had to do with the length of the cable, or that it was routed after the ceiling was installed<sup>69</sup>. Mr Browne remarked, "Before the catenary dropped it wouldn't have been good workmanship if it was run in place above a gang nail plate"<sup>70</sup>.

Photograph depicting various features including catenary and dislodged saddle
