# OFFICE OF THE STATE CORONER

## FINDINGS OF INQUEST

**CITATION:** **Inquest into the death of Seongeun CHOI and Sang Won PARK**

**CATCHWORDS:** CORONERS: Inquest Adventure tourism – white water rafting – Tully River – 8 person rafts – collision between rafts – diversion to hazardous route - capsize and entrapment with prolonged period of immersion – drowning – adequacy of safety risk management

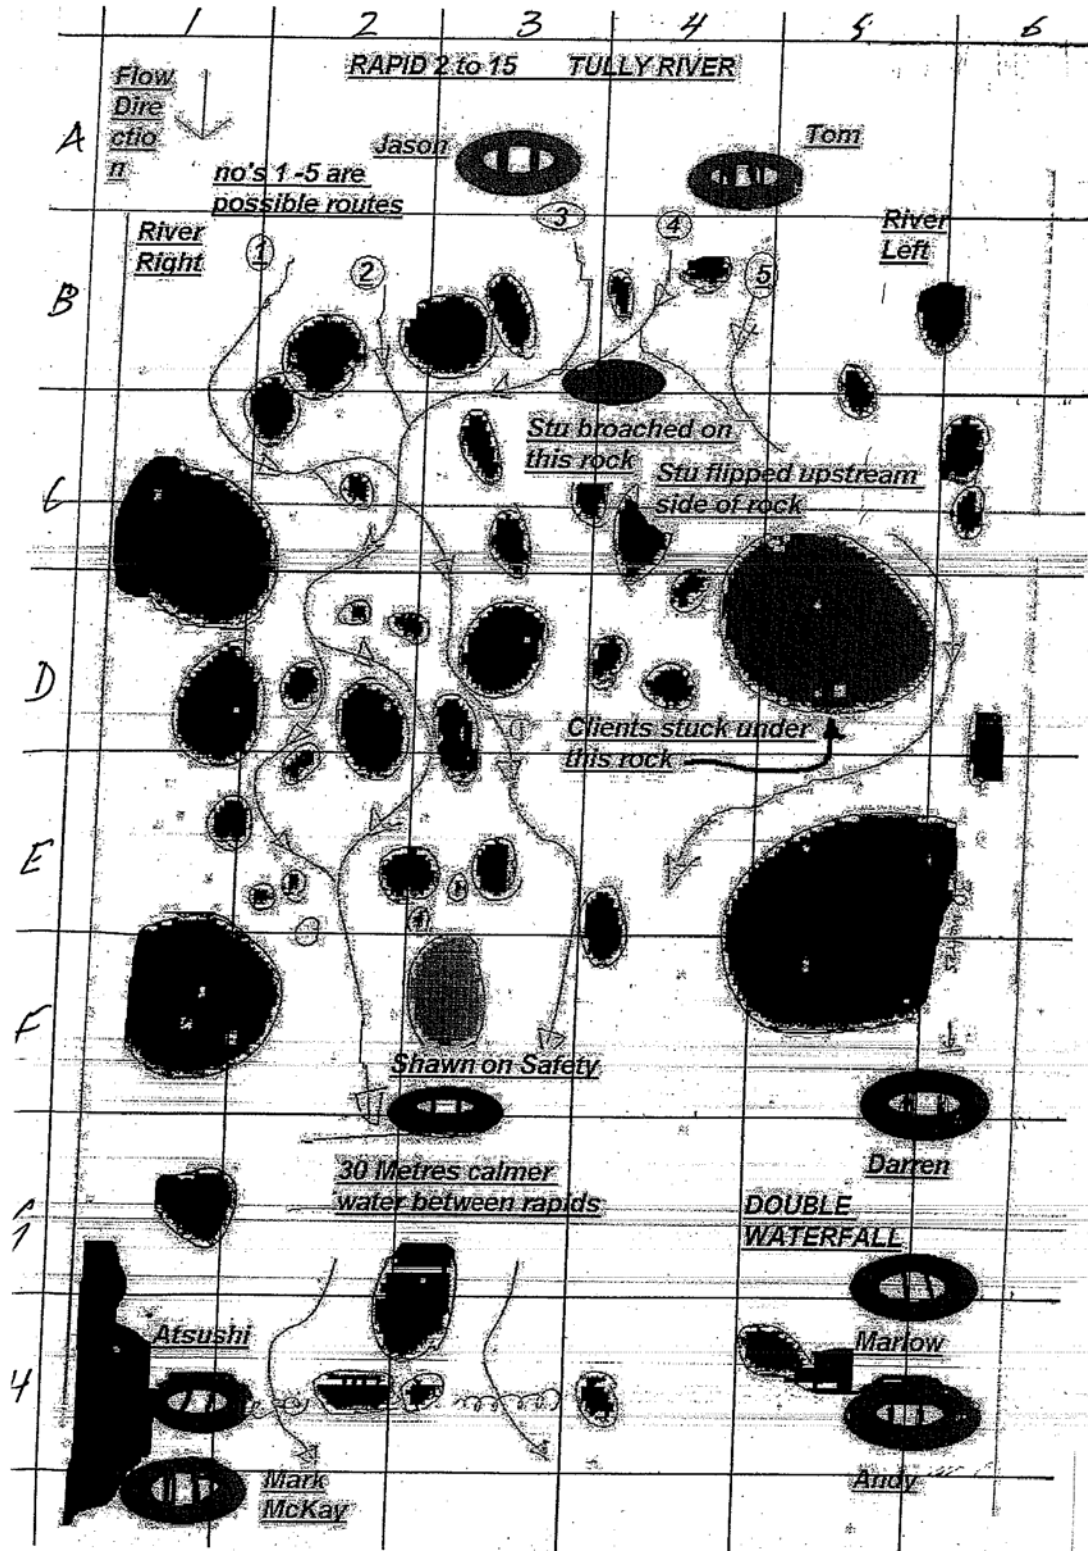
Attachment A is a sketch plan prepared with the assistance of RnR for the purpose of these proceedings. The plan was referred to by witnesses during the course of proceedings to assist in clarifying aspects of what happened. It is acknowledged that it is only a plan and not to scale. It does not attempt to reflect the complexity of the dynamics involved. Nonetheless, it was very helpful when used in conjunction with photographs of the scene to

trace key movements. There is a grid overlay on the plan to assist in describing particular locations. I will adopt the language used by the river guides in explaining directions. The expressions “river left” and “river right” are used to denote direction from the perspective of a person facing downstream.

River Guide Shawn Forster had descended 2-15 and eddied out to right in the middle of the river to assume the cover position depicted on the plan at FG3. He pulled his raft up, partly on rocks to hold it in position.

The plan also depicts the positions of other river guides who had descended 2-15. At H 1-2 is depicted the rafts of river guides Mark McKay and Atsushi Karni. On the opposite side of the river, at FGH 5 and 6, are the rafts of River Guide Darren Nunn (also a River Medic), River Guide Marlo McGregor, and River Guide Andrew Loxton (also a River Medic). At row 3, there are circled numbers 1 through to 5 indicating the possible entry points to 2-15. It is accepted that entry points 1, 2 and 3, at this water level, tend to carry a raft to river right and are relatively safe. Entry points 4 and 5 tend to carry a raft to river left, towards and around the very large bolder situated at D5 and known as Sieve Rock. This route is very hazardous due to the presence of multiple sieves (locations where water is forced under large boulders resting on smaller boulders creating entrapment points).

Mr Dearlove’s raft entered 2-15 through chute 3 and broached sideways onto rock at BC3 and 4, stopping and facing river right. In his statement Mr Dearlove describes what followed in these terms:

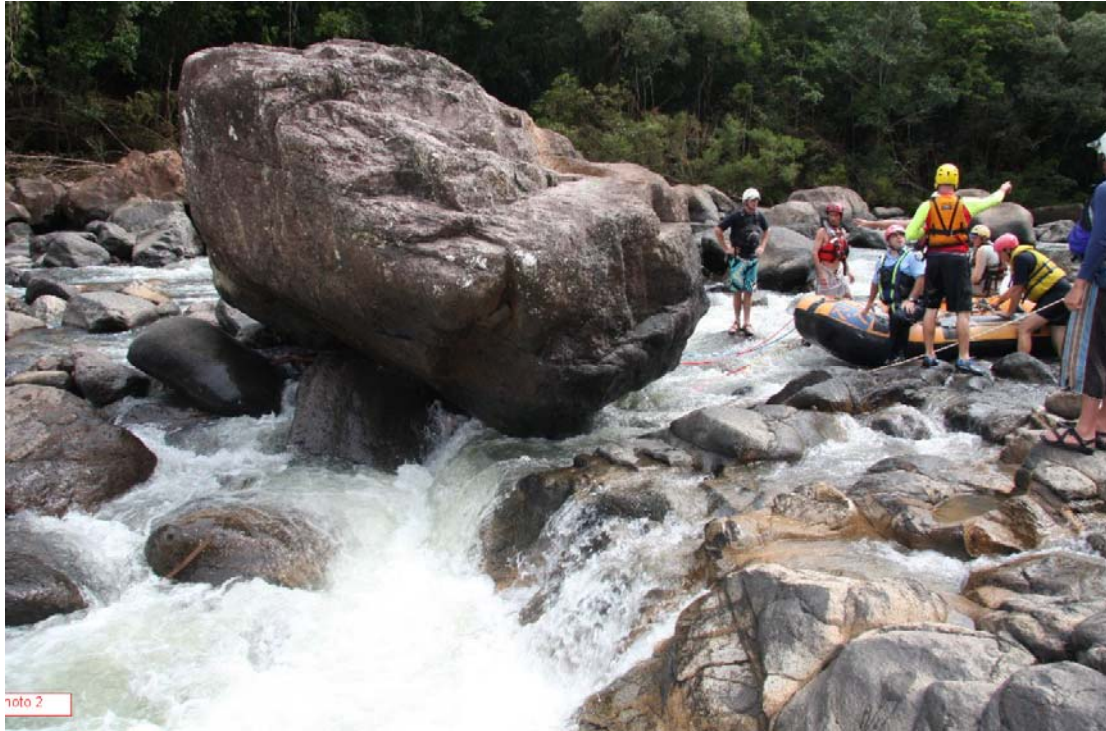
**Attachment B**

The rock that the raft struck causing it to flip was Sieve Rock.

The decision was made, given the substantial passage of time, the prolonged period of immersion and the heightened risk of danger to the rescuers, further efforts to extricate Mr Park be suspended. Queensland Fire and Rescue Service attended the scene and were ultimately able to extricate Mr Park but only on the following day, using specialist equipment to achieve a controlled lift of Sieve Rock and sufficient space for extrication. Mr Park was deceased.

Dr Botterill reports that post-mortem examination showed severe crushing chest and abdominal injuries with severe trauma of the liver, bladder, and kidneys, near amputation of the left upper limb, bruising under the scalp and over the brain surface, extensive grazing over the skin surfaces, and probably lung bruising. Dr Botterill concluded that although many of the injuries appeared to be post-mortem, some changes were consistent with at least some peri-mortem injury. There were injuries associated with the displacement of the rock and subsequent crushing of the body.

Photograph depicting Sieve Rock under which Ms Choi and Mr Park became entrapped. The water level had lowered substantially and efforts were continuing in an attempt to recover Mr Park. The flow of water beneath Sieve Rock is apparent.

***In the course of implementing my earlier recommendation, RnR include within its formal risk assessment of each set of rapids, the prospect of collision between rafts and with rocks as a potential initiator of a flip - as a hazard, assess the risk of such an event, and select control measures that will mitigate that risk to a defined acceptable level. The other attributes of my earlier recommendation also apply.***
