CORONERS COURT OF QUEENSLAND

FINDINGS OF INQUEST

CITATION: Inquest into the death of Christopher Ian Powell

CATCHWORDS: Coroners: Inquest, Elevated Work Platform, Outrigger Collapse, Unstable Ground, Mobile Crane Code of Practice 2006, Geotechnic Report, Safe Support Mobile Plant Guide, Photography.

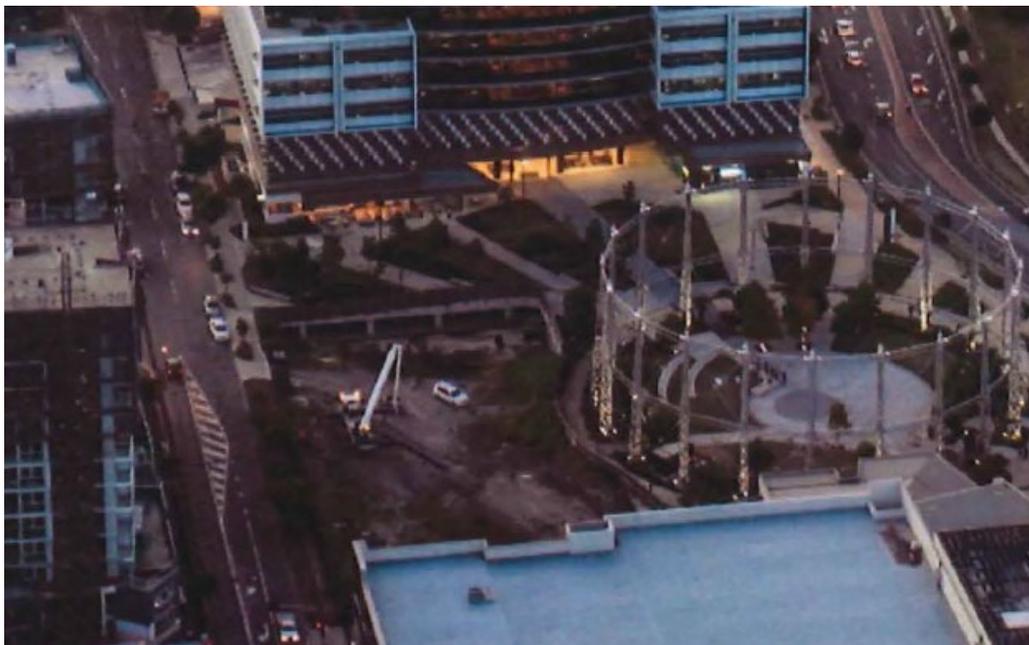
Figure 1 - EWP being set up in position before the collapse on 14 December, 2015.

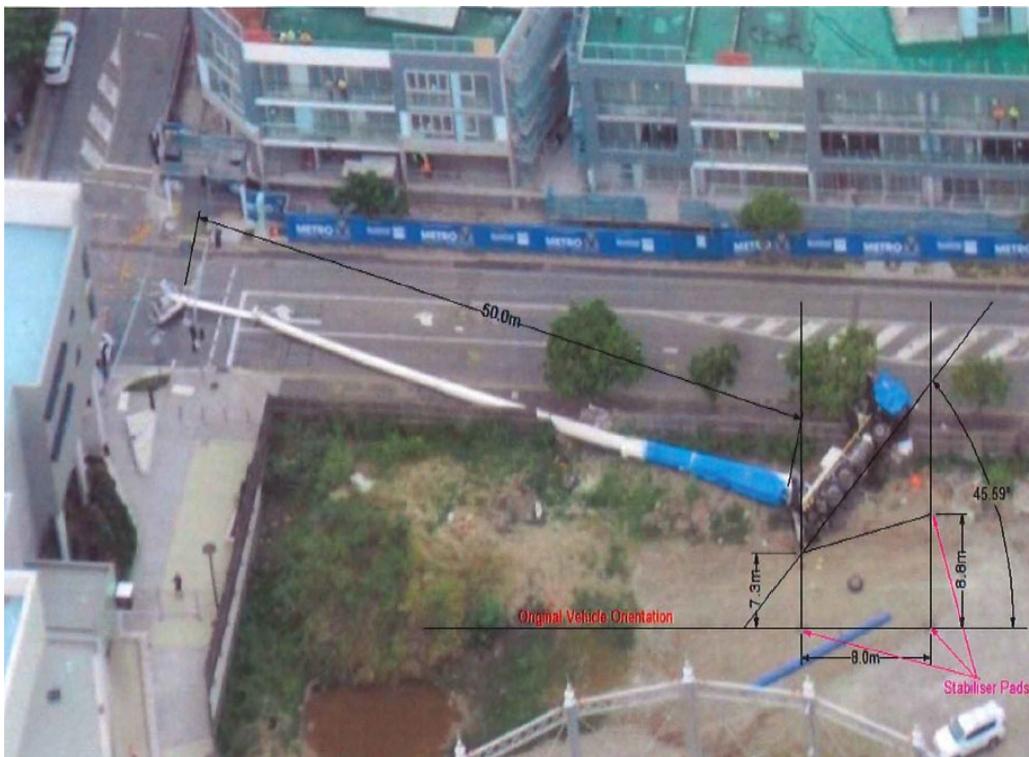
Figure 3 - Aerial view of the EWP the next morning (15 December, 2015)

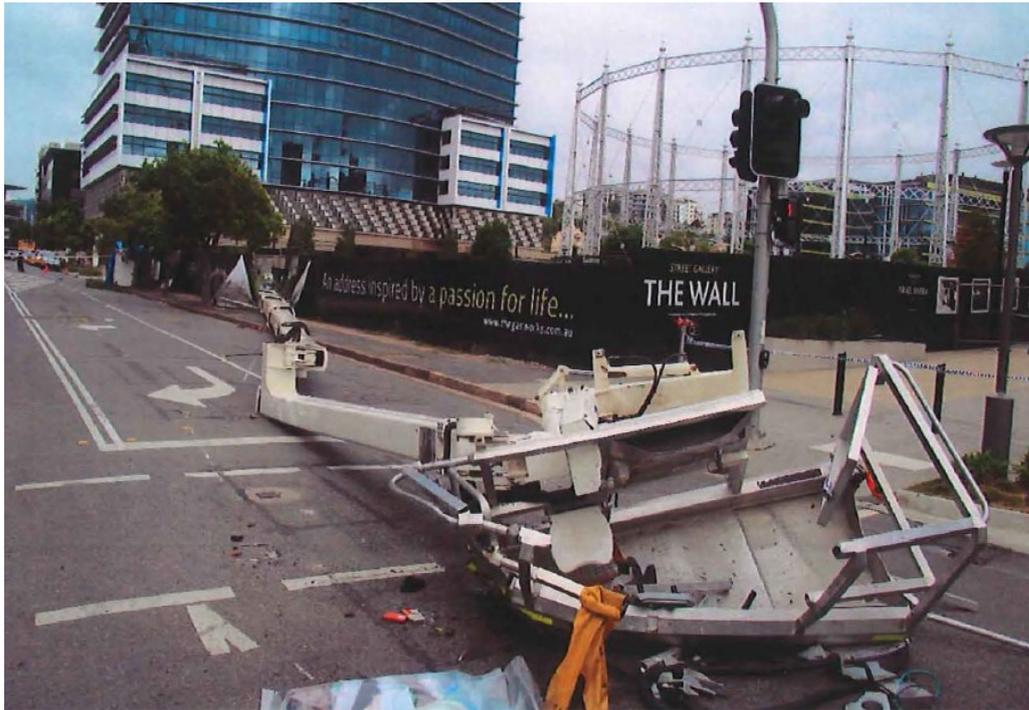
Figure 4 - Final position of the EWP basket on Longland Street. The front of the basket has been cut away by emergency services.

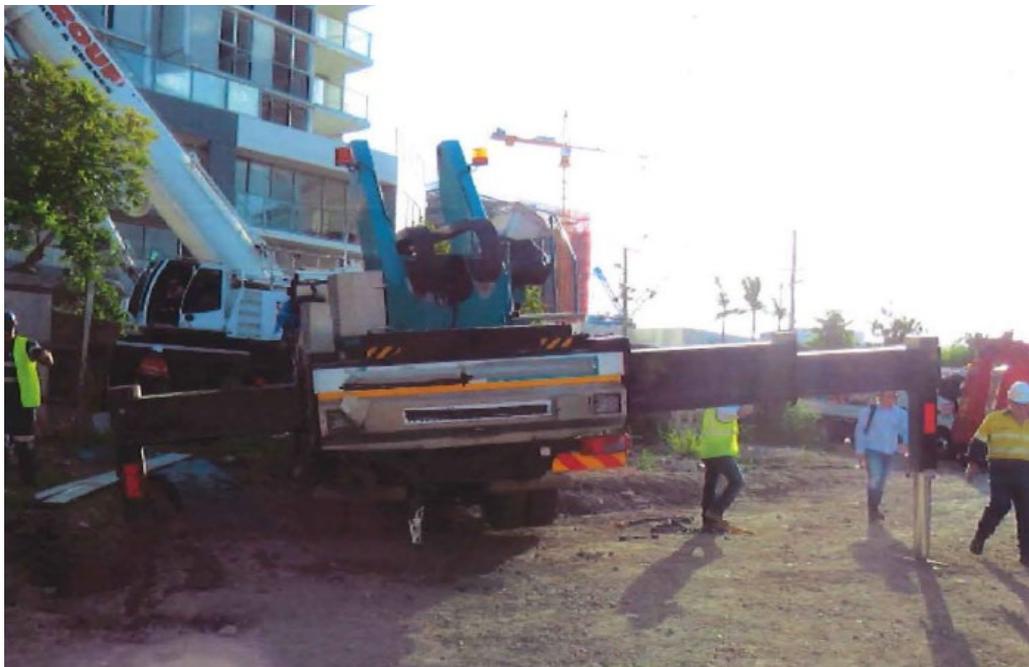
Figure 5 – The subject EWP after being recovered and “uprighted” but not returned to its original position. Note the rear outrigger “arm” on the passenger’s side is not fully deployed to 3 metres unlike the driver’s side leg. It was half deployed at 1.4 metres which reduced the “spread” of the load.

- (a) The most likely cause of the instability of the EWP was "bearing capacity failure under the rear left outrigger pad which was not fully extended".
- (b) A secondary component may have been the reduction in ultimate bearing pressure of the foundation as water pressures dissipated towards fully drained conditions.
- (c) The failure occurred because the area of the plastic pad beneath the outrigger was inadequate for the prevailing ground condition and applied loads.
- (d) Geotechnical assessment indicated that the pad size should have been at least 2.6 times larger than was actually used beneath the outriggers, and possibly larger if the outrigger load was greater than 19.9t as shown on the Lincon Logistics load tables.
- (e) Using the plastic pads with an area of only 0.46m², necessitated permissible ground bearing pressures of 40t/m² to 50t/m² for the

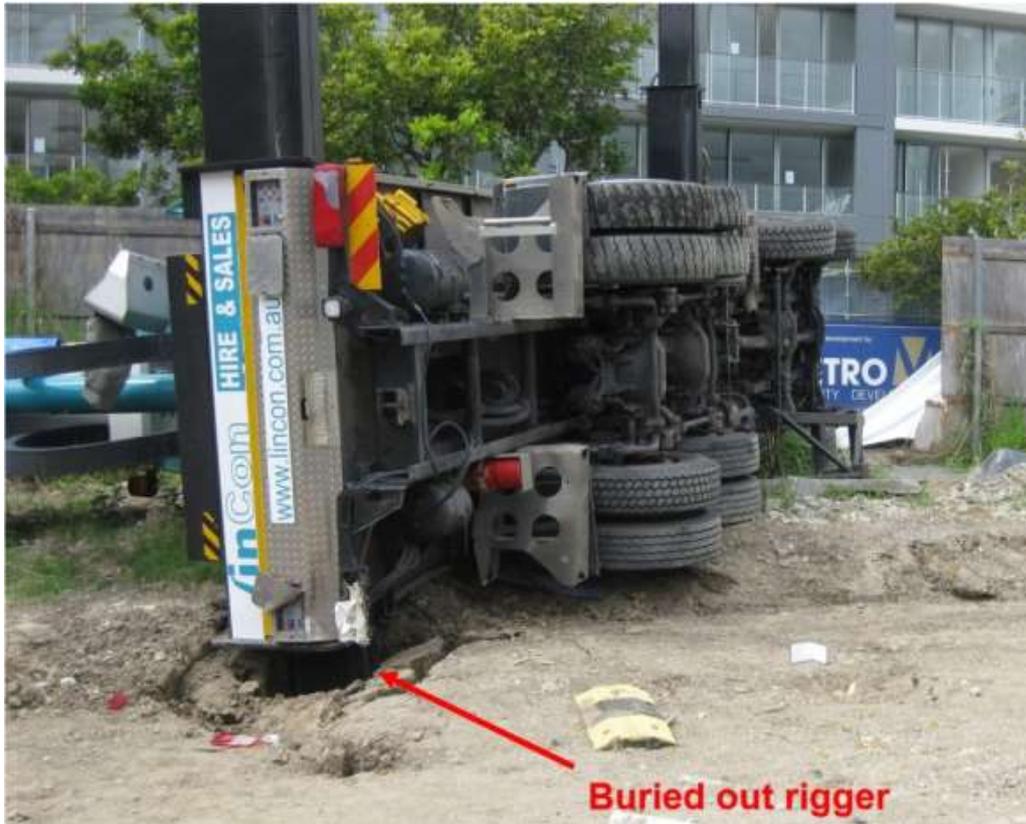
Figure 6 – Note the EWP in situ before being “uprighted” and buried passenger’s side outrigger leg. The hard gravel crust can be seen but not the soft clay underneath.

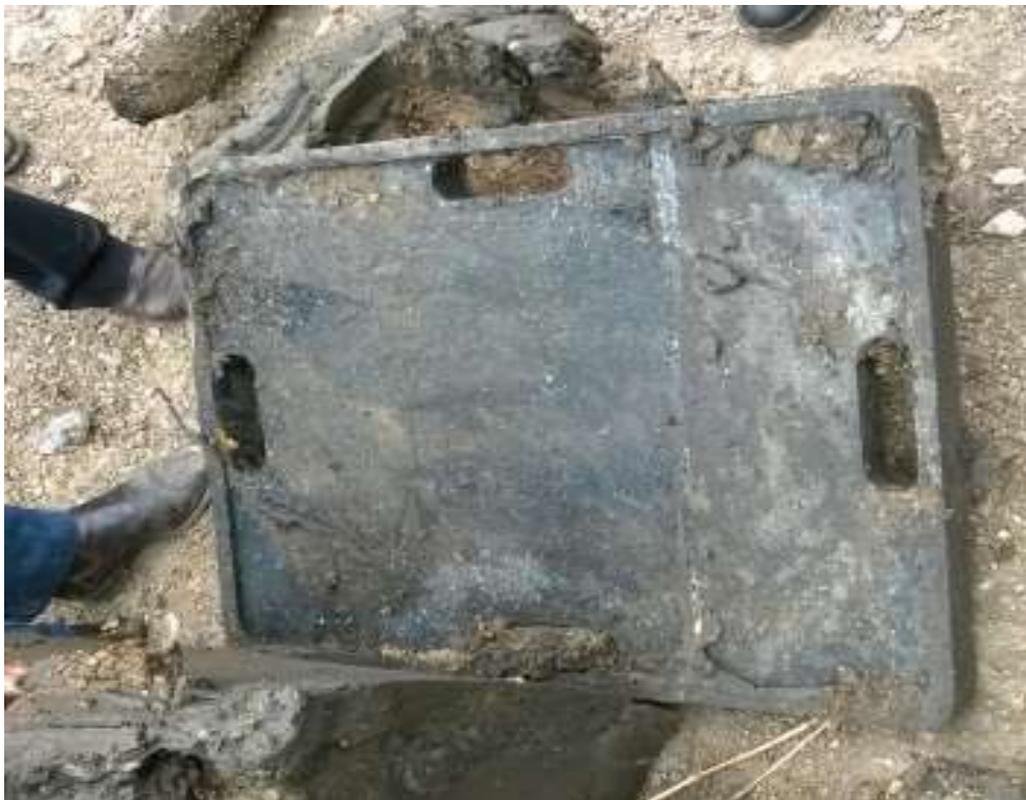
Figure 7: View of the recovered stabiliser pad upon which the rear passenger’s side outrigger leg was placed. Note the soft underground of clay below the hard gravel crust.

- (f) The Factor for Safety⁹⁰ was calculated as 1.03.
- (g) Factors for safety for the plastic pads beneath the outriggers could be assessed as being as low as 1.0 to 1.2, which is grossly inadequate when compared to industry norms of 2.5 to 3.0, and this essentially foreshadowed failure.
