OFFICE OF THE STATE CORONER

FINDINGS OF INQUEST

CITATION: **Inquest into the death of Scott Anthony Bennett**

CATCHWORDS: Coroners: Motor vehicle crash, road train jack-knife, mechanical defects, road design.

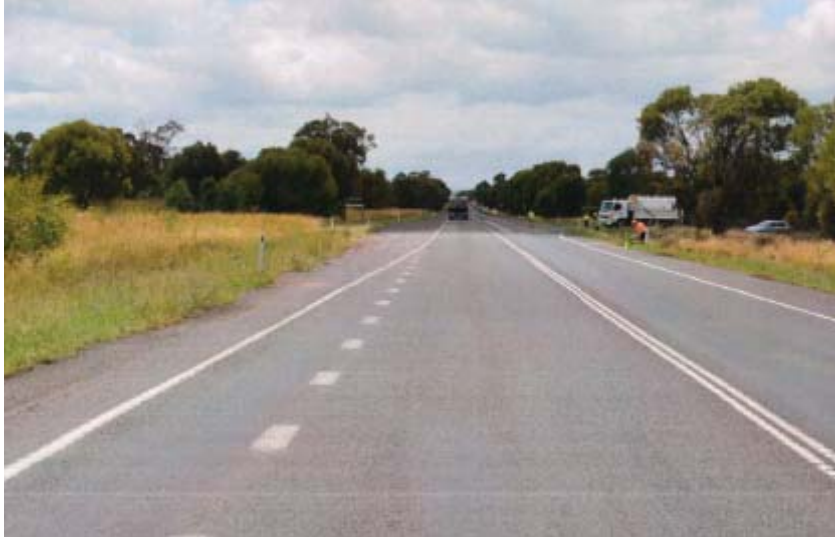
Photograph of end of overtaking lane merge and approaching the intersection

The report also noted that the Jondaryan-Mt Tyson Road intersection is 96 metres east from the end of the merge taper of the overtaking lane.

Based on the speed limit of 100 km/h, the desirable spacing represented 417 metres. The report noted that the probability of a crash event occurring increases with a spacing distance of only 96 metres. The reasoning was that overtaking vehicles are more than likely to be travelling at high speed at the end of an overtaking lane and are not expecting to brake or slow down behind a right turning vehicle even if the turning vehicle is indicating.

It will therefore be recommended (if not already being implemented), that TMR proceed with the design and construction of a Channelised Right Turn at the intersection of the Warrego Highway and the Jondaryan Mount Tyson Road with priority.

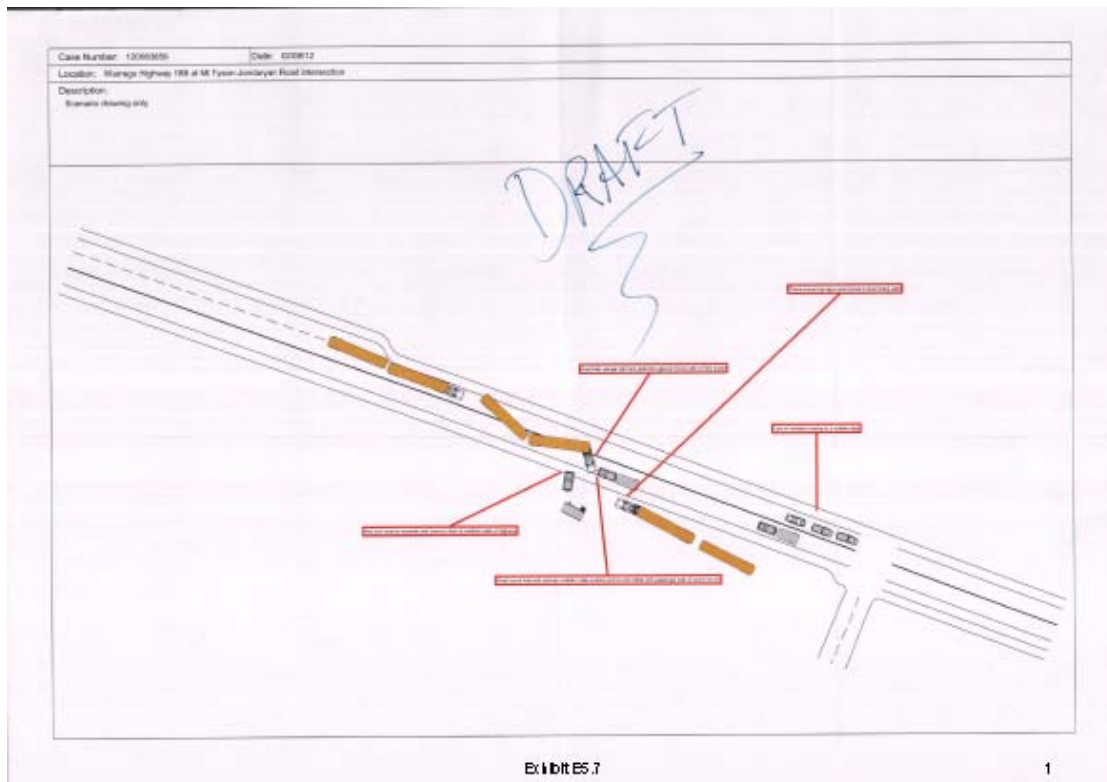
Scenario Drawing showing movement of Road Train

The unusual position and angle of the prime mover which collided with Mr Bennett's vehicle suggested to SC West that the road train had 'jack-knifed' prior to the collision. In particular, damage to the prime mover's driver's door and the front of the A trailer was consistent with the prime mover being in a jack-knife position with the prime mover rotated fully to the driver's side and wedged against the front driver side of the A trailer.

A forensic examination found there were road surface skidmarks from the eastbound lane into the westbound lane and a yaw (curve) in that direction. There were skidmarks on the northern side of the road, located in the grass verge, with the skidmarks consistent with the trailers swinging around behind the prime mover.
