OFFICE OF THE STATE CORONER

FINDINGS OF INQUEST

CITATION: **Inquest into the death of Sean Lawrence Guy Edwards**

CATCHWORDS: Coroners: inquest, motor car racing, instructor training, race track safety features, gravel trap, tyre wall, mechanical failure causing crash, recommendations for conduct of private track

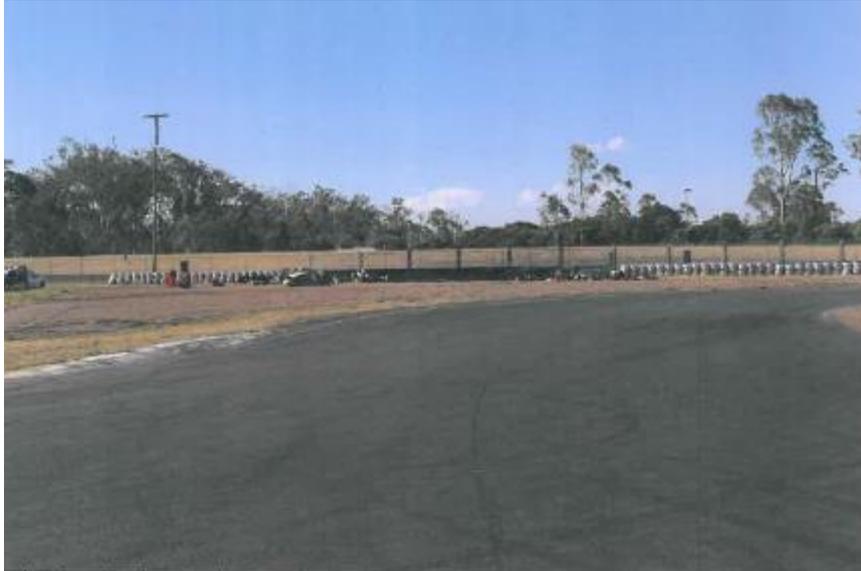
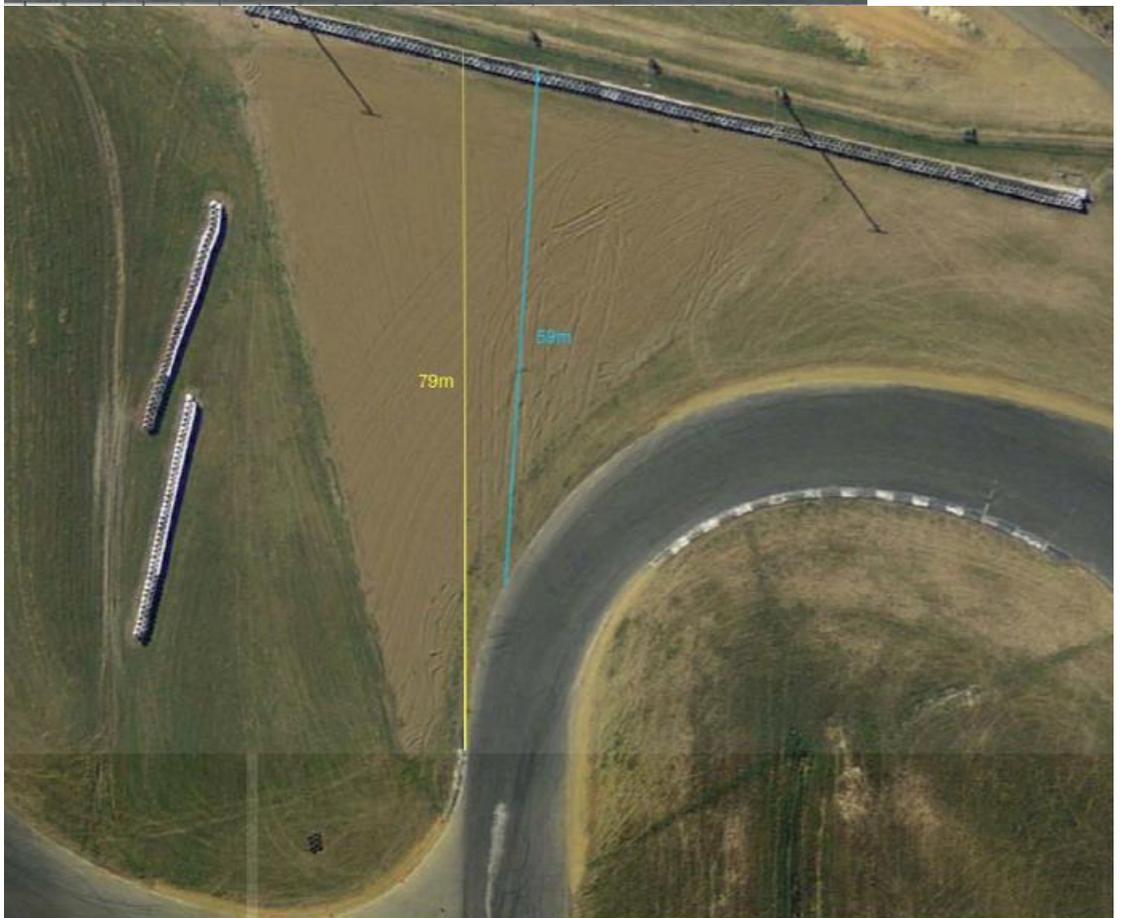
98. It is now quite apparent Turn 6 was not designed in such a way that it would arrest a vehicle travelling at high speed on the approach to that turn in the event of total brake failure. The track design models developed by FIA assume full effective braking. Mr Hall pointed out in his report, he is '*unaware of any race circuit in the world that has a gravel bed within a run-off zone that is designed to arrest the fastest race-car using that track in the event of total brake failure*'.

99. Accepting that is the position, that should not mean that the risk of a total brake failure should not be addressed. That could be done by considering the gravel trap and barriers and either making appropriate changes to the
