## OFFICE OF THE STATE CORONER FINDINGS OF INQUEST

**CITATION:** **Inquest into the death of  
Pekka Tuppurainen**

**CATCHWORDS:** Coroners: inquest, underground mine at Mt Isa,  
inadvertent entry of loader into stope, traumatic  
asphyxiation of operator, adequacy of control  
measures, adequacy of remedial action, implications  
of incident for effectiveness of safety management  
system.

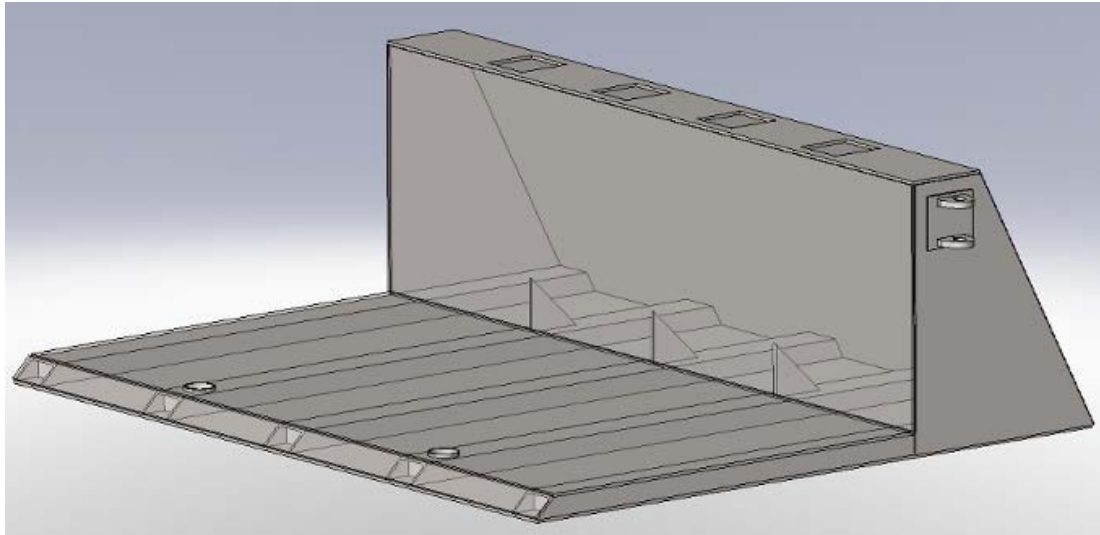
Mines published a Guidance Note in August 2010 to disseminate to industry the lessons to be learnt from this incident. It included the following depiction of a steel temporary stop logs. The publication included extensive guidelines about managing hazards associated with vertical edges.

Accompanying the introduction of temporary steel stop logs were new Backfill Risk Assessments, new Backfill Procedures and associated training packages for loader operators and supervisors. The new backfilling procedure makes it clear that prior to commencement, a backfill risk assessment must be completed, read and understood by the operator, a removable steel stop log be installed for any work being conducted within 3 m of vertical opening, and visual indicators be installed including two Candy polls, one Flicker light and vertical edge delineation streamers. New checklists were devised for completion by the operator’s supervisor as a step to ensuring all pre-requisites are satisfied before backfilling operations commence.

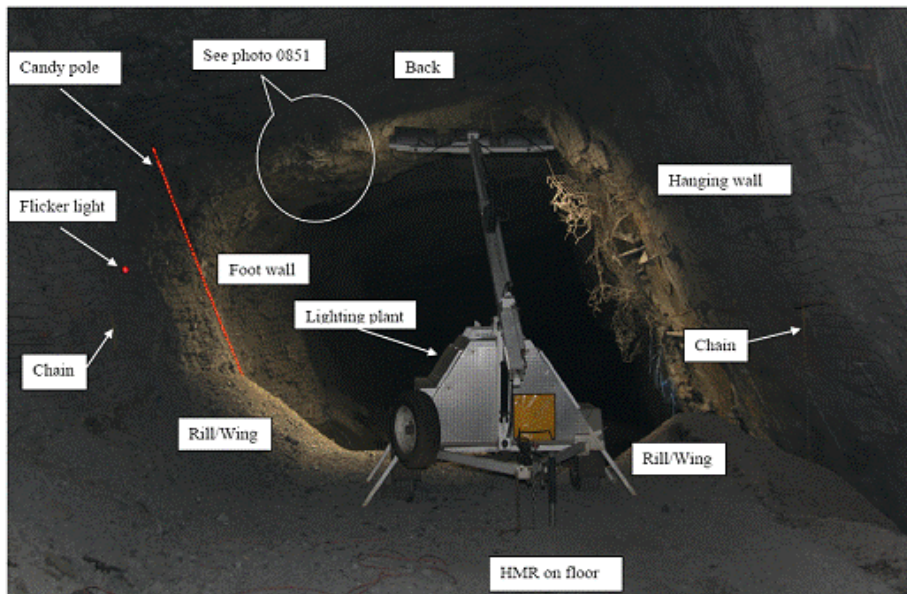
This photograph depicts a view of the edge of the stope with temporary lighting in place. This is the perspective that Mr Tuppurainen would have had in view when he approached the stope. The location of the candy pole and flicker light is shown on the left side. These are reference marks placed by the operator to assist in determining the edge or location of the stop log. The reader should also note the identification of the foot wall to the left and hanging wall to the right.

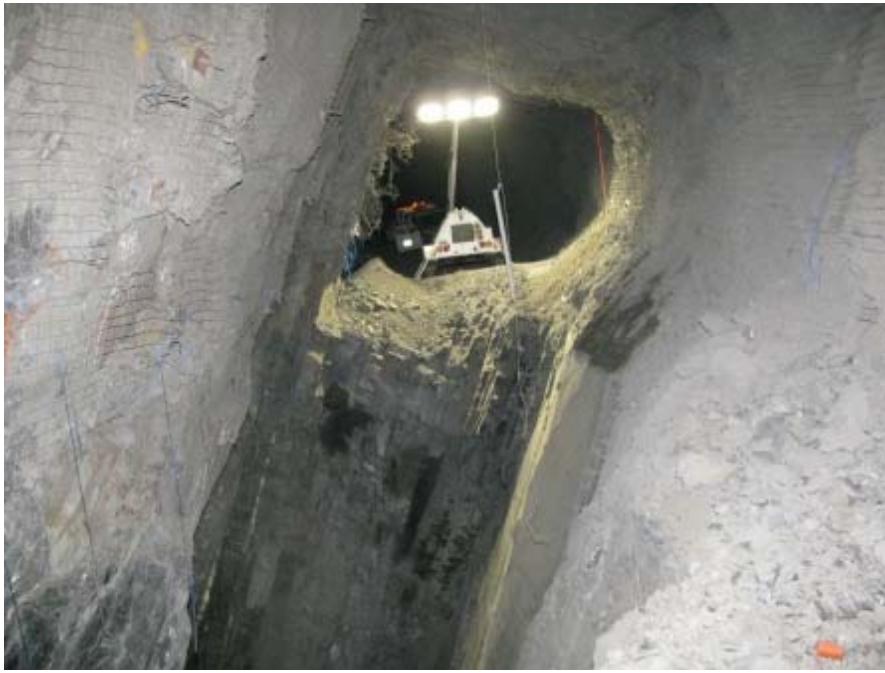
The above photograph was taken from the opposite side of the void looking back to the edge over which the loader entered the stope.
