OFFICE OF THE STATE CORONER

FINDINGS OF INQUEST

CITATION: **Inquest into the death of Cameron Brandt Cole**

CATCHWORDS: Coroners: inquest, petroleum lease, drilling rig move, safety management systems, risk assessment, training, safety awareness, load restraint, vehicle design, emergency medical response at remote worksites.

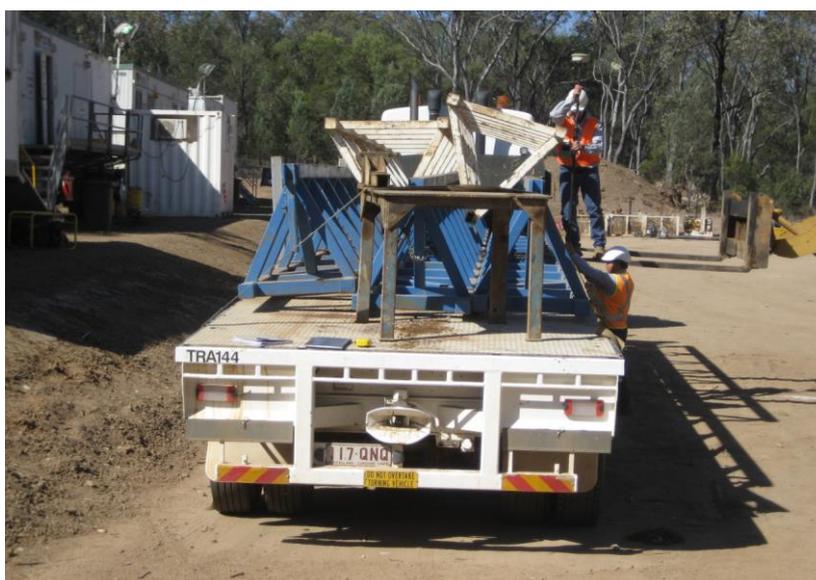
Figure 1

Two chains held the lower three racks in place and a third chain held the upper two inverted pipe racks in place. The chains were secured by load binders. Stanchions were in place on the left hand side of the trailer but were not able to be fitted to the driver’s side.

With the benefit of hindsight, it would have been preferable to place the load binders on the same side of the trailer as the stanchions, as when the chains were released there would have been a hard barrier in place between the workers and the pipe racks.

A further two white pipe racks were then placed on top of the three pipe racks in an inverted position in the channels created by the three pipe racks, as

demonstrated by figure 1.⁴ The top pipe racks were secured in place with another chain and load binder. Mr Springer's evidence was that this was an accurate picture of the way in which the racks were loaded.

⁴ Exhibit B2, while there was some contention about the accuracy of the re-enactment this picture is included to illustrate the load position.
