CORONERS COURT OF QUEENSLAND

FINDINGS OF INQUEST

CITATION: Inquest into the death of Matthew Trent Ross

CATCHWORDS: Electrocution, workplace incident, adequacy of investigation, loss of continuity of crucial physical evidence, Residual Current Devices

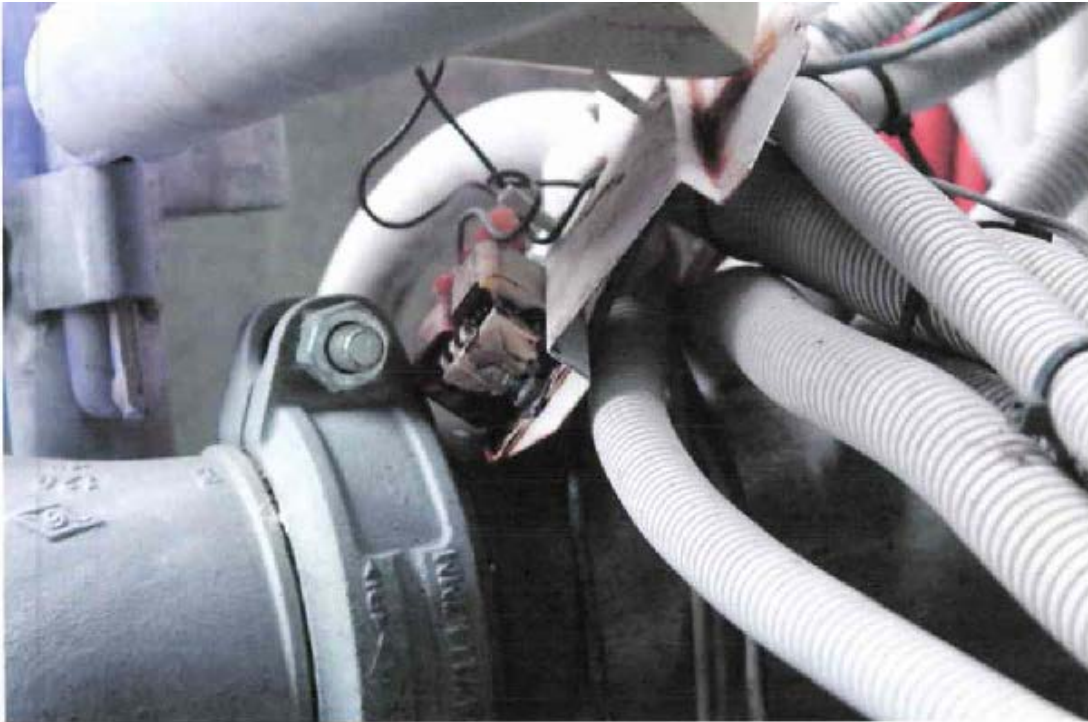
13. Subsequent tests and calculations indicated to ESO inspectors that any current that may have been flowing through Light Fitting Y would be of insufficient magnitude to cause electrocution. ESO inspectors attended some time later at the site to determine if another shock path existed. ESO inspectors noted evidence of what they considered to be “arcing” on the water pipe corresponding with where the damaged Light Fitting Z had been sitting. Light Fitting Z had not been immediately seized by the WHSQ investigator on that day but photographs had recorded Light Fitting Z in situ.

Photo taken by Garaty shows inners of light resting on scaffold

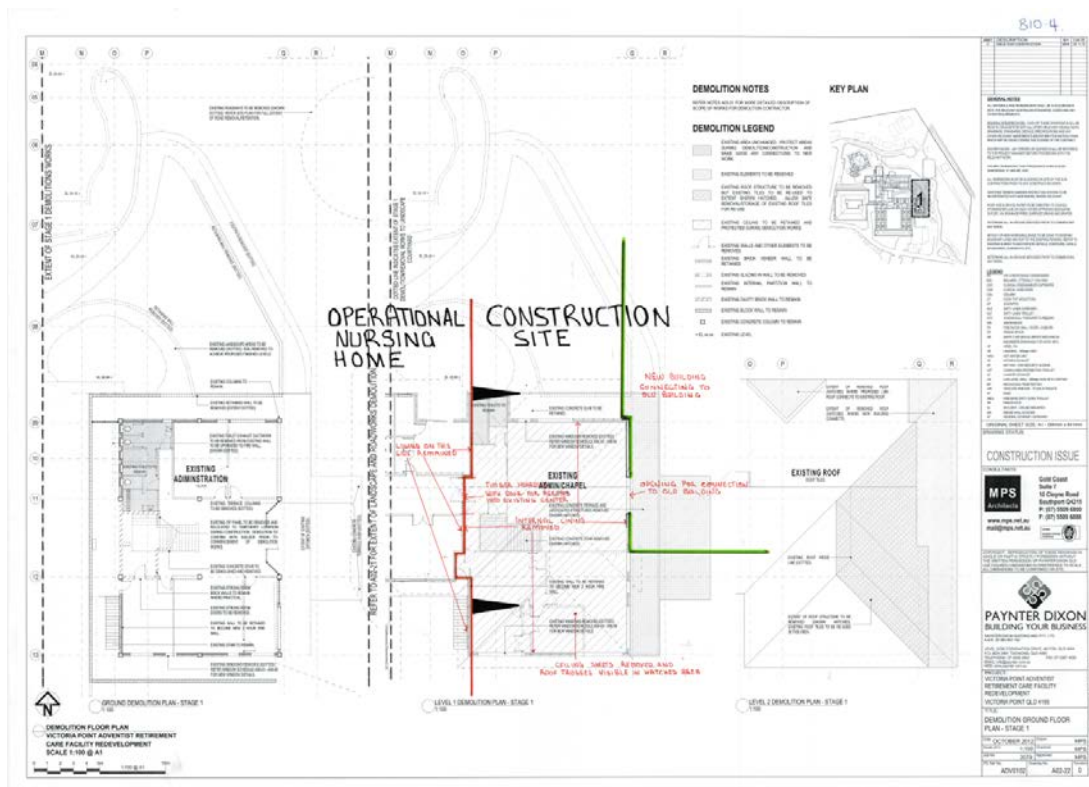
38. What was precisely the “demolition zone” was also the subject of much scrutiny during the course of the inquest. This was largely due to the fact that there was a fine line (literally if you consider the various attempts by some witnesses who were asked about the demolition zone and marked the exhibits accordingly) between the initial demolition zone and where it is likely Light Fitting Z was situated.
