OFFICE OF THE STATE CORONER

FINDINGS OF INQUEST

CITATION: **Inquest into the death of Annette Lee Spencer**

CATCHWORDS: CORONERS: balcony collapse, method of construction, adequacy of building inspections, bearer span width and renovations

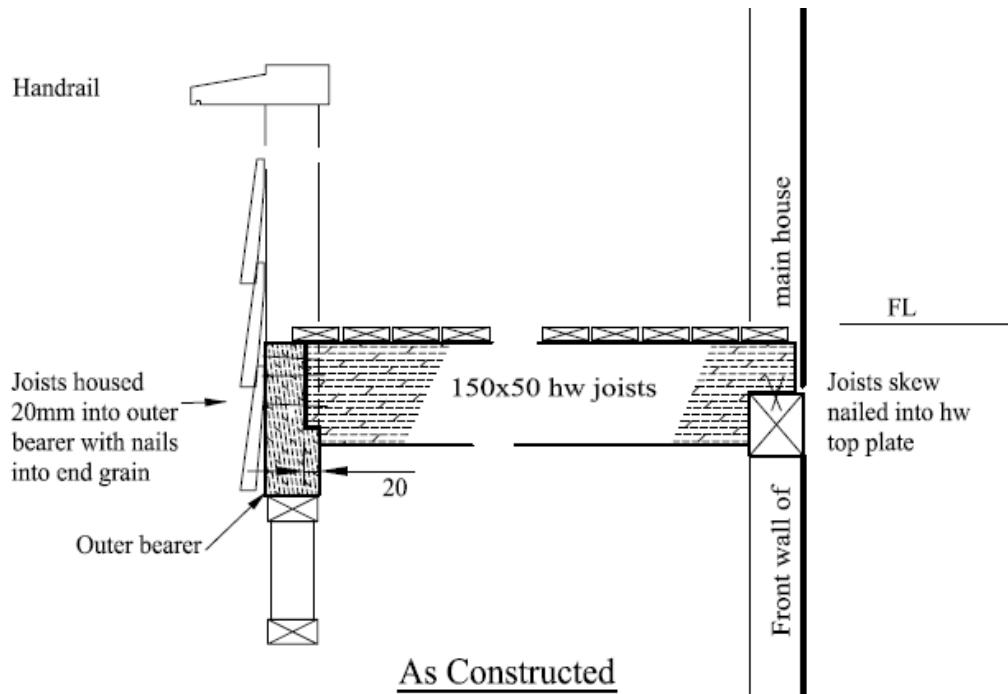
I have previously detailed a brief description of the balcony which collapsed. The support structure for this balcony consisted of hardwood timber joists supported on a timber top plate running along the front wall of the dwelling and on a hardwood bearer along the front of the balcony. At the time of construction, the joists were housed approximately 20 millimetres ("mm") into the bearer along the front of the balcony secured with only nails into the end grain and skewed nails into the side of the joists. The nails used at the time of construction around 1910 would have been non-galvanised and would corrode over time, although the evidence suggests that galvanised nails are also fallible to corrosion.

A diagram (all diagrams were copied with the kind permission of Mr Peter Wright) of the method of construction is detailed below.

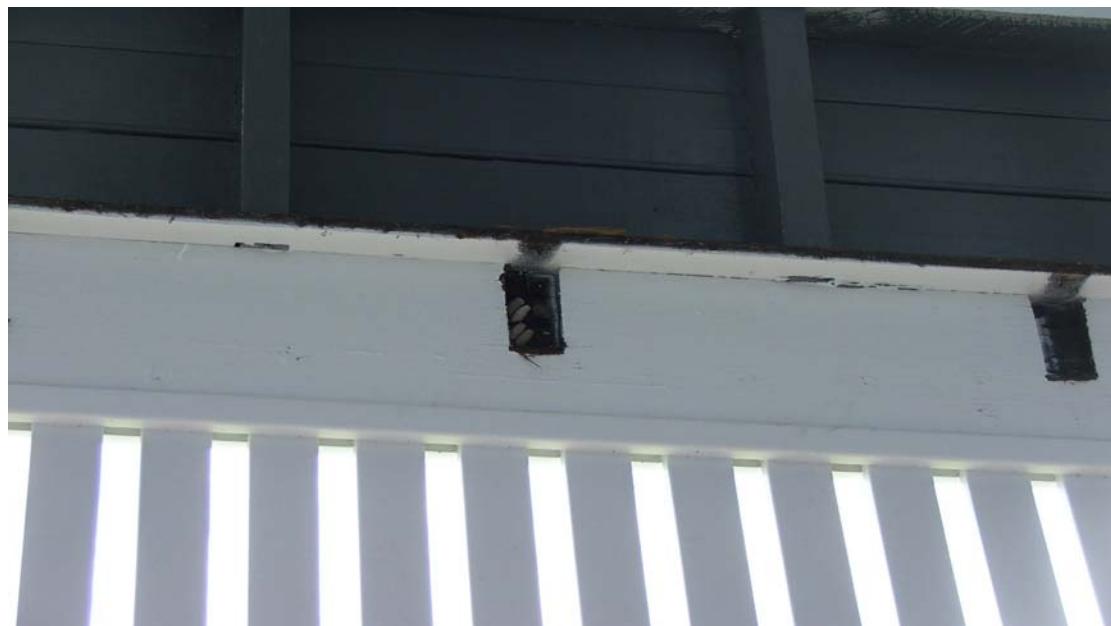
The photograph below illustrates how the joists where coggded into the bearer. Of note insect nests can be clearly seen indicating that the joist was not fully coggded into the bearer.

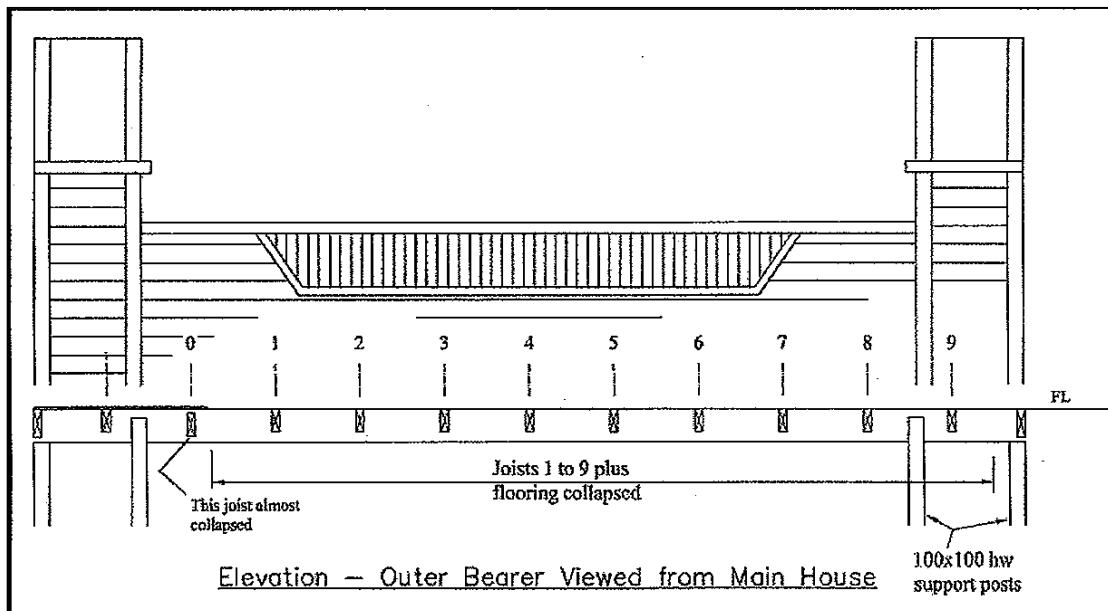
A fair portion of the inquest focused on the movement of particular joists. The diagram below details the numbering system that was attributed to the joists by all of the witnesses. By way of explanation the end of the balcony where joist 9 was located was the end of the balcony that adjoined the new balcony constructed when the property was renovated.

The experts again all agreed that the joists which failed first, causing the collapse, were the joists which had the least amount of bearing (the joists towards the middle of the balcony) into their respective cogs and because the bowing was the most pronounced at the middle of the balcony. The Brisbane City Council employees and Mr Wright were of the view that joists 3, 4 and 5 failed first. Mr Stick was of the view that joists 2, 3, 4 and 5 failed first. Mr McKenzie was of the view that joists 1 and 2 failed first.

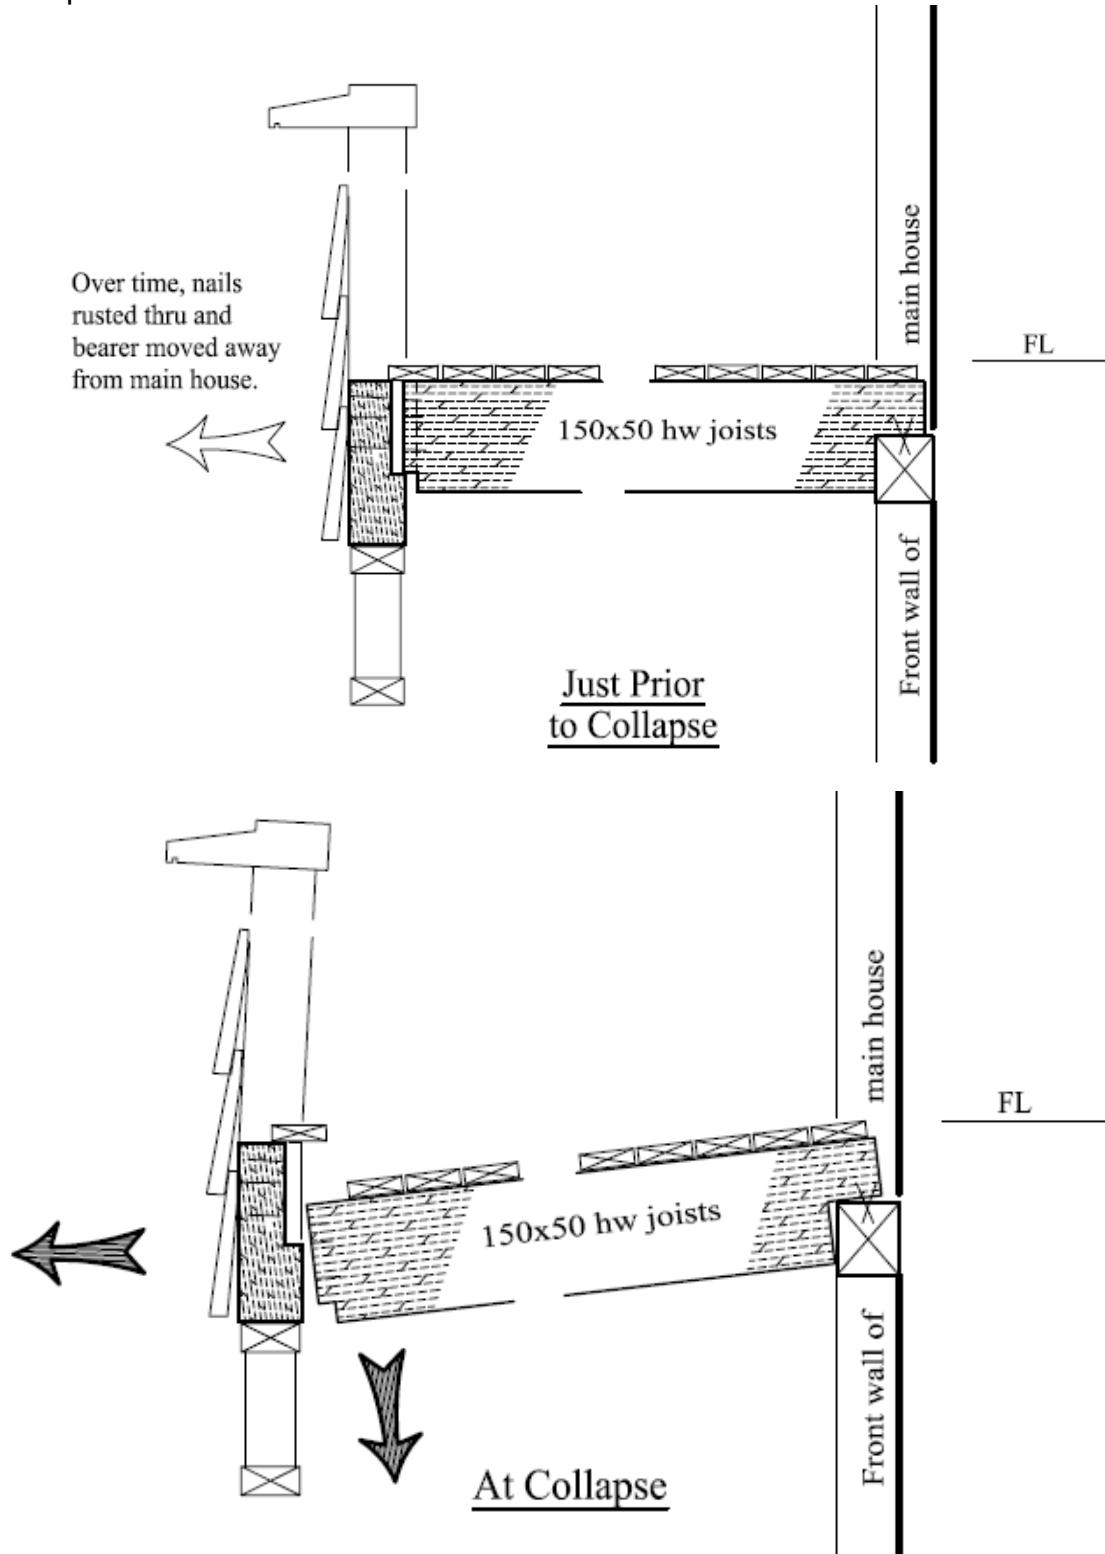
The diagrams below detail the mechanism of the collapse.

Mr McKenzie (with whom the other witnesses agreed) was of the opinion that the joists disengaged from the front bearer due to one or a combination of the following:

- Inadequate bearing of the joist ends onto the bottom of the housing;

- Outward deflection or bowing of this bearer; and/or
- Insufficient restraint provided by nail fixings at the ends of the deck joists due to corrosion of the nails and loss of embedment due to the existing separation of joist ends from the front bearer.

The experts all identified significant corrosion in many of the nails used in the construction of the collapsed balcony. The only items restraining the bearer up against the joists were nail fixings. Once the nails rusted out they were no longer restraining the joist into the bearer and this would not have provided any significant resistance to prevent disengagement of the joists from the front bearer.

1. house occupiers of all residential dwellings consisting of a wooden deck or balcony, but particularly those built pre World War 2, have those constructions checked for their structural integrity generally, but in particular for the particular construction method identified in this case; and
2. the Building Services Authority, the Brisbane City Council and other Local Government Authorities, and Building Code and Residential Building Associations disseminate these recommendations to their members, stakeholders and the general public to highlight the need for

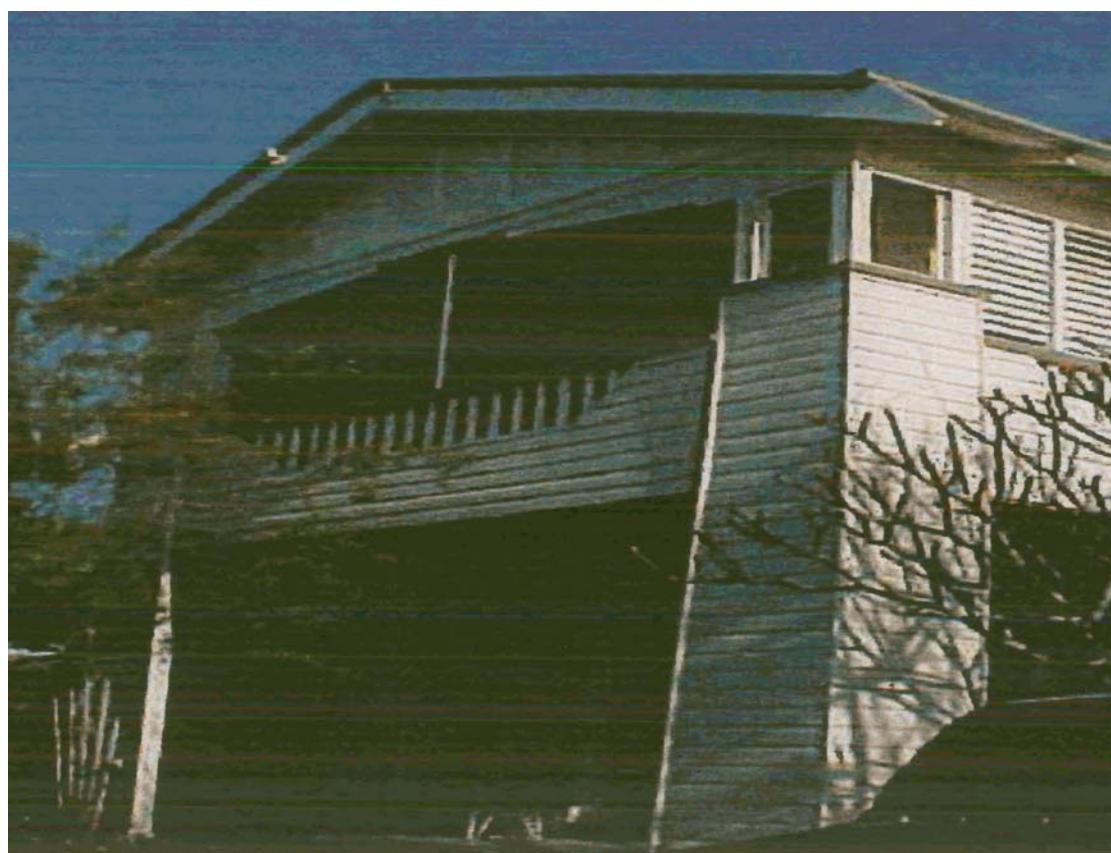
Below is a photograph of the property taken prior to the renovations showing the balcony and the trousers facade:

Mr Henning gave evidence that when he was at the property taking measurements, prior to drafting the designs, the width at the top of the "trouser" was 600mm and at the bottom of the trouser was 900mm.

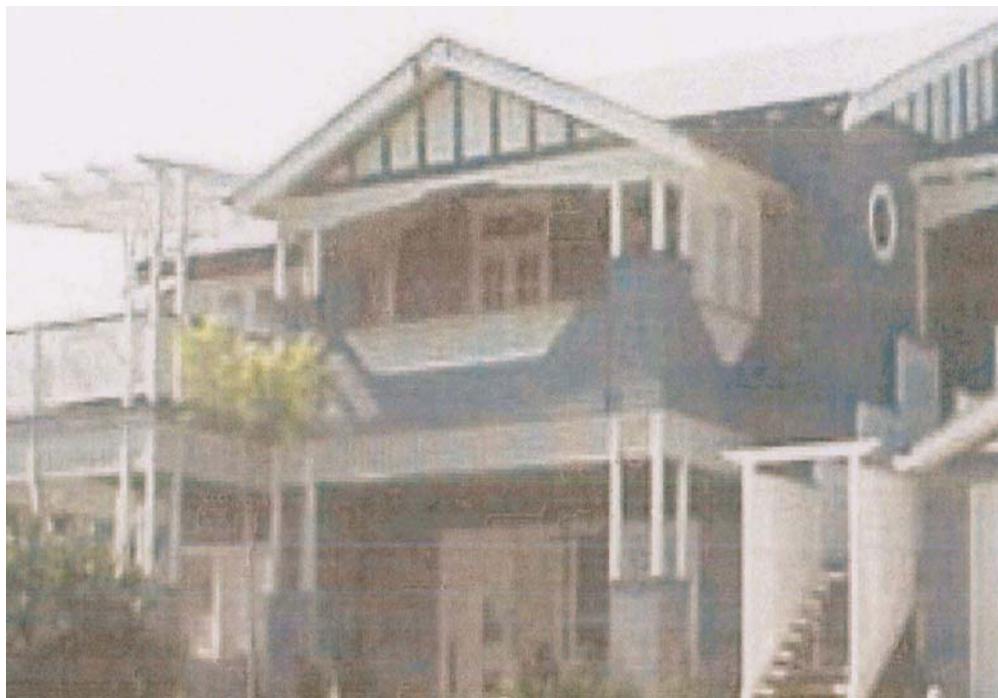
I have included a photograph taken of the property following the renovations for comparison showing the three support posts that were replaced and that ultimately the trousers were not replicated in the renovation:

replaced. A decision was then made to not replace the trousers as such but to simply replicate the pattern of the new deck in so far as the posts were concerned and he replaced the support posts in the same position as he found them. This meant the span was 4900mm.

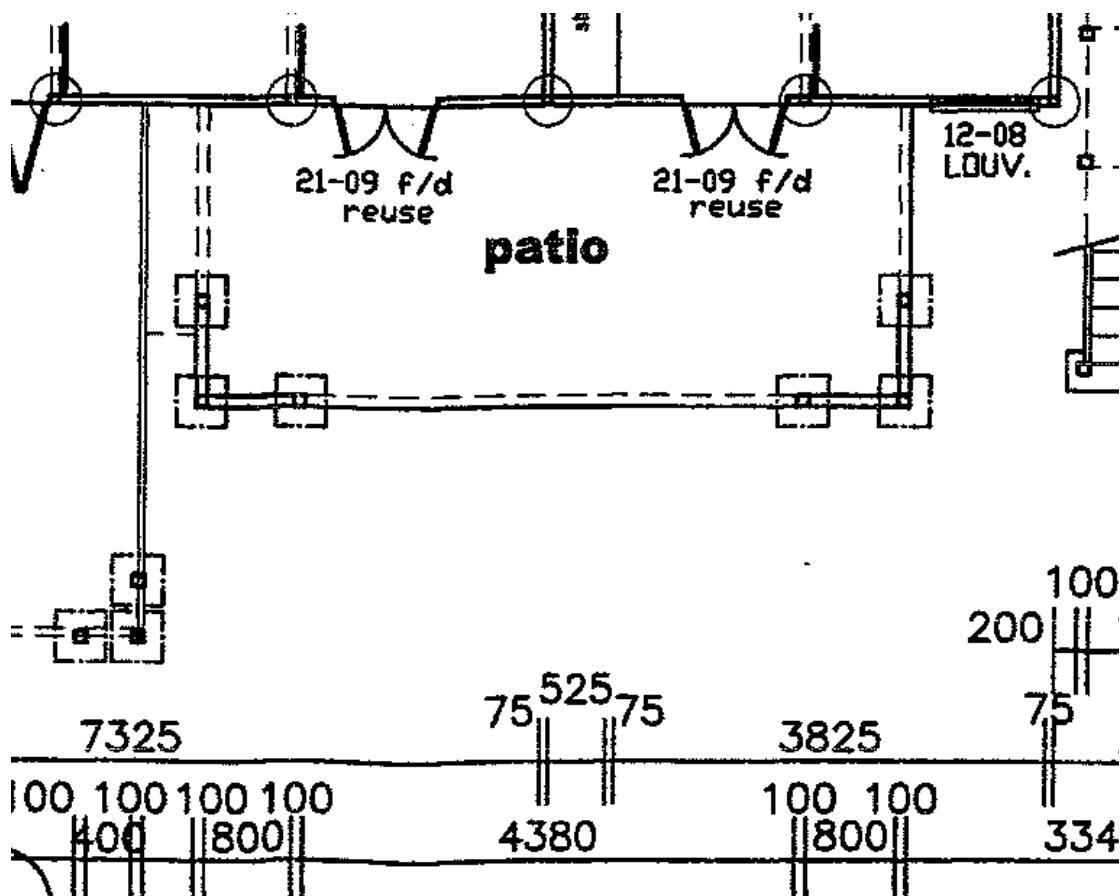
Below is a portion of drawing 5 from exhibit I2 that provided the measurements for the existing balcony. The plan indicates that the distance between the two inner posts is 800mm with 100mm distance for each post and a span of 4380mm.

Essentially the plans would suggest that the bearer span from the inner two posts was 4380mm. The measurement of 4380mm is indicated clearly on the plans and appears to have been taken by Mr Henning from the footing measurement of the existing trousers façade which was built at an angle such that the width at the top was less than the width at the footing. In my view this measurement was simply a mistake on the part of Mr Henning in his drafting of the plan. Some of the confusing evidence from Mr Henning was I think a retrospective attempt to give some explanation as to why that measurement was valid, including references to the use of angled support posts, which although technically possible, did not make a lot of structural engineering sense.

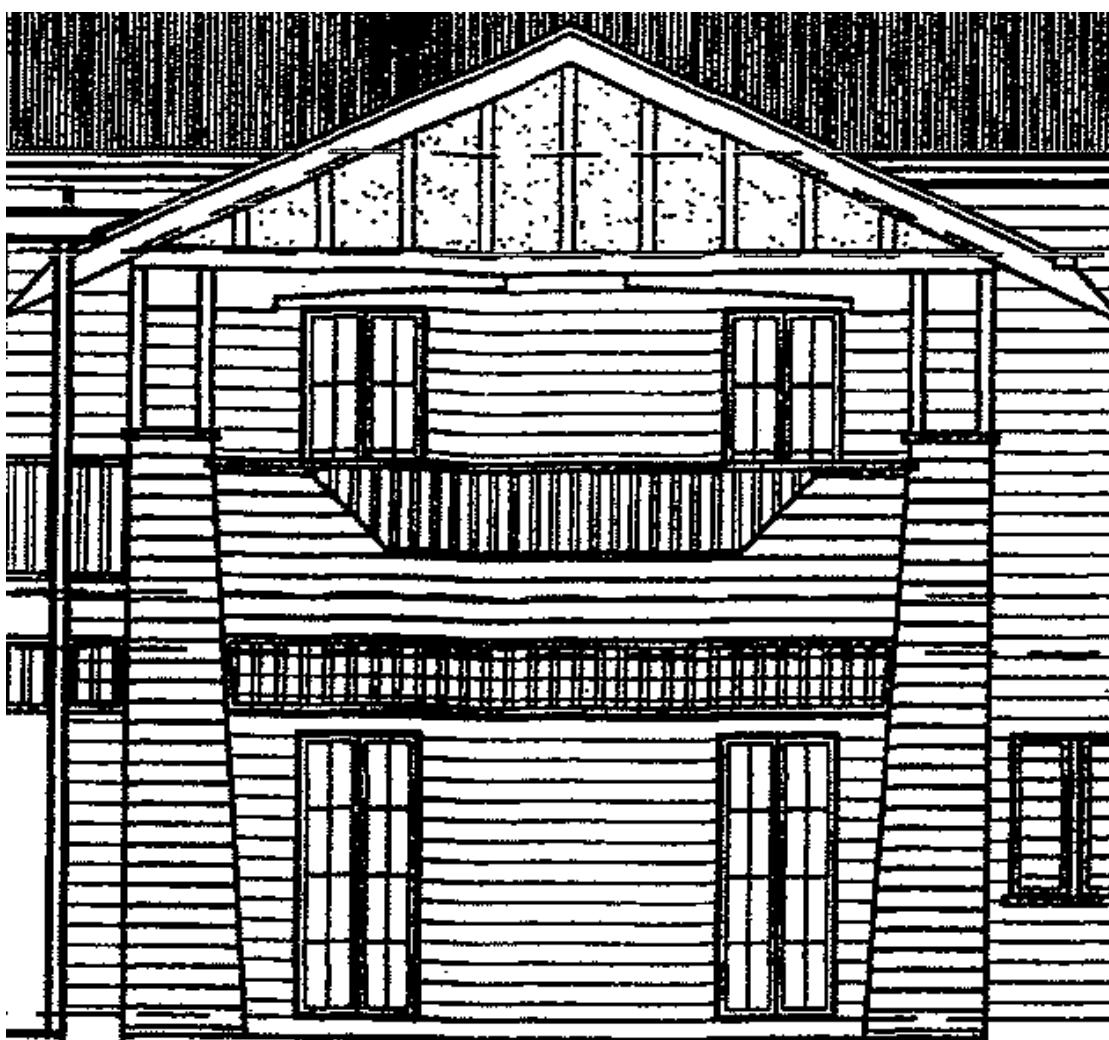
Below is an extract of the front on view of the property from drawing 6 of exhibit I2 showing the trousers façade was included in the approved plans:

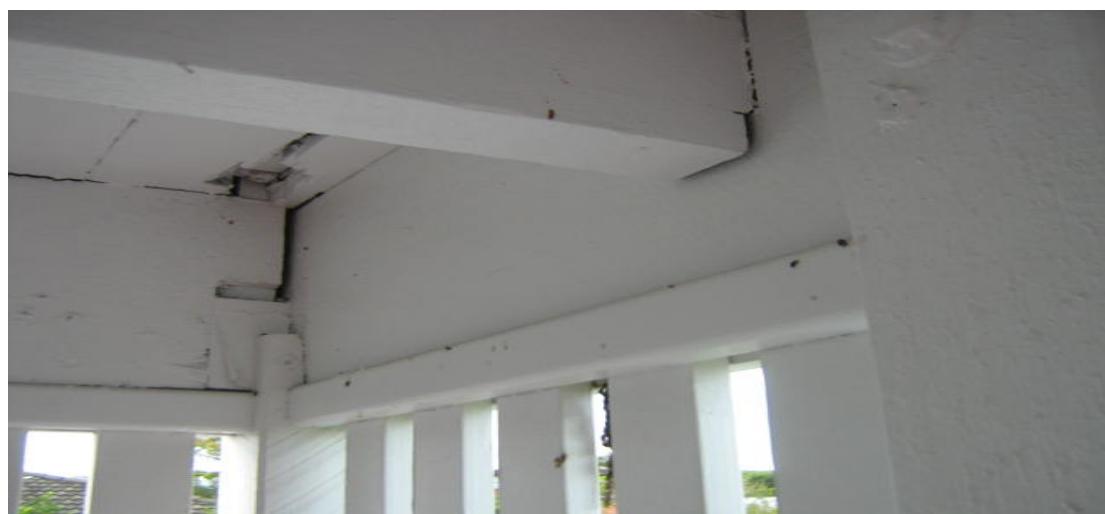
The following photograph depicts the view that would have been evident at the time of the inspection with the exception that the underneath of the deck was in its original colour, either a brown stain or unpainted but dark.

The experts were also all of the opinion it is unlikely that the bowing and sagging would have been obvious to those inspecting the property prior to the collapse. They commented that it was only after the collapse (when they were looking for a cause of collapse) and they were underneath the balcony observing it that they identified there was potentially a bow and sag. Mr Wright commented he had attended the property suspecting there may have been a bow in the bearer and it still took him sometime to identify the bow.
