# **CORONERS COURT OF QUEENSLAND**

## FINDINGS OF INQUEST

CITATION: Inquest into the deaths of Danny George

CATCHWORDS: Construction, high voltage transmission towers

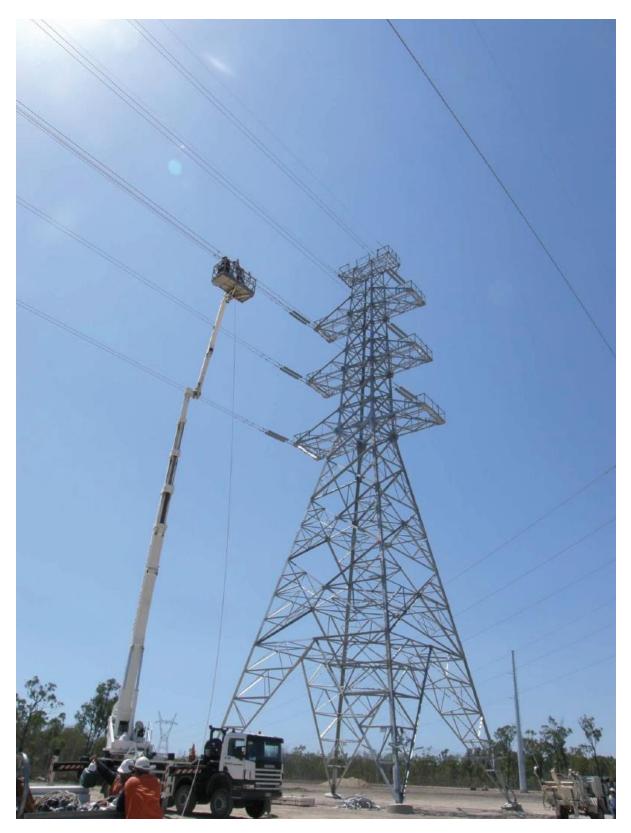
The scene showing the positioning of the Elevated Working Platform positioned under conductors moments before the incident

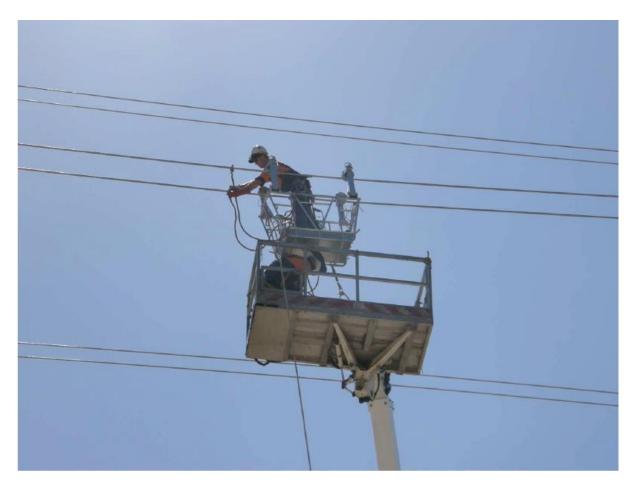
Mr Ellem was involved in retrieving Mr Cheney and found his lanyard still connected to the EWP was pulled taut. The earth leads were lying tangled on top of him, not attached to anything at the time of the rescue<sup>34</sup>.

A closer image depicting Mr Cheney in the conductor cart and Mr Parungao in the Elevated Working Platform. Mr Cheney is unclamping and detaching the earthing lead from the conductor.
