CORONERS COURT OF QUEENSLAND

FINDINGS OF INQUEST

CITATION:	Inquest into the death of Daniel Geoffrey Springer
TITLE OF COURT:	Coroners Court of Queensland
JURISDICTION:	NORTHERN
FILE NO(s):	2017/3427
DELIVERED ON:	23 February 2021
DELIVERED AT:	CAIRNS
HEARING DATE(s):	23 May 2019, 2-6 March 2020, 2 June 2020
FINAL SUBMISSION:	12 August 2020
FINDINGS OF:	Nerida Wilson, Northern Coroner
CATCHWORDS:	Coroners: inquest, mining accident; BHP Billiton Mitsubishi Alliance Coal Operations; Goonyella Mine; excavator bucket; external steel vertical wear plate package; indentions; build up of stored energy; air carbon arc gouging; 1.150 metre spring-back event; fatal injuries to head due to industrial accident; death of qualified boilermaker; no prior industry knowledge regarding magnitude of spring-back.

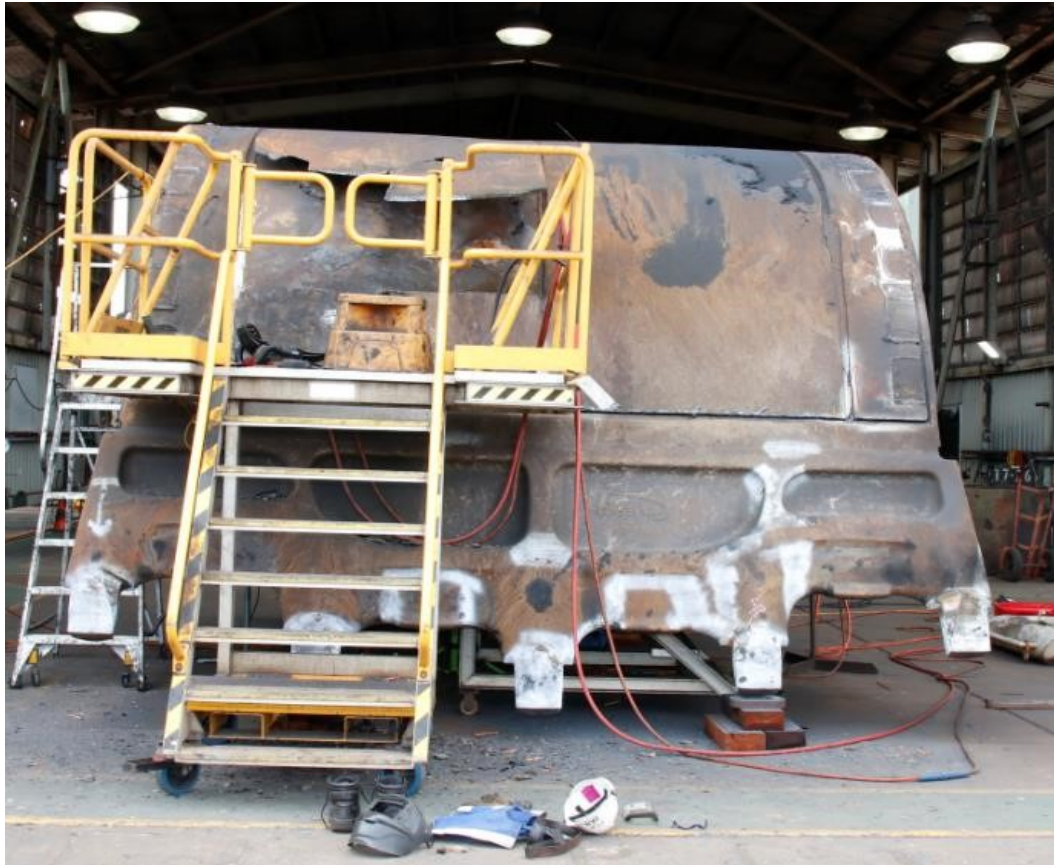
49. Annexed to these findings is a photograph of the bucket Daniel was working on at the relevant time and gives a sense of the:
 - size of the plant;
 - the scaffolding platform used to reach the wear plates;

- and the wear plate in its resting position after the spring back event.
50. It was established as a general proposition that wear plates usually require replacing at approximately every nine to twelve months, which equates to approximately 6000 hours in operation. The bucket subject of these proceedings completed 9528.60 hours production prior to removal from the excavator for repair and maintenance. The life span of a wear package depends on the variability of conditions which can significantly alter the wear rate.

Photo of work platform in situ from which Mr Springer was working on bucket #1 at the time of the spring back event.
