OFFICE OF THE STATE CORONER

FINDINGS OF INQUEST

CITATION: **Inquest into the death of
Peter Raymond FENTON**

CATCHWORDS: CORONERS: maritime accident, loading provisions onto ship from barge, crane, insulated container, chain and slings, job hazard analysis, work health and safety.

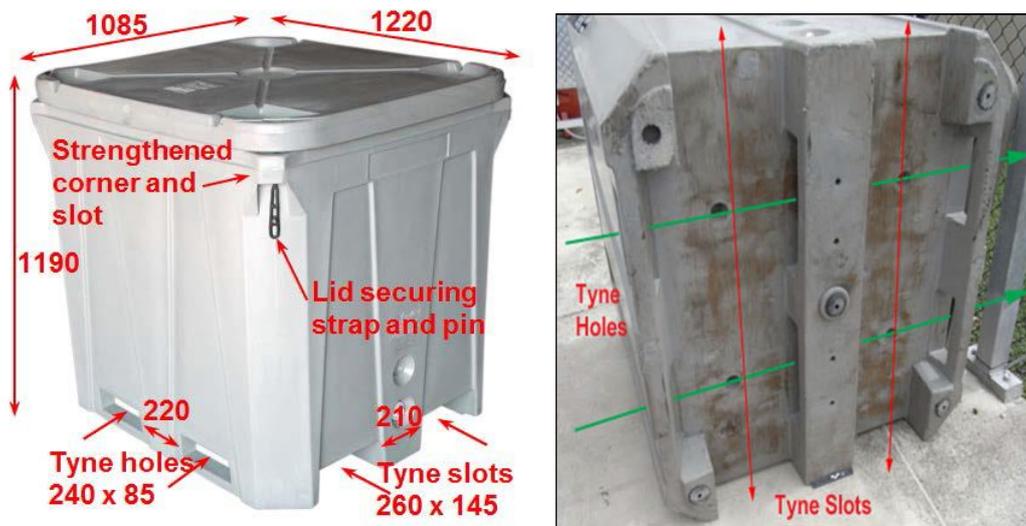
Figure 4

The plastic insulated stores container involved in this incident (Figure 4) was of a design, which had been in production since the mid-1970s. It was made of food grade polyethylene in a sandwich construction of varying thickness. The container had a capacity of about 1 cubic metre and 1,000 kg. The empty container was weighed after the incident at 98 kg, of which the lid weighed about 16 kg.⁴

strap under the middle rib while the other strap was in a slot and hence loose. When lifted in this way the bin would be very insecure and likely to fall out of the slings with only a very minor disturbance, such as a gust of wind or stopping and starting the hoisting (lowering) or slewing of the crane.

1. *No instructions were placed on the insulated container to identify appropriately safe lifting points and to indicate recommended techniques for safe lifting in compliance with the manufacturer's specifications.*

I am not able to reach a conclusion as to the precise cause of the container falling from its slings. In his evidence to the inquest Dr Grigg considered it unlikely that the two returned boxes of fish alone would have caused the container to become dangerously unstable.

It is likely that the boxes exacerbated a situation that was already unstable due to a failure to position the straps in such a way that the container was properly balanced. The crew on the *British Beech* agreed that they did not pay close attention to the manner in which the crew of the BT7 had rigged the containers. They incorrectly assumed that because the fully laden containers were secured through the open tyne holes it was safe to rig the empty containers in the same manner.

Fortunately, one of the proximate causes of Mr Fenton's death can be addressed (and indeed already is being) by a relatively inexpensive engineering solution. The inquest heard that the use of fully enclosed cage systems for the task in which Mr Fenton was involved is now the norm, at least in the Port of Brisbane and on BP ships. This has the benefit of ensuring that an unstable load is unable to fall. The sling mechanism also worked in this way if applied correctly through the enclosed slots of the container; however, the cage system is less susceptible to the adoption of alternate, and unsafe, means of use. In this regard, Mr Servin's report recommends that:
