FINDINGS OF INQUEST

CITATION: **Inquest into the death of Gregory Clifford Paterson**

DELIVERED ON: 18 October 2010

CATCHWORDS: CORONERS: Inquest – Concrete pumping, hose whip, supervision of construction site, Workplace Health & Safety

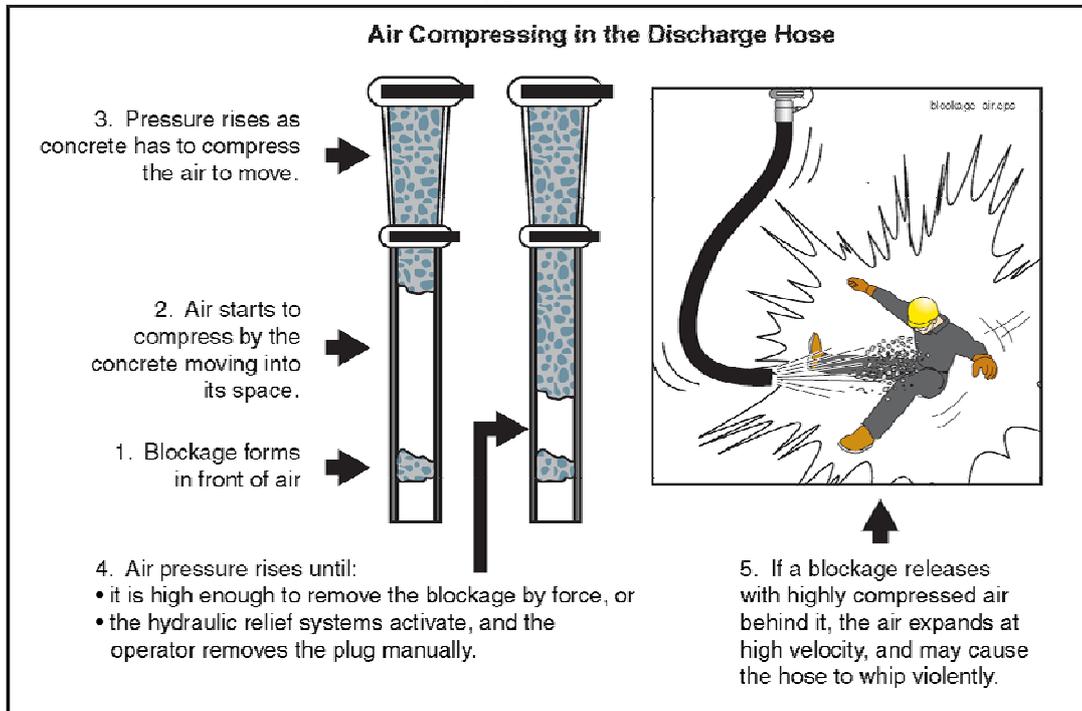
Appendix A

Once inside the pipeline, the air is pushed by the concrete coming behind it, and, in turn, pushes the concrete in front of it. Within moments, the air pressurizes to the same pressure required to push the concrete in front of it. When the air pressurizes, it takes less space, in much the same way a spring takes less space when a force is applied.

As the air travels through the pipeline, it takes less and less pressure to push the concrete in front of it, (because there's less and less concrete in front of it). As the pressure drops, the air expands, taking more space than it had a moment before. As it expands, the concrete in front of it must move faster to accommodate the ever-expanding air pushing it.

The vast majority of the time, concrete accelerating in front of the air pocket results in a harmless escape; the concrete squirts out rapidly, there's a small "puff" as the air escapes, and the concrete behind the air resumes flowing normally. Perhaps the hose gives a small jerk and there's some splattering by the air/concrete mixture. No one is at risk in this case.

A small percentage of the time, the material accelerating in the delivery system gathers in the hose or reducer and forms a blockage. The fact that air is forcing the material to accelerate rapidly may cause some segregation of the material components, thereby increasing the chances of blockage formation. Whatever the cause, once a blockage has formed in front of air, the hazard is in place.

In the best-case scenario, the blockage releases with minimal pressure increase, or the blockage is so complete that even when the pump reaches maximum pressure, it does NOT release. In the latter case, there is no expulsion, the pump stops moving material as the hydraulic relief systems are activated, and the operator can relieve the pressure before looking for the plug.

In the worst-case scenario, high pressure is exerted on the air pocket before the blockage releases, and the reaction of the air escaping at high velocity causes the hose to whip violently.
