CORONERS COURT OF QUEENSLAND

FINDINGS OF INQUEST

CITATION: Inquest into the death of Stephen Ross Brown

CATCHWORDS: Coroners: inquest, heavy vehicle crash, whether fatigue failure to suspension caused crash or event of pulmonary thromboembolism, maintenance of heavy vehicles, National Heavy Vehicle National Law

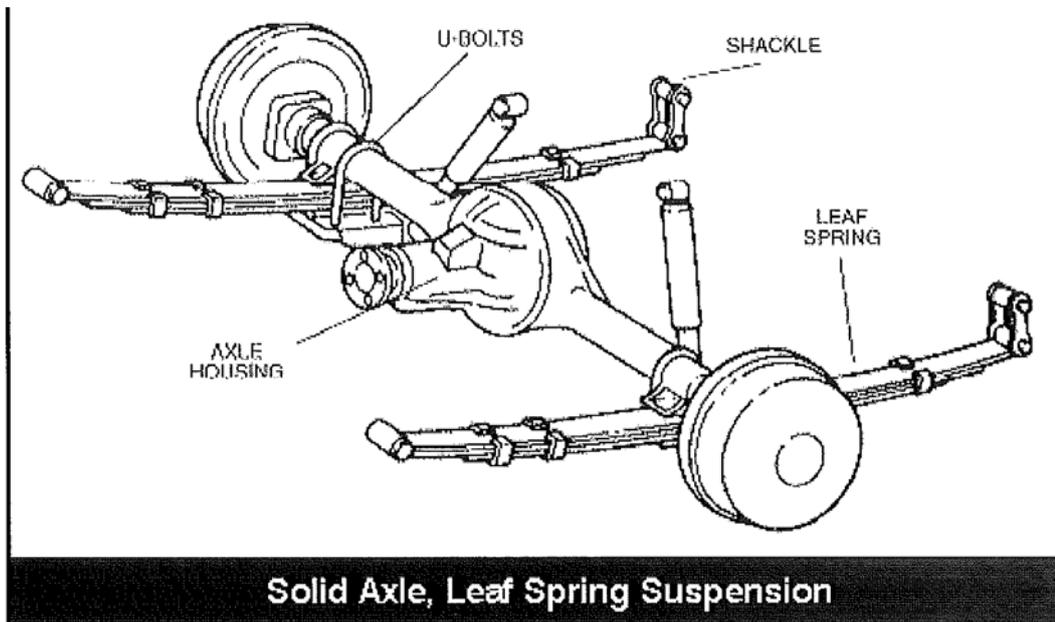
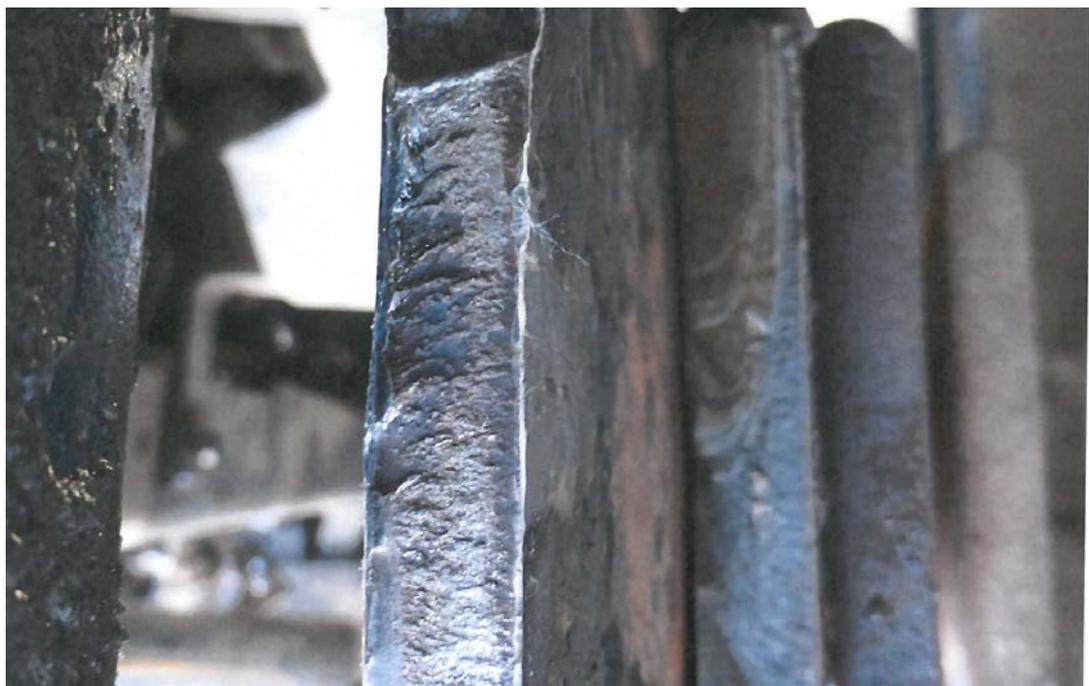
42. The overall conclusion from the inspection was that the catastrophic failure of the prime mover's right front second leaf spring caused a sudden change in the vehicle direction with the vehicle veering to the right. This condition was considered by Mr McLaren as the major contributing cause of the incident and would most likely go unnoticed during servicing due to the presence of

46. Mr McLaren reiterated in evidence that he found no other reasons apart from the failed leaf springs for the sudden change in direction. Without the grease Mr McLaren said you would see the fracture in the first leaf spring but only after it had been a complete fracture.

47. The FCU report to the coroner recommended that heavy vehicle companies, when conducting their scheduled servicing and maintenance regime, assign time to clean the vehicles so that inspections can be conducted more thoroughly. This is an issue that arose in evidence. The National Heavy Vehicle Accreditation Scheme (NHVAS) documentation did suggest all

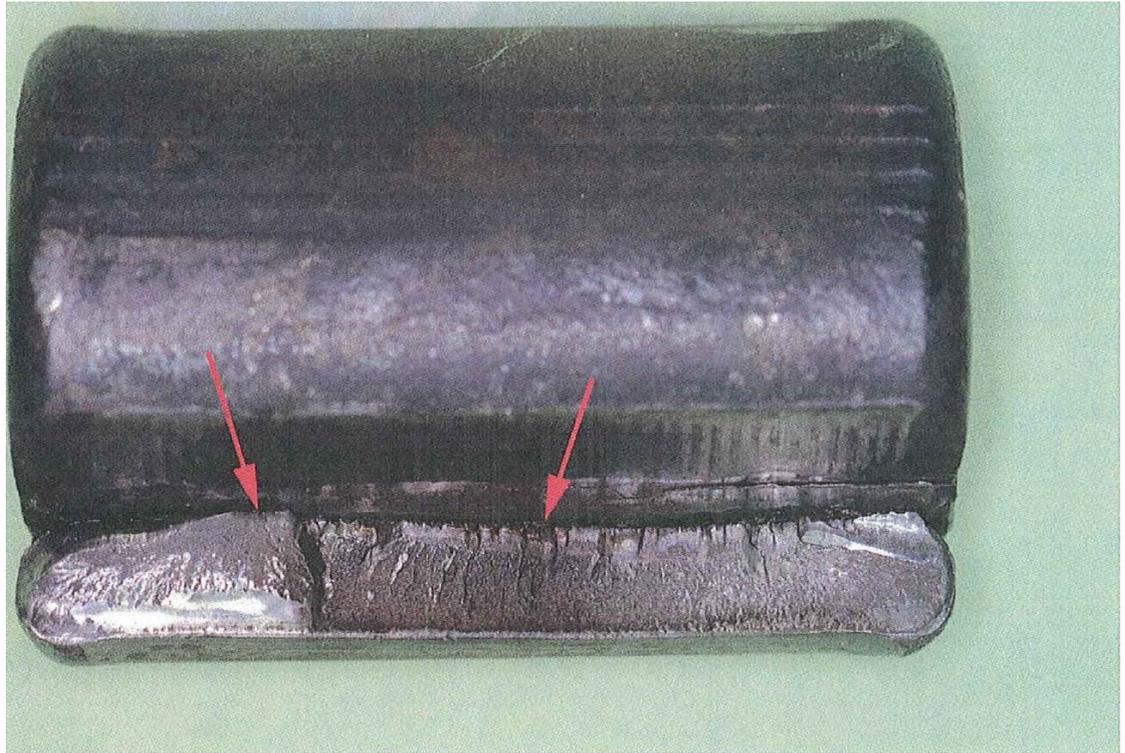
65. Mr Casey found that both leaves showed evidence of long standing fatigue fractures, and it was likely they failed prior to the crash. The conclusion was that both the submitted leaves of the right front suspension of the prime mover had failed as a result of the initiation and growth of fatigue cracks, with the main leaf spring failing prior to the second leaf. Contact wear patterns, shown by the section of the main leaf, indicated that the vehicle had continued in operation for some time subsequent to failure of the main leaf spring. Mr Casey in evidence was unable to say what this meant in hours or kilometres. It would be hours or tens of kilometres at least but could have been weeks or thousands of kilometres. This occurred at some time well before the failure of the second spring.

Fatigue fractures the main spring had initiated at the locations arrowed.

68. Mr Casey stated that the corrosion of the main leaf and the corrosion of the fatigue area of the second leaf were different indicating a time difference between the final failure and the production of the fractures. Mr Casey stated that the fatigue cracks in the upper surface of the main leaf accounted for 15% of the fracture, and would have occurred over an extended period of time and there would have been a sudden event causing a fairly high level of unusual stress to cause the final stress fracture.

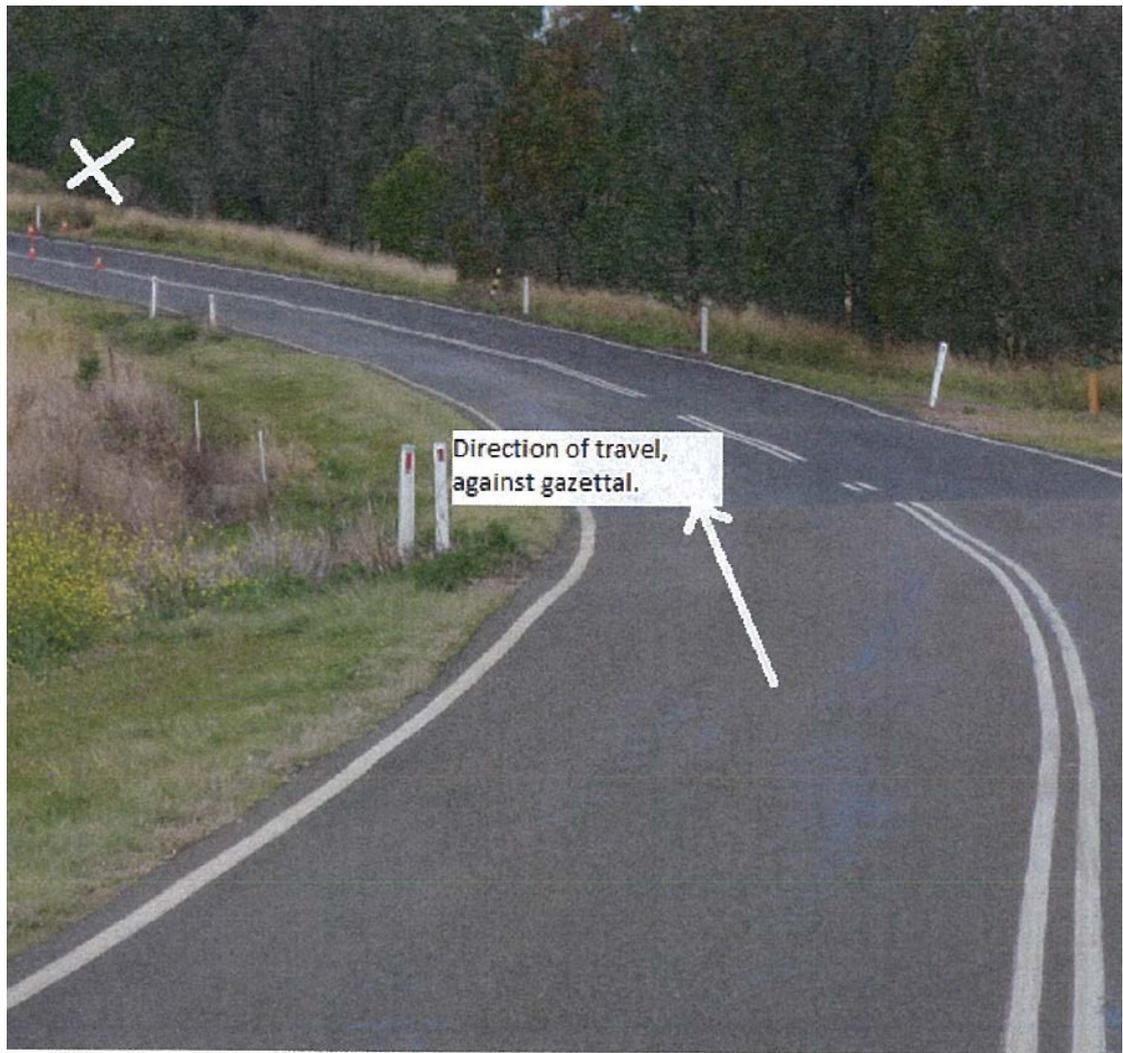
76. Although SC Britten noted in his report and confirmed in evidence he did not observe any significant road features that could have contributed to the crash, evidence was introduced as to the existence of a depression or subsidence in the road surface about 100 metres prior to where the truck left the roadway and near where the crash occurred. SC Britten did not consider the subsidence referred to was significant in the context of the particular roadway, which he said was not in the best condition in any case. A report from DTMR referred to depressions, which on the basis of the percentages stated were insignificant. SC Britten stated he did not observe a pot hole or crater in the roadway, which would have been sufficient to break the leaf spring.

77. It is apparent from the evidence of a number of witnesses there was an area of the road surface, which drivers considered was rough. For instance, Mr Niemann stated in evidence there was a 'sinkhole type thing' that everyone knew about and drove around. He describes that it covered up a fair proportion of the road and if another vehicle was coming in the opposite direction you could not avoid it. Mr Niemann said the road was a typical country road and there were bad spots, one of which was near where the accident occurred.
