OFFICE OF THE STATE CORONER

FINDINGS OF INQUEST

CITATION: **Inquest into the death of Natarsha CHARLESWORTH**

CATCHWORDS: CORONERS: Inquest – Adventure tourism – white water rafting – Tully River – 8 person rafts – capsize and entrapment with prolonged period of immersion – drowning – adequacy of safety risk management

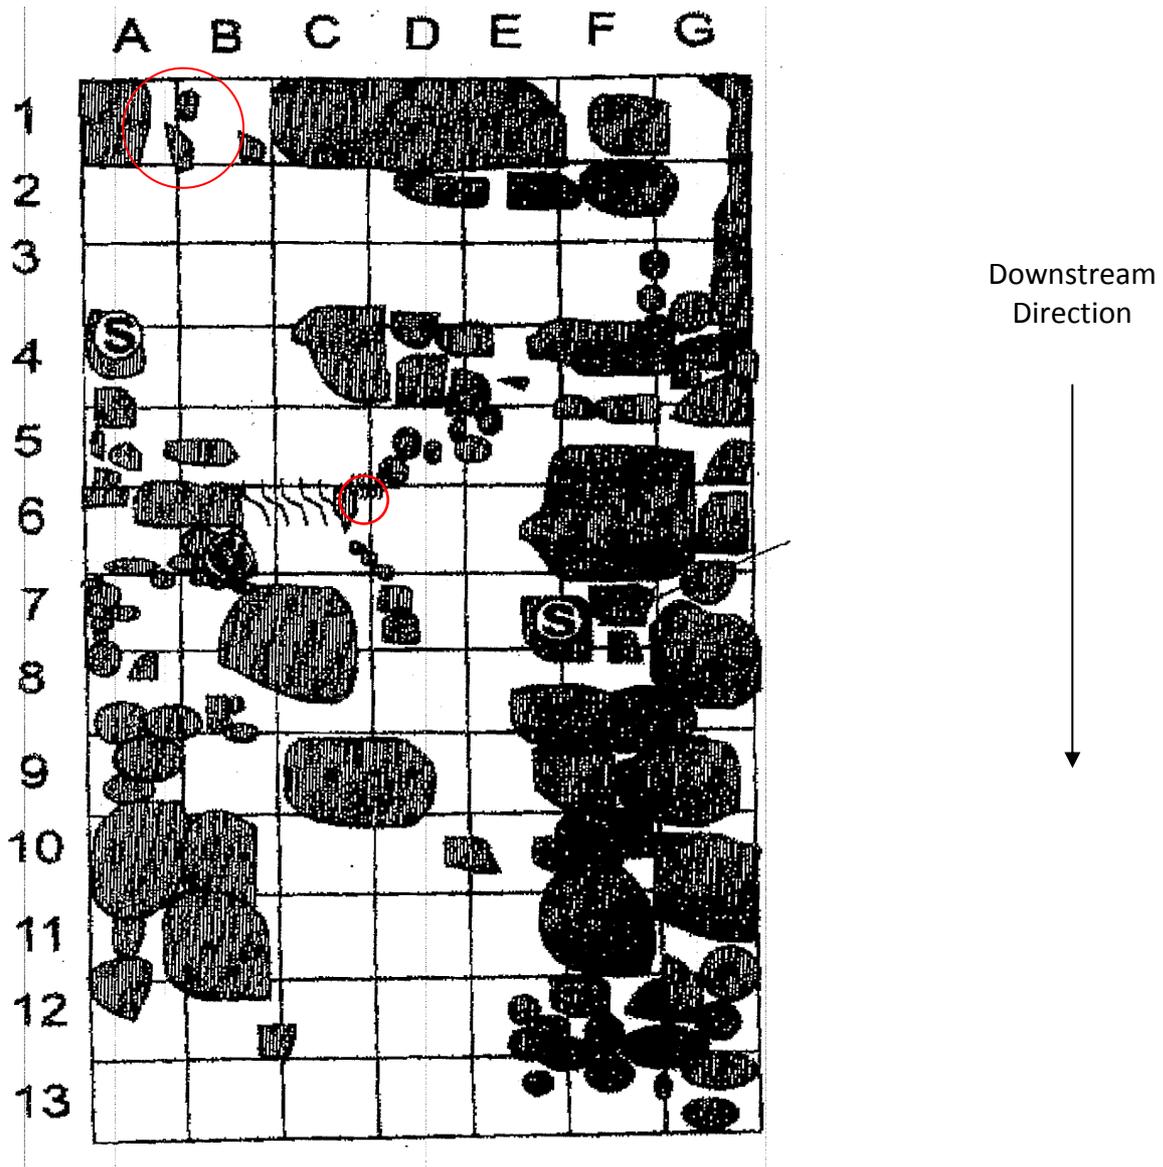
Therefore, the cover arrangements below Scales Rock were one guide at Full Stop Drop cover position. There was no guide on cover below Nipple Rock (A4 – Full Stop Drop Map).

| 1 A/B | Flip over point |

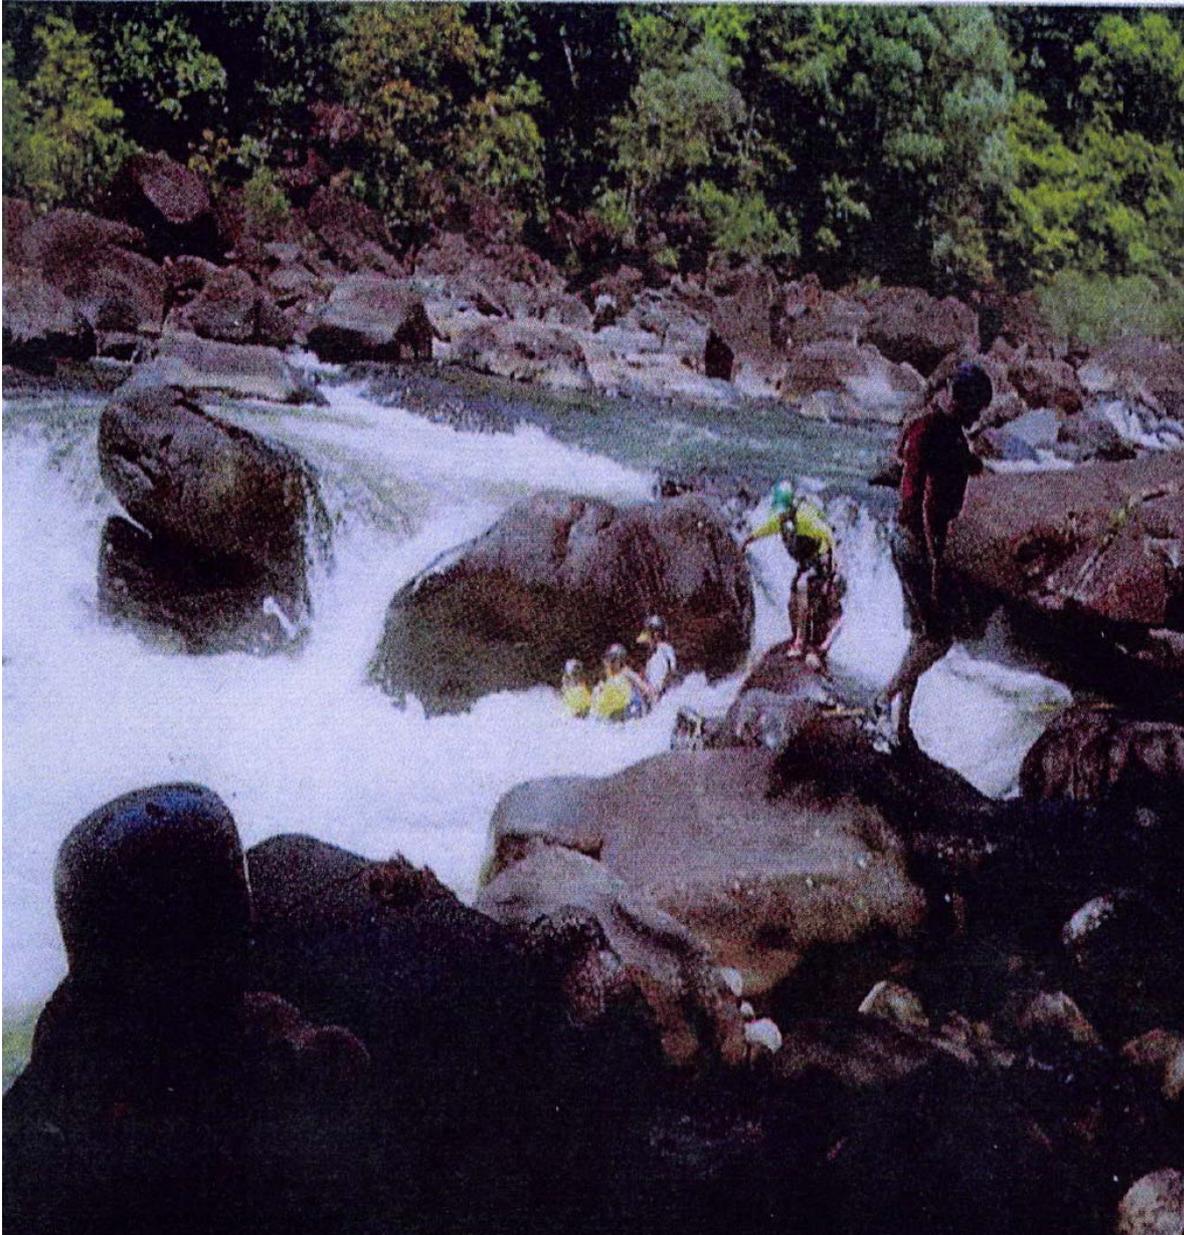
Attachment B

The challenges faced in extricating Ms Charlesworth are best depicted by the photograph of the scene (attachment B). Three guides made every effort to extricate her. While their efforts continued, other guides rigged up a rescue platform using a raft and lowered it into position

Photograph of scene during extrication efforts. The group of guides in the centre of the picture, in the water and in front of the boulder are attempting extrication.
