OFFICE OF THE STATE CORONER

FINDINGS OF INQUEST

CITATION: **Inquest into the death of Michael James Cameron**

CATCHWORDS: Coroners: inquest, workplace incident, crush injuries, mobile crane, free fall ability, lock out bar incorrectly installed, safety inspections

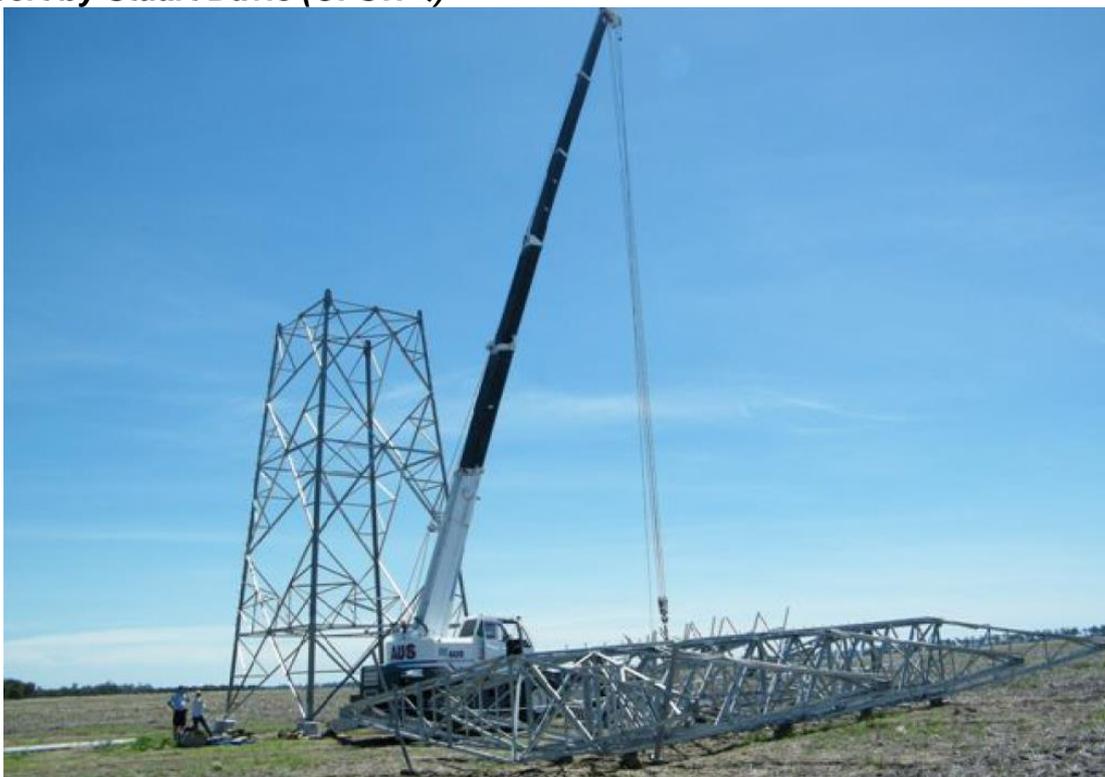
33. A review of the incident was conducted by Stuart Davis, Principal Advisor (Construction Engineering) within OFSWQ. On 5 March & 12 March 2012, Mr Davis inspected and carried out testing on the crane. Mr Travis Butler was employed as a crane driver to operate the crane on 5 March 2012. In November 2013 Mr Davis provided a report, in the form of an internal memorandum, detailing his opinion as to the cause of the incident.

34. Mr Davis confirmed that the crane involved in the incident was a Tadano TR 200M-5 mobile crane, known to be a rough terrain hydraulic mobile crane with a maximum lifting capacity of 20 tonnes (20,000kg). The crane was manufactured in Japan in 1999.

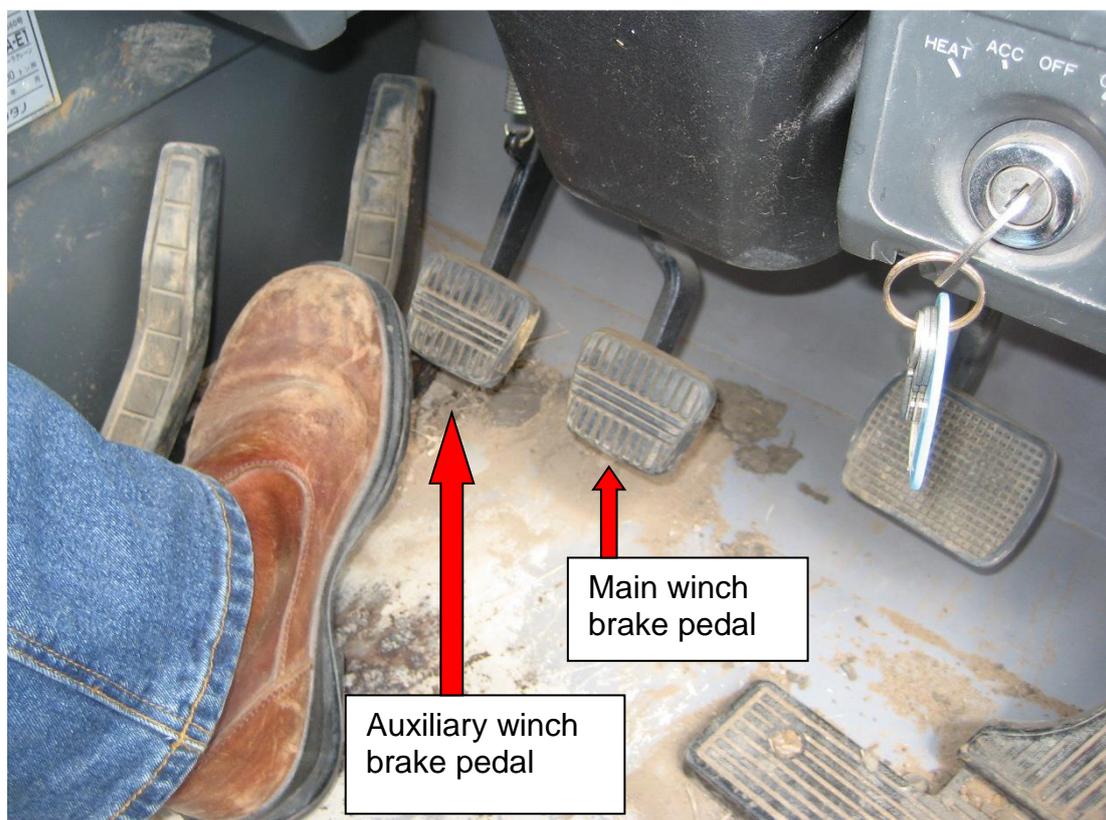
View of auxiliary and main winch brake pedals

51. Mr Davis went through each of the different pedals on the floor of the operator's cabin. There were a total of 6 pedals – 2 x winch pedals on the far left, 2 x free fall brake pedals in the middle, and the road travel brake pedal and accelerator pedal on the right. Mr Davis opined that it would be relatively easy for the

operator to unintentionally depress the auxiliary winch brake pedal – especially if he had intended to activate the winch pedal just to the left of the brake pedal.

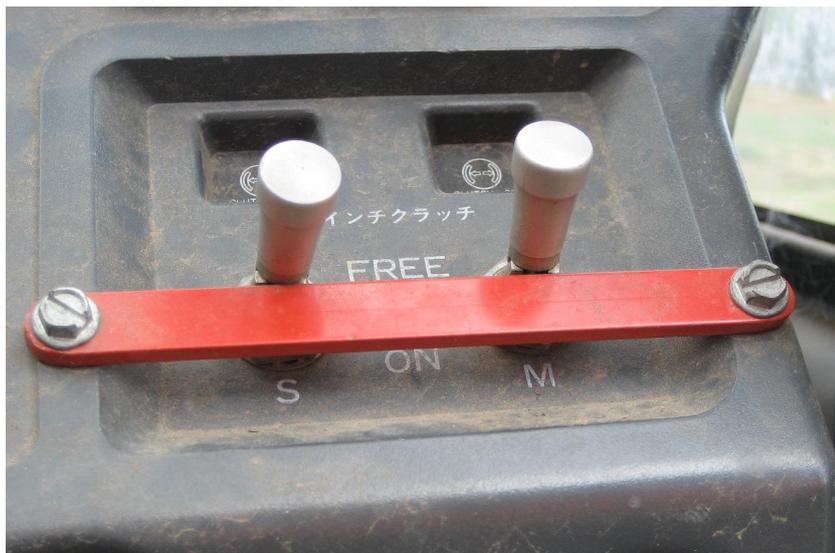
50. Mr Davis said the red lock bar on the free fall toggle switches had been attached to the wrong side of the switches. Instead of the bar locking the switches into the 'on' position, and thus disengaging the free fall function, it was actually locking the switches into the 'Free' position, thus engaging the free fall function. The green indicator light, which is supposed to indicate when the switches are in the 'On' position, was not working for the auxiliary winch but it was for the main winch.

Lock out bar installed under the switches at time of incident

- The lock out should have been a keyed lock out as recommended by the Mobile Crane Code of Practice 2006 – a keyed lock out is more tamper proof than a screw type such as that provided on the crane involved in this incident.
