CORONERS COURT OF QUEENSLAND

FINDINGS OF INQUEST

CITATION: Inquest into the death of Stephen Leonard Viner

CATCHWORDS: Coroners: inquest, workplace death, undetermined cause of death, electrocution or natural causes.

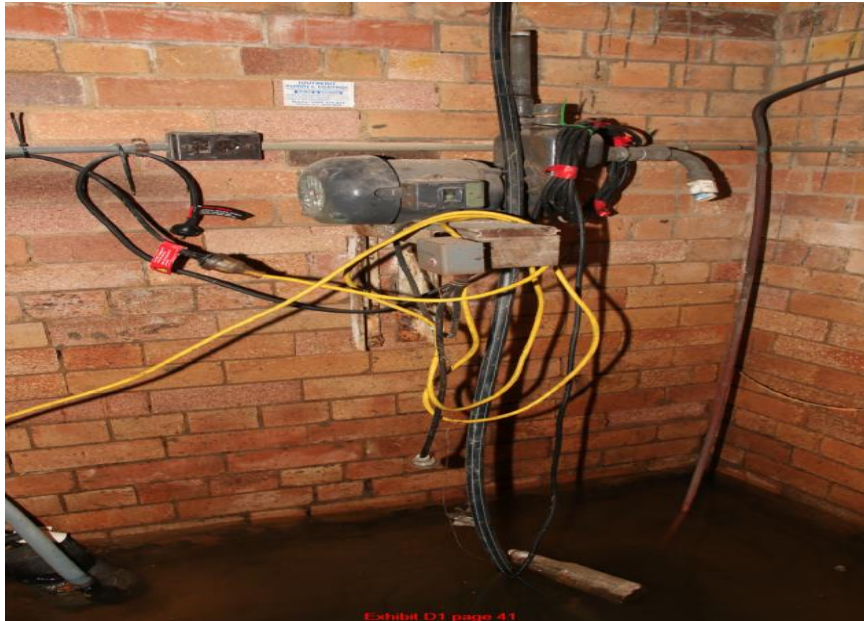
Yellow extension lead plugged into submersible pump

93. Mr Sparkes tested insulation resistance of the extension lead while the submersible pump was still plugged in and found no faults with the insulation of the active and neutral conductors of this equipment. The next day he inspected the socket outlet and found no evidence of arcing or damage.

109. In his summary, Mr Sparkes stated he found no defects with the submersible water pumps, the extension lead and the power circuit he was informed was being used by Mr Viner at the time of the incident. He stated there was an increased risk of electric shock of anyone entering the basement while it was flooded and the electrical installation was energised as the electrical installation in the basement was not electrically safe due to serious defects. However, he did not find evidence of the required circumstances to be in place for a person to receive an electric shock because the blue coloured refrigeration unit was found switched off at the wall, the basement power circuit rewirable fuse was blown, and the basement lighting circuit rewirable fuse was not inserted. He found no serious insulation resistance fault with the parts of the electrical installation that would have been energised according to how he found the incident scene. He concluded the only probable cause of a fatal electric shock was the exposed terminals of the rewirable fuses at the basement switch board that a person could directly contact. The rewirable fuse bases appeared to be typical of electrical industry standards when this equipment was permitted to be installed. It was noted the fuse board was some metres away from where Mr Viner was found in the water.

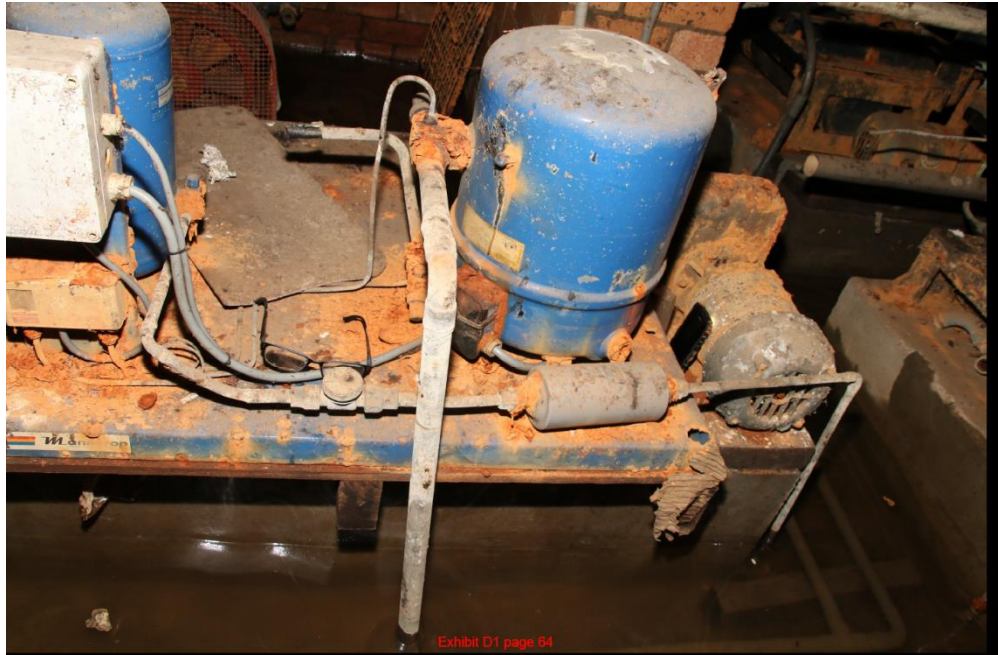
Blue Refrigeration Unit with spectacles and mobile

found there and his body was nearby. It can be accepted from the evidence of the ESO investigators it was possible for the Blue Refrigeration unit to have a live circuit if the isolator switch was turned “on” and a person came into contact with earthed conductive parts such as the metal post the terminal enclosure was mounted on. If, as I find likely, Mr Viner leaned across the Blue Refrigeration compressor unit to reach and turn on the isolator switch or to turn it off and at the same time came into contact with one or more of the exposed conductive parts of the Blue Refrigeration, then Mr Viner would have received an electric shock.

155. Secondly, and of more significance to this case, the partially submerged Blue Refrigeration Unit had faulty earthing that could be energised if the isolator switch mounted on the basement wall was turned to the 'on' position. The faulty earthing system meant that if the unit was energised, it could cause a person touching it to receive an electric shock.
156. Whatever can be said to be the reasonableness of Mr Kouzoukas' state of mind and knowledge as to the decommissioning of the basement and who was said to have performed that task, it is clear some of the electrical equipment in the basement was not electrically safe.

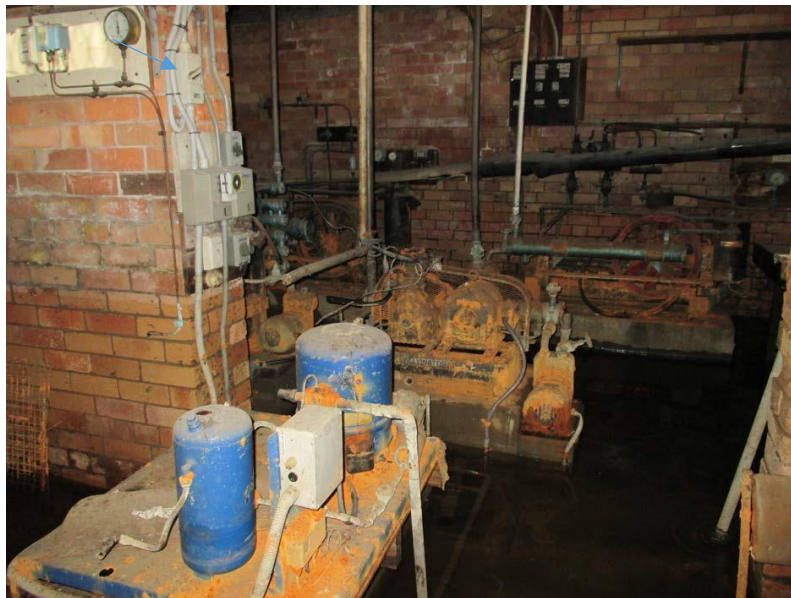
Isolator Switch to activate Blue Refrigeration unit

105. Mr Sparkes switched on the wall isolator for the blue refrigeration compressor and verified continuity from the load side of the middle cold room fuse base at the switchboard to one of the terminals of the terminal strip at the Blue Refrigeration compressor.

107. Mr Sparkes stated the testing revealed the basement power and cold room circuits were not effectively earthed and this was a potentially immediate electrical risk defect because if a fault occurred from a live conductor to an exposed conductive part requiring effective earthing, a person potentially might receive a fatal electric shock from contacting the exposed conductive part.

110. Mr Sparkes issued Improvement notices in relation to the defects and his understanding is the notices were complied with.
111. Mr Sparkes agreed there was a potentially unsafe situation if someone was standing near the Blue Refrigeration unit if it was switched on. He agreed the metal post to the unit was not earthed and was an open circuit. Some other parts were partly earthed. The cold room power circuit was 3 phase with one fuse missing.
