CORONERS COURT OF QUEENSLAND

Inquest into the deaths of Kate Goodchild, Luke Dorsett, Cindy Low & Roozbeh Araghi at Dreamworld, October 2016

Findings and Recommendations February 2020

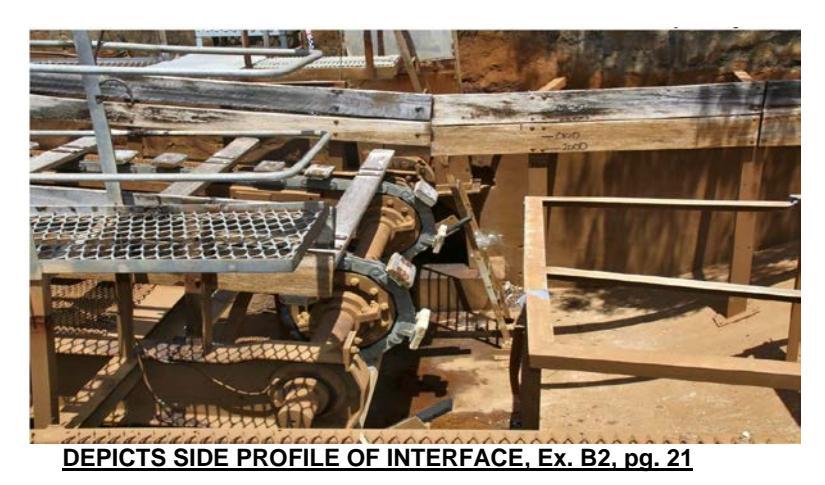
- 74. The speed of the conveyor was found to be 2.7 kph.⁸¹
- 75. An open air gap was found between the end of the conveyor closest to the unload station and the beginning of the raft supporting rails. This interface area, which was significant during the incident as it was into this gap that Raft 5 was pulled down once inverted, was extensively examined and measured. The gap of the

interface between the conveyor's long planks at their furthest point, and the leading edge of the support rail was found to be 430 mm, with a 760 mm gap between the leading edge of the support rails and the drive axle (when exposed).⁸²

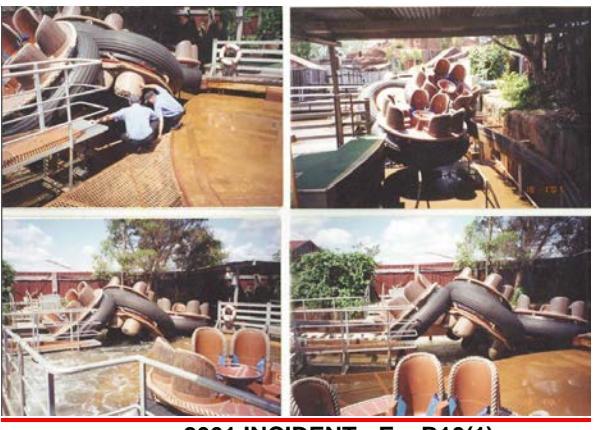
2001 INCIDENT - Ex. B10(1)

218. On 18th January 2001, Ms. Melinda Lynd was rostered to perform the role of No. 1 Ride Operator on the TRRR. She commenced the start-up procedure at approximately 9:17 am, releasing all of the rafts to run a full cycle, prior to opening the ride to guests.³²³ She was the only Operator present at the time. At around 9:30 am, Mr. Joe Stenning, who was rostered on as the No. 2 Operator for the TRRR that day, arrived and opened the queue line for quests. Whilst the empty rafts were travelling the water course, guests had commenced lining up. As Ms. Lynd began speaking to guests in line, two rafts became stationary at the unload area, with a further three traveling down the conveyor, having completed a full cycle of the ride.³²⁴ This was noticed by both Ms. Lynd and Mr. Stenning, however, no attempt was made by Ms. Lynd to release the stranded rafts. As the three additional rafts came off the conveyor, they collided with the stationary rafts, causing one to flip. Having seen the rafts flip, an operational Code 6 was called, at which time Ms. Lynd called 222 and tried to describe the incident, which was not clear. She then hit the emergency jack button and stopped the conveyor.³²⁵ The rafts were unable to be freed. Senior Attractions staff arrived at the TRRR shortly thereafter, and quests were cleared from the area. The following photographs of the aftermath of the incident depict the scene.

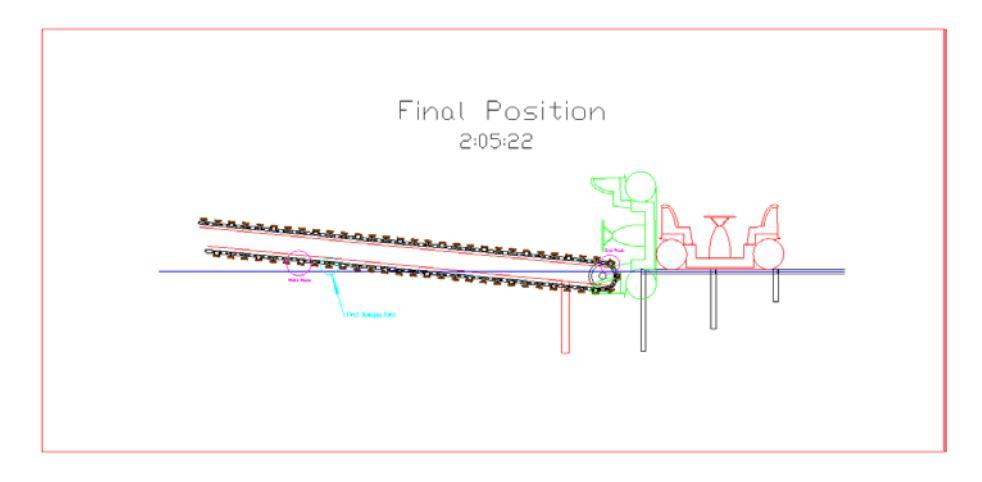
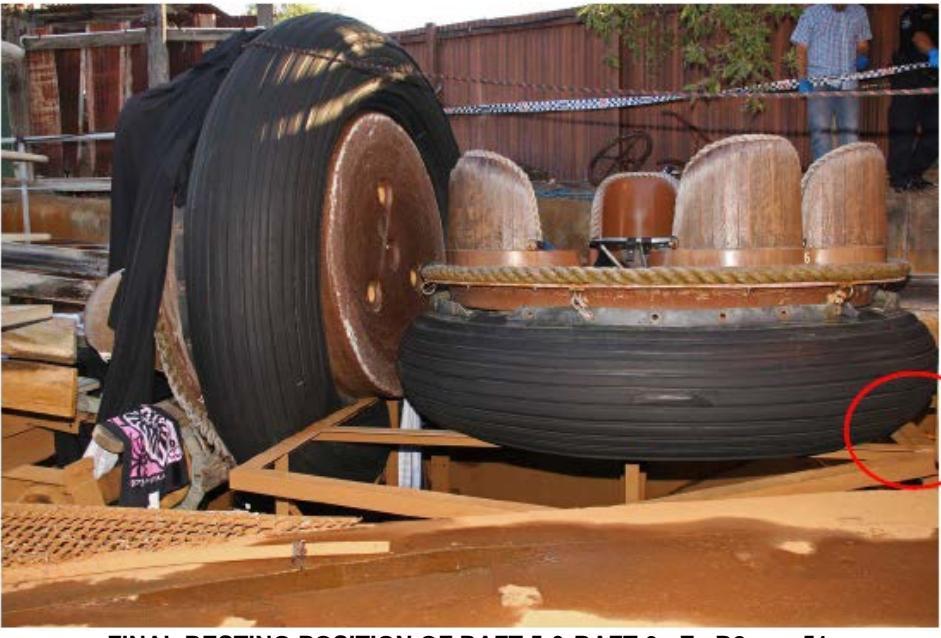
FINAL RESTING POSITION OF RAFT 5 & RAFT 6 - Ex B2, pg. 51

- 471. It is evident that it only took one minute and 17 seconds from the time the south pump failed until Raft 5 became inverted.⁸⁸⁵
- 472. Investigators have established that within the first 15 seconds of a pump failure on the TRRR, approximately (200mm) of water height was drained.⁸⁸⁶ As Raft 6 entered the unload area, there was insufficient water flow for it to proceed forward over the support rails once it exited the conveyor. This occurred within 20 seconds of the pump failure.⁸⁸⁷
- 473. Further testing conducted by Investigators following the incident confirmed that when one pump was not operational there was a difference in water level of

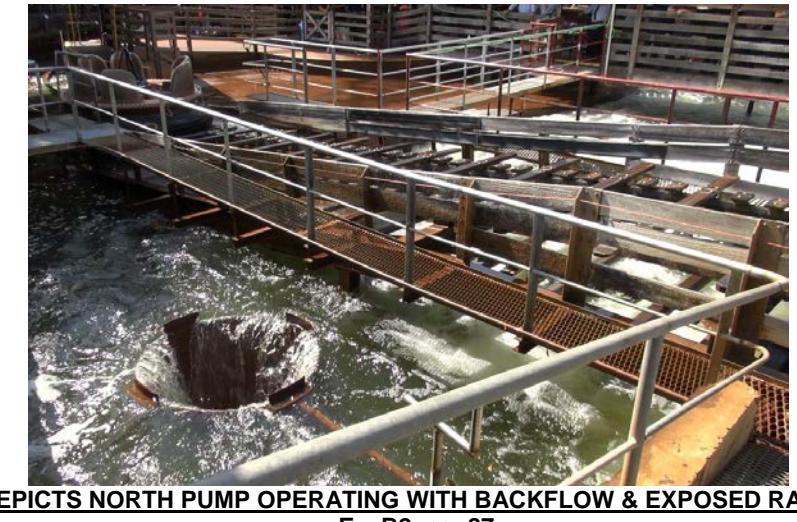
DEPICTS NORTH PUMP OPERATING WITH BACKFLOW & EXPOSED RAILS - Ex. B2, pg. 87

- 478. Testing also revealed that the opening of the pump outlets within the pit area under the conveyor were at a level lower than that of the raft support rails.⁸⁹³ Due to this design aspect of the ride, and the large volume of water that is extracted during the reverse flow, the water drops below the level of the rails guickly.⁸⁹⁴

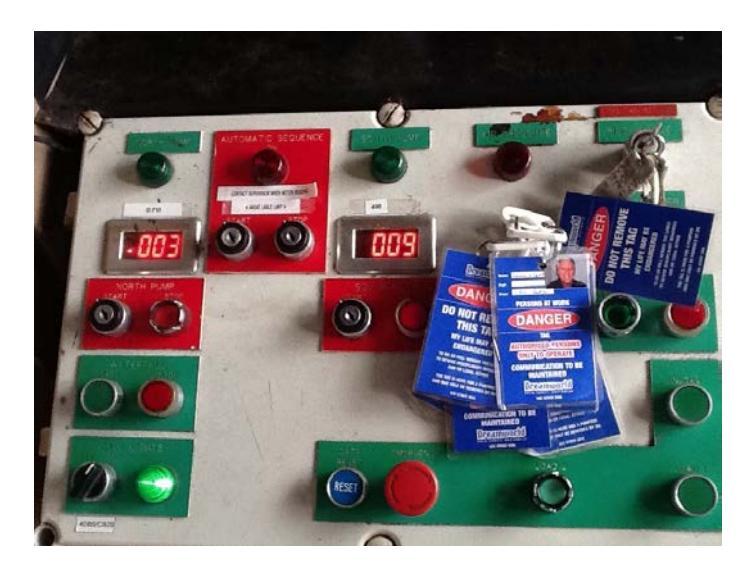
555. Furthermore, some of the recommendations made by JAK, which may have pertained to safety, such as the labelling of the Main Control Panel buttons and the E-Stop at the unload area, which were raised in previous years, were not actioned by Dreamworld. In 2013, the Main Control Panel at the loading area when considered by JAK appeared as below:¹¹⁴⁸

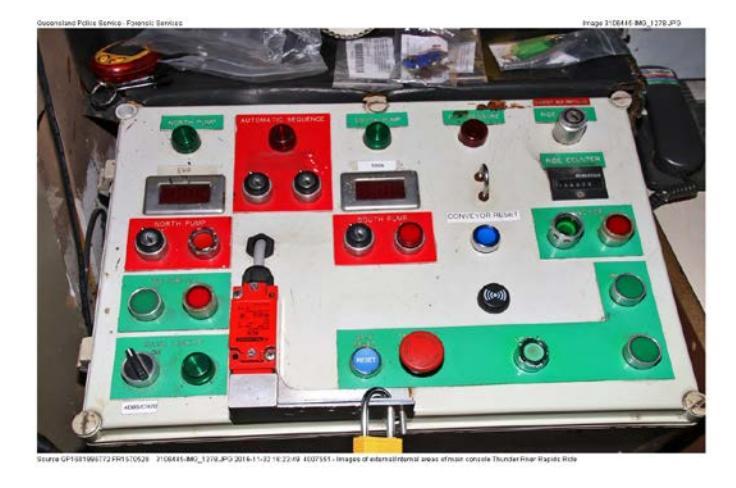
556. The Main Control Panel on the date of the incident, appeared as follows:¹¹⁴⁹

557. Mr. Naumann, the Maintenance Planner for Dreamworld at the time of the incident, acknowledged during his interview with OIR, that the recommendations made by JAK, particularly as to the labelling of the control panel and E-Stop at the unload area at the TRRR, should have been actioned during the annual shutdown of the ride, however, were not carried out.¹¹⁵⁰ He could not offer an

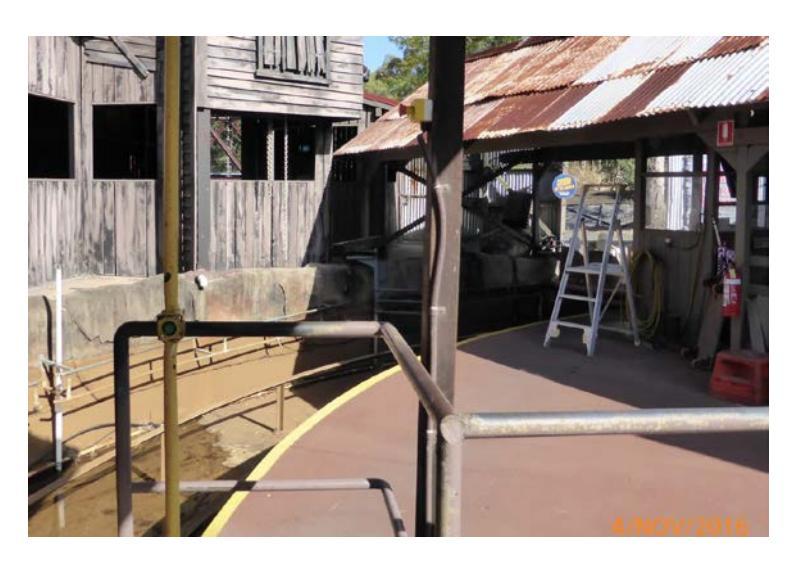
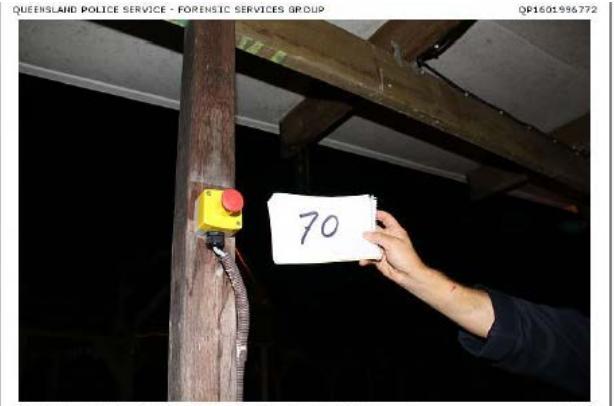
3107505-JMG_0613.JPG Dreamworld Thunder River Rapid Ride' WHS inspection 4019152

558. The E-Stop at the unload area at the time of the tragic incident, appeared as below:¹¹⁵¹

559. Despite the recommendations made by the external auditor that the ride control buttons, including the E-Stop, should be labelled and the action identified, in a response provided to OIR by Ardent during the course of their investigation into the circumstances of this tragic incident, they maintain that *'the emergency stop button at the unload platform of the TRRR was clearly marked on 25 October 2016'*.¹¹⁵² This is clearly not the case.
