OFFICE OF THE STATE CORONER FINDINGS OF INQUEST

CITATION: Inquest into the Death of
Muraka Jenny Vearncombe

CATCHWORDS: Inquest, operation of slasher, ejection of debris,
traumatic head injury, experienced operator, use of
manufacturer's safety information, adequacy of WHS
investigation, missed opportunities for better industry
awareness.

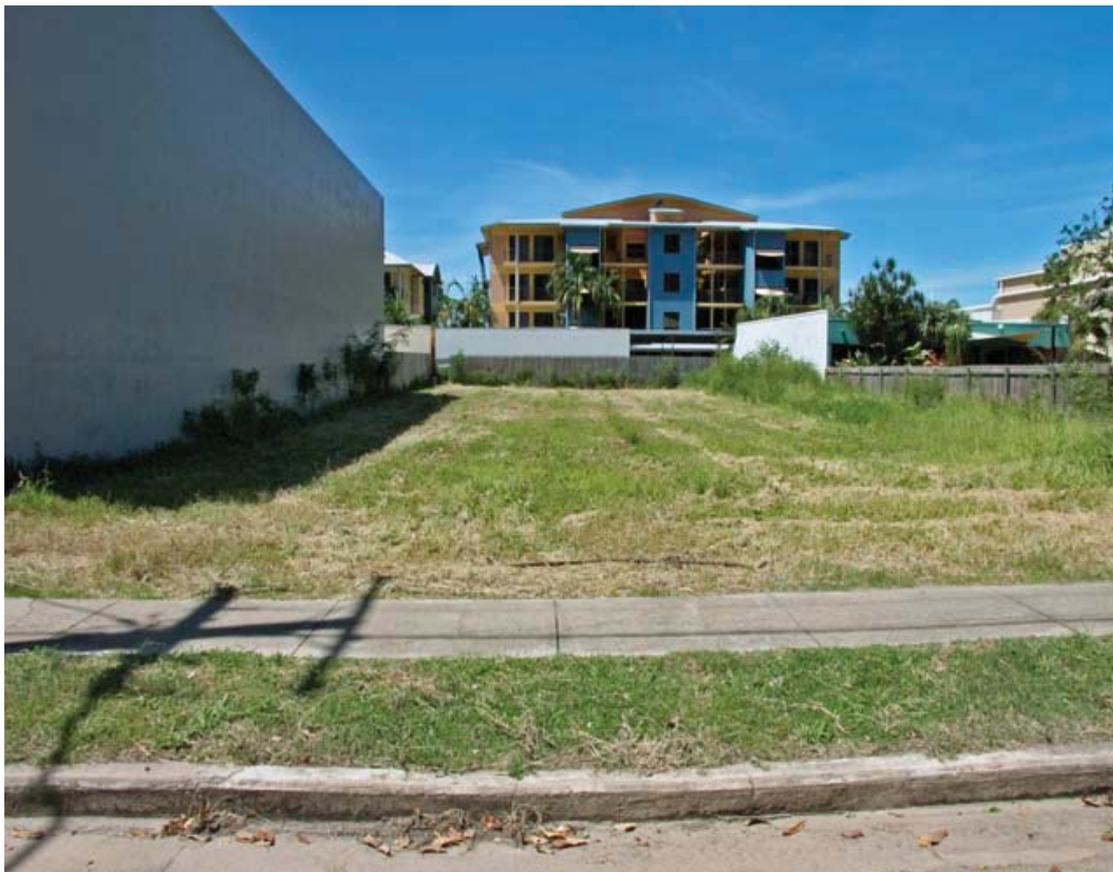
Photograph showing the vacant block being slashed – section of remaining steel pipe visible just beyond the footpath

Police officers re-attended the scene two days later and found a metal pipe lying on the grass. It was not found at the time of the initial scene investigation. This pipe ran parallel with the front of the vacant block and then disappeared under the surface into the ground. It was rusted and housed electrical wiring, possibly for a dwelling originally on the block. The pipe was bent back on itself and identical to that which struck Ms Vearncombe. Police officers saw an indentation on the surface of the ground running at a 45 degree angle to the pipe. The investigator laid the bent pipe along this indentation. It was a perfect match. The officer concluded that the indentation showed the position of the pipe prior to the slasher running over it.

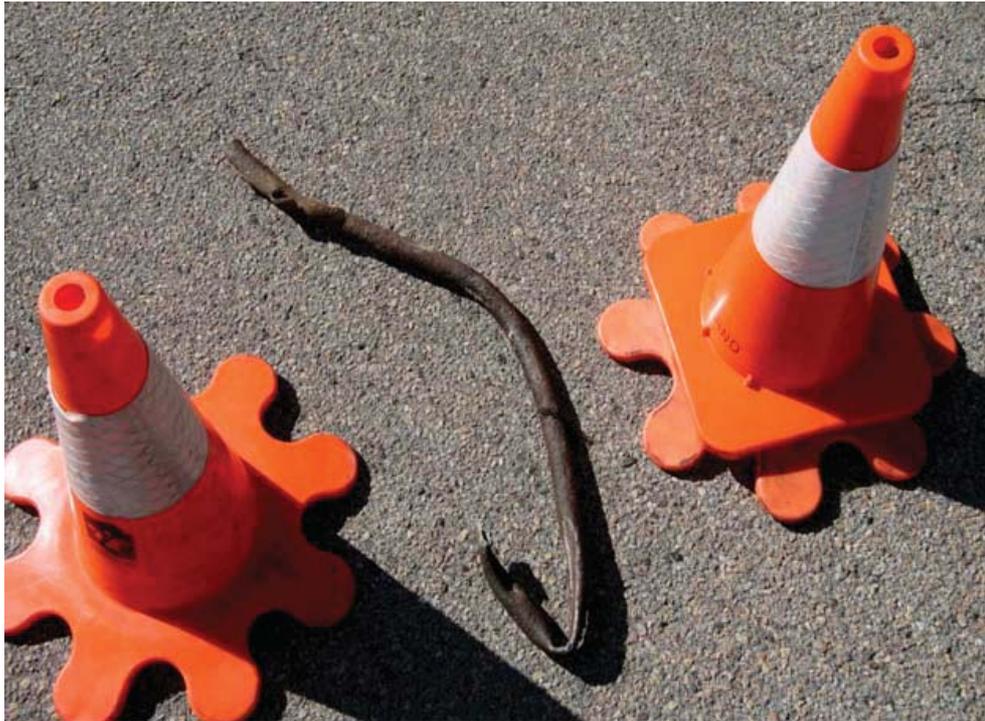
Photograph showing the section of metal pipe found on the road

slasher faced the direction of Ms Vearncombe. During the turn, the slasher blade made contact with a length of metal pipe and flung it with great force towards Ms Vearncombe, then only about 15m away. She was struck in the head and died instantly. The metal pipe came to rest about 20 metres beyond Mrs Vearncombe, having continued in the same direction after striking her.

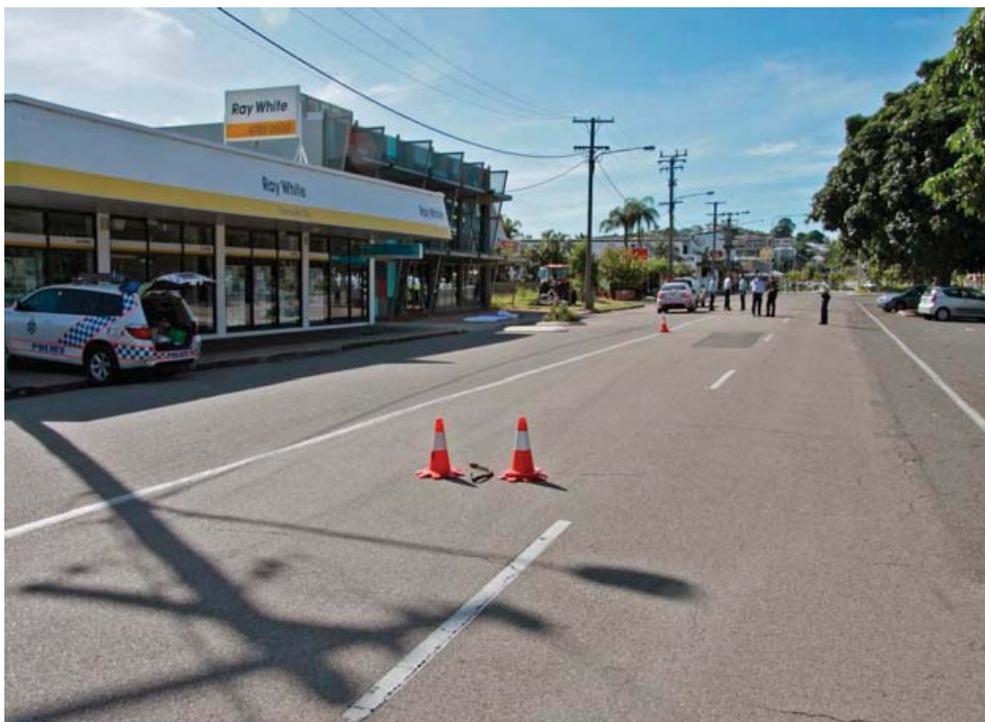
Photograph showing the general location – pipe in the foreground – tractor in background

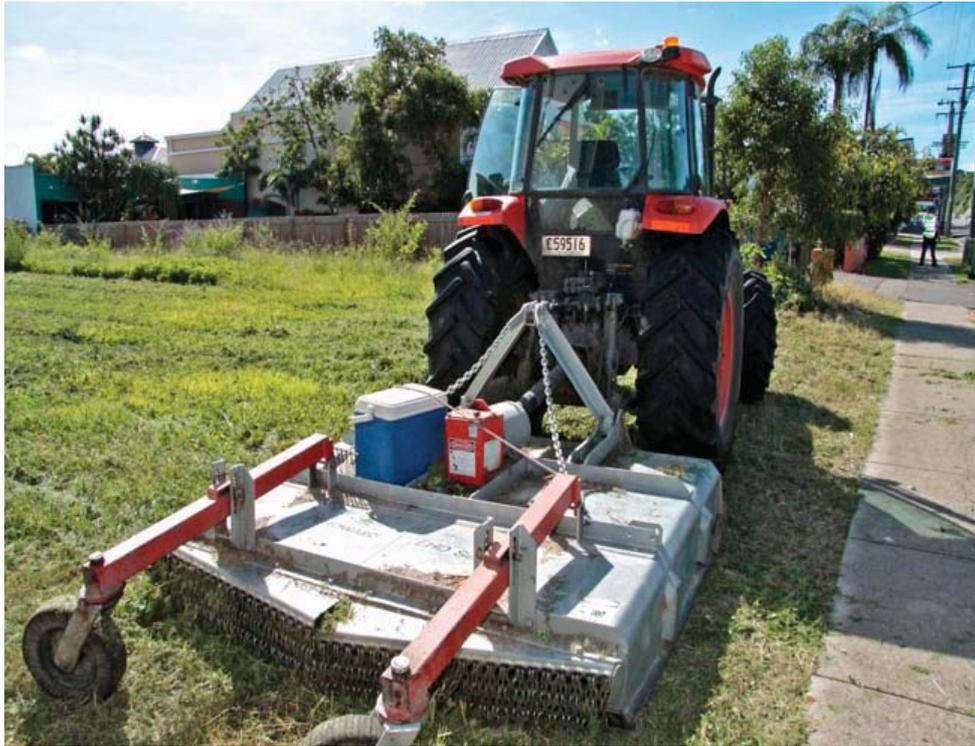
Photograph of tractor and slasher – a curtain of chains across the rear opening of the slasher

A later mechanical inspection of the tractor and slasher revealed there were no mechanical defects which might have contributed to the incident. While inspecting the slasher at the scene, the investigating Forensic Crash Unit officer found a couple of the chains at the rear discharge area 'knotted' together creating a gap in the curtain of hanging chains. It was his opinion that this feature was more likely the area where the piece of metal pipe was discharged.

Clearly, although the slasher used in this instance had a chain guard fitted to the discharge area, its use in a built up area with the possibility of persons and vehicles in the general vicinity warranted further control measures as the manufacturer recommends.

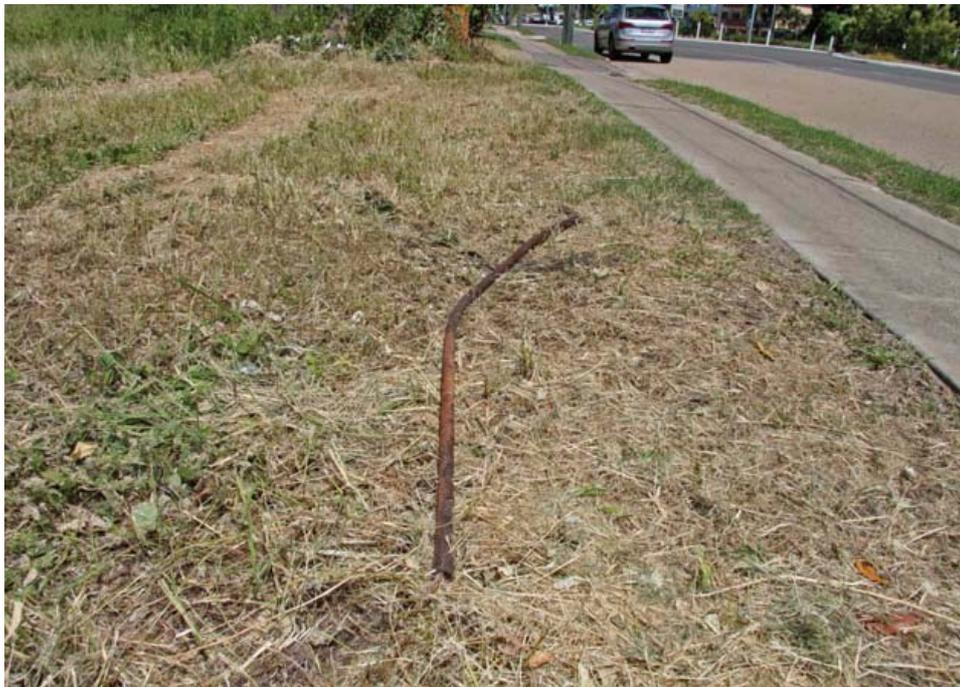
Photograph showing the section of remaining section of pipe
