OFFICE OF THE STATE CORONER

FINDINGS OF INVESTIGATION

CITATION: **Non-inquest findings into the death of Robert Charles Berrill**

CATCHWORDS: Non-inquest findings, motorcycle collision, loss of control, experienced motorcyclist, risk taking behaviour.

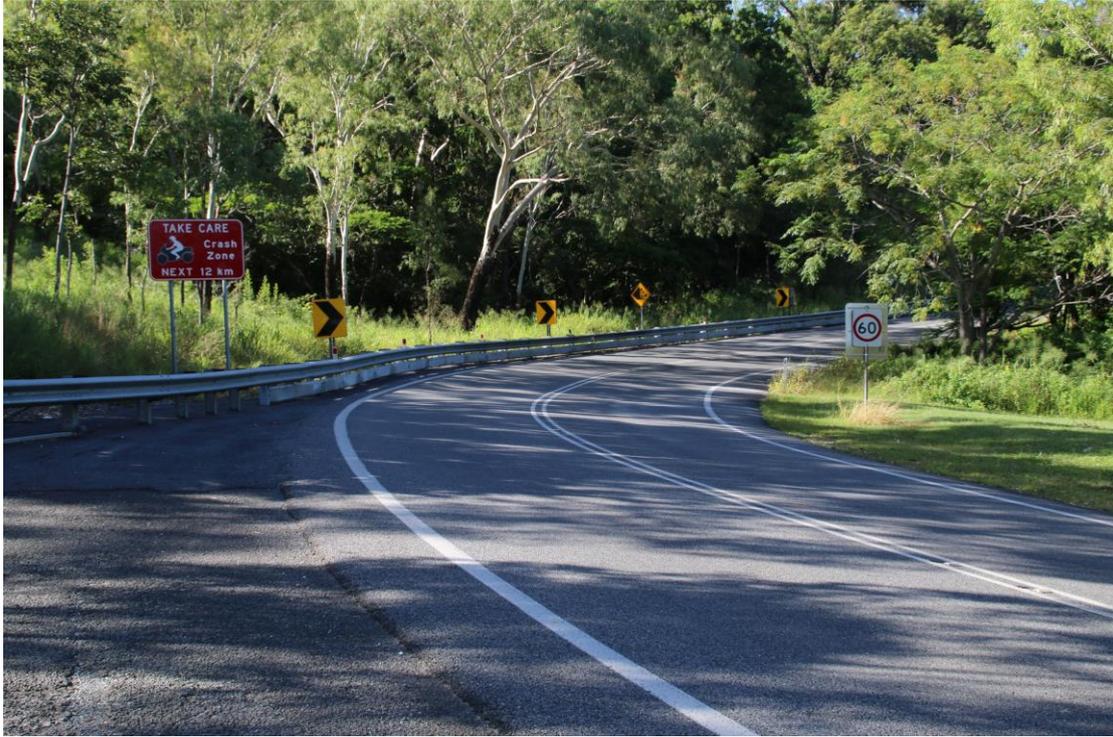
Photograph of the red warning sign for motorcyclists

Taken from the direction of travel of the motorcycle
