CORONERS COURT OF QUEENSLAND

Inquest into the deaths of Kate Goodchild, Luke Dorsett, Cindy Low & Roozbeh Araghi at Dreamworld, October 2016

Findings and Recommendations February 2020

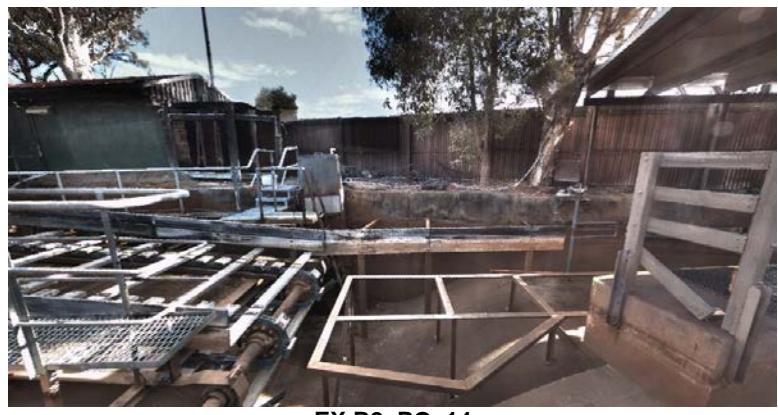
EX B2, PG. 14

- 66. Additionally, there were a series of support railings in the trough prior to the beginning of the conveyor (bottom), which were installed in 2015.⁶⁸
- 67. In the area of the incident at the end of the conveyor (top), there was no variation in the level, with the support rails having been adapted to suit the sloping nature of the flooring leading back to the area beneath the conveyor, known as the 'pit'.⁶⁹ This area is where the water for the ride was gravity drained back into the storage reservoir.

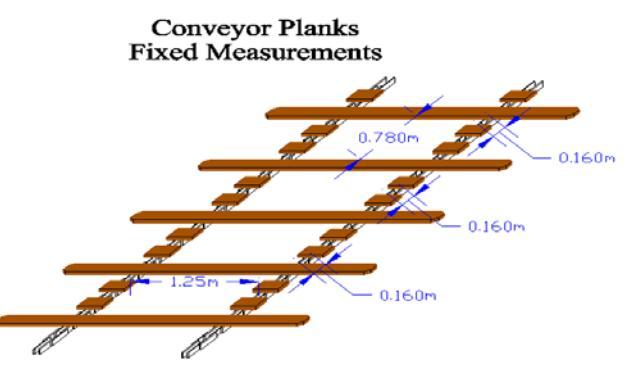
- 73. The measurements of the conveyor planks, including the spacing and configuration, are as follows:⁸⁰

- 74. The speed of the conveyor was found to be 2.7 kph.⁸¹
- 75. An open air gap was found between the end of the conveyor closest to the unload station and the beginning of the raft supporting rails. This interface area, which was significant during the incident as it was into this gap that Raft 5 was pulled down once inverted, was extensively examined and measured. The gap of the

interface between the conveyor's long planks at their furthest point, and the leading edge of the support rail was found to be 430 mm, with a 760 mm gap between the leading edge of the support rails and the drive axle (when exposed).⁸²

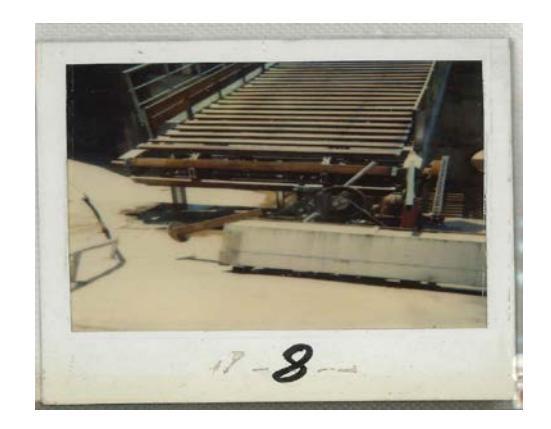
106. The below photograph depicts the conveyor as it was initially constructed in 1985.¹³²

- 107. Mr. Wood stated during the inquest that by the time he left employment with Dreamworld in 2012, every 2nd and 3rd slat had been removed from the conveyor.¹³³
- 108. According to Mr. Tan, who was employed in various roles within the Engineering Department, including as the Manager since 1987, the removal of the wooden slats on the conveyor took place between 1988 and 1990 because it was frequently tripping.¹³⁴ The boards were removed to reduce the weight the conveyor motors were required to drive, and to improve the chain 'release' from the head sprocket.¹³⁵

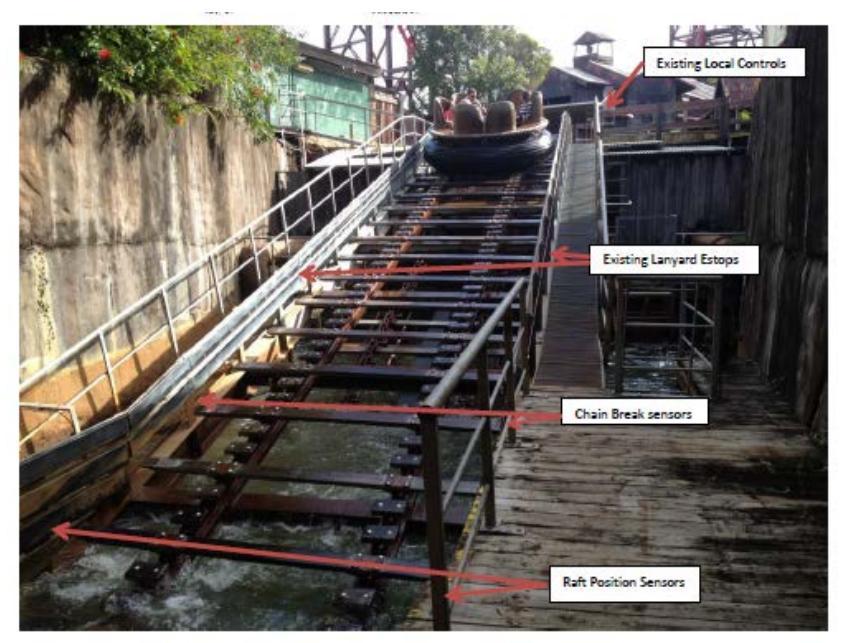
TRRR CONVEYOR CONTROLS UPGRADE OVERVIEW - EX B12 (11), PG. 2

- 131. It was also proposed that the scope of work be expanded to include an upgrade of the Main Control Panel, as it had been 'adapted and added to over many years and are in a poor state'.¹⁷² Mr. Ritchie clarified that he was referring to the organisation of the wiring on the Main Control Panel as it was difficult to follow and untidy.¹⁷³ The hardware was older and there was no colour coding, numbering, labelling or features that would be expected for new wiring that readily identifies the systems that each wire operates.¹⁷⁴ Furthermore, there were no 'as built' electrical drawings, as well as different electrical components that had different voltages in the same system.¹⁷⁵ Mr. Ritchie noted that these aspects made reviewing the electrical components of the Main Control Panel 'slow and time consuming'.¹⁷⁶ He did not consider, however, that the state of the control panel adversely affected the safety or operation of the ride.¹⁷⁷
