CORONERS COURT OF QUEENSLAND

FINDINGS OF INQUEST

CITATION: Inquest into the death of Christopher Ian Powell

CATCHWORDS: Coroners: Inquest, Elevated Work Platform, Outrigger Collapse, Unstable Ground, Mobile Crane Code of Practice 2006, Geotechnic Report, Safe Support Mobile Plant Guide, Photography.

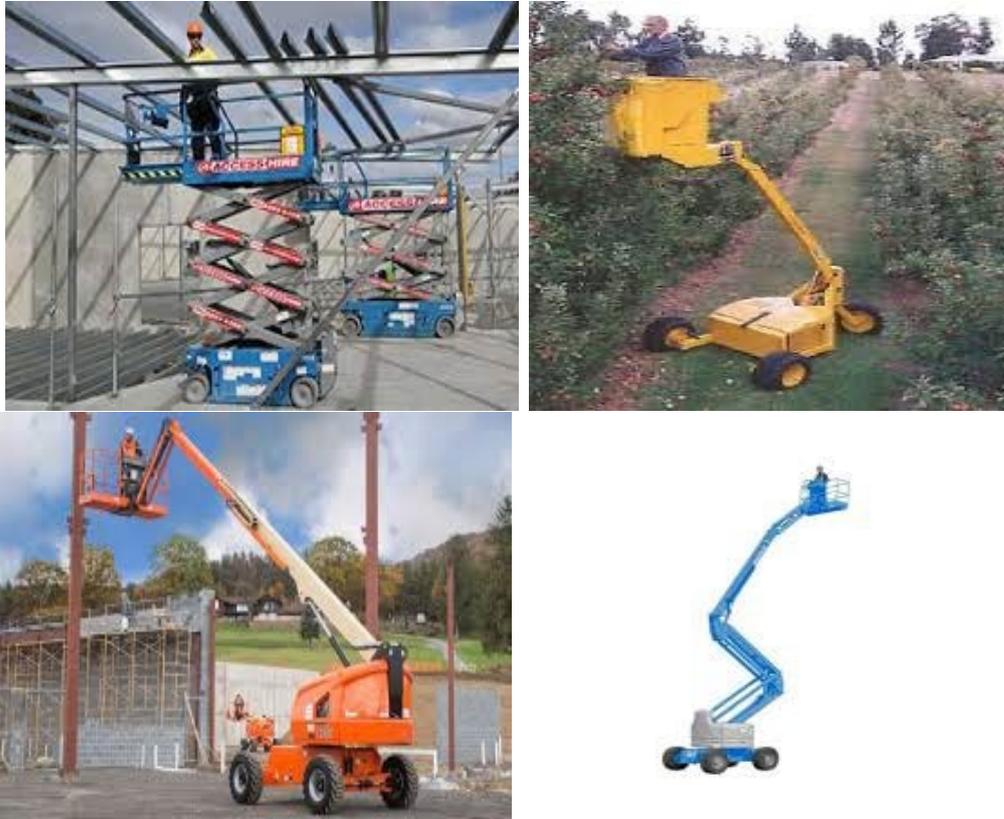
Figure 6 – Examples of mobile elevated Work platforms and the great variety of sizes and uses. The top two EWP's only extend to a working height of five metres and weigh less than one tonne. The bottom two EWP's extend to a working height over 11 metres and weight over five tonnes.

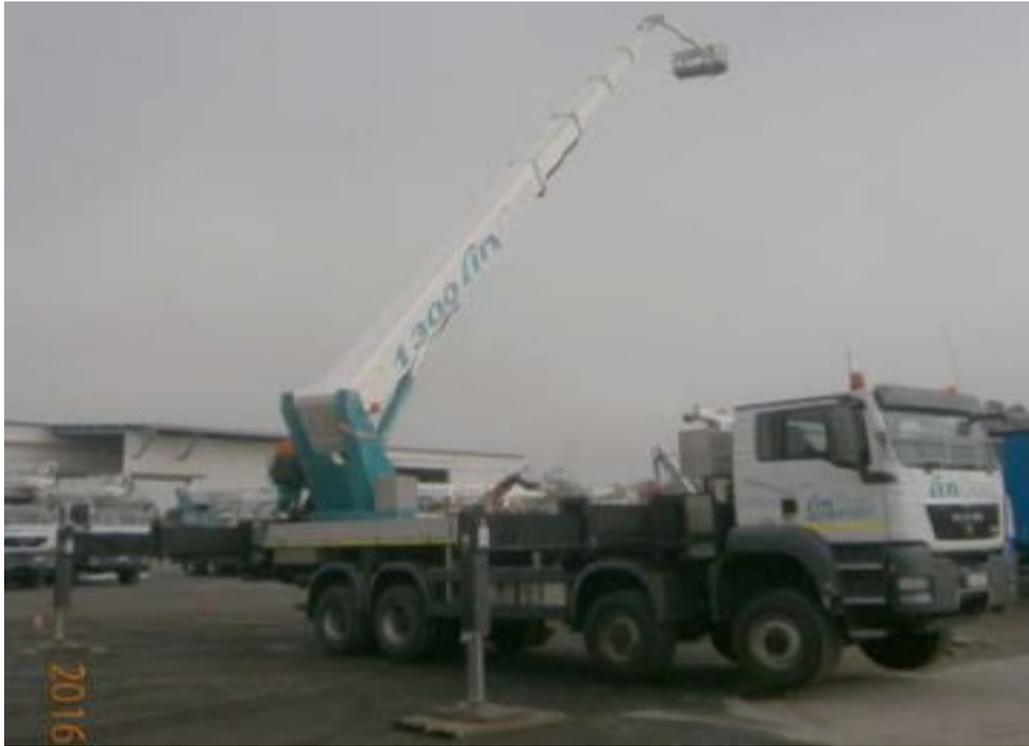
Figure 2 - Example of a similar Wumag-Palfinger WT 700 EWP in operation: note only the front outrigger legs and pads and crew bucket on this vehicle
