## OFFICE OF THE STATE CORONER FINDINGS OF INQUEST

**CITATION:** **Inquest into the death of  
Pekka Tuppurainen**

**CATCHWORDS:** Coroners: inquest, underground mine at Mt Isa,  
inadvertent entry of loader into stope, traumatic  
asphyxiation of operator, adequacy of control  
measures, adequacy of remedial action, implications  
of incident for effectiveness of safety management  
system.

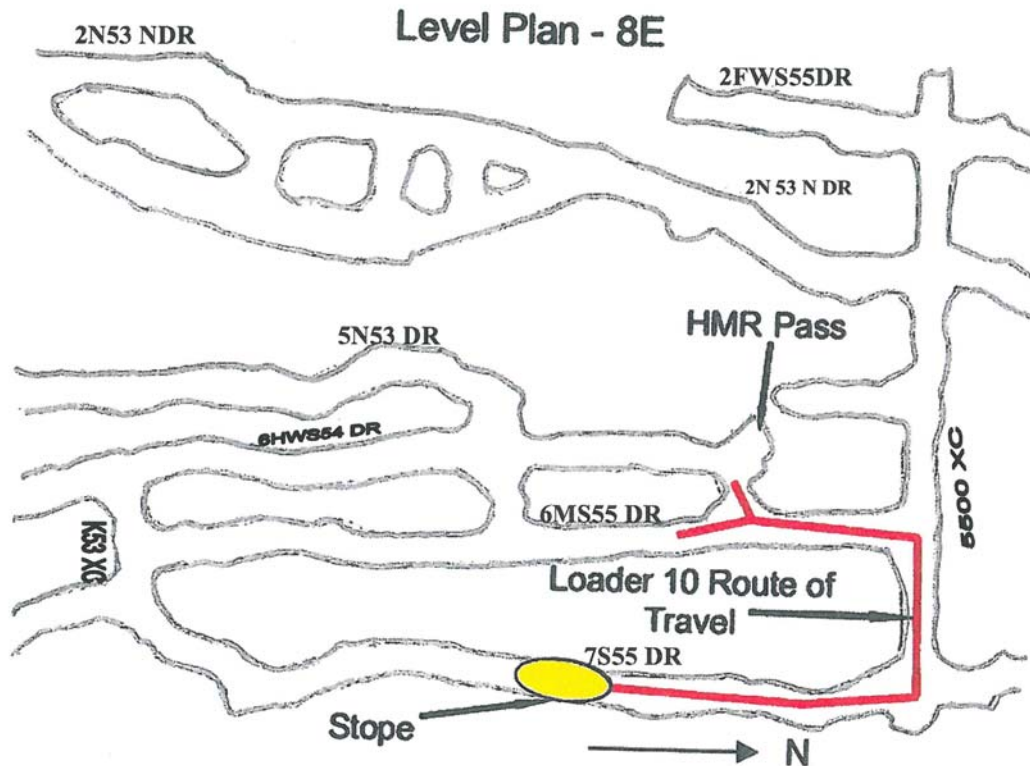
Figure 5. Schematic Plan View of 8E Sublevel Indicating Route of Travel of Loader LD10

Backfilling is a repetitive task, in this case driving (conventional operation) into L54 and picking up a bucket of HMR, reversing out and driving forwards around to the stope, a distance of some 110 metres, dump the bucket and then reverse back around to L54 and repeat the activity. The drive where the backfill material was sourced ran parallel to the stope void drive.

Plan of 8E level indicating route of travel for Loader 10

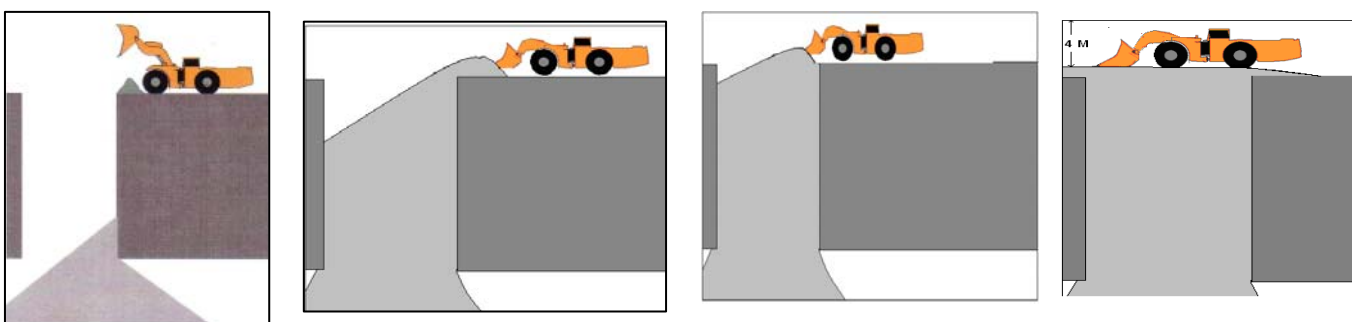
Figure 6. Illustration of Bench Stope Backfilling

As the edge being tipped over involved a sheer vertical drop, (in this case 29 metres by the footwall bedding to the floor of 8C Sublevel), it was normal for a mullock (waste rock) stoplog (or barrier) to be used until a rill is established up to the stoplog. The stoplog would then be advanced to progressively fill the void to the level (8E Sublevel in this instance).

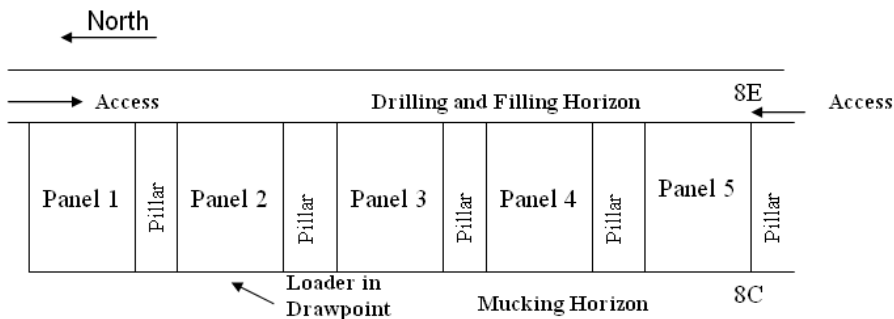
Figure 7. Schematic Cross Section Looking East

7N53 Panel 2 was the second of 5 panels to be taken in the 7N53 Bench, 8E-8C. The panel was designed to have a span of 13 metres and a vertical height of 24 metres.<sup>52</sup>
