OFFICE OF THE STATE CORONER

FINDINGS OF INQUEST

CITATION: **Inquest into the death of Rebecca Louise Fenton**

CATCHWORDS: Coroners: Inquest, Motor vehicle collision, CHR Intersection, Slip Lane, Micro-sleep, Boonal Coal Loader

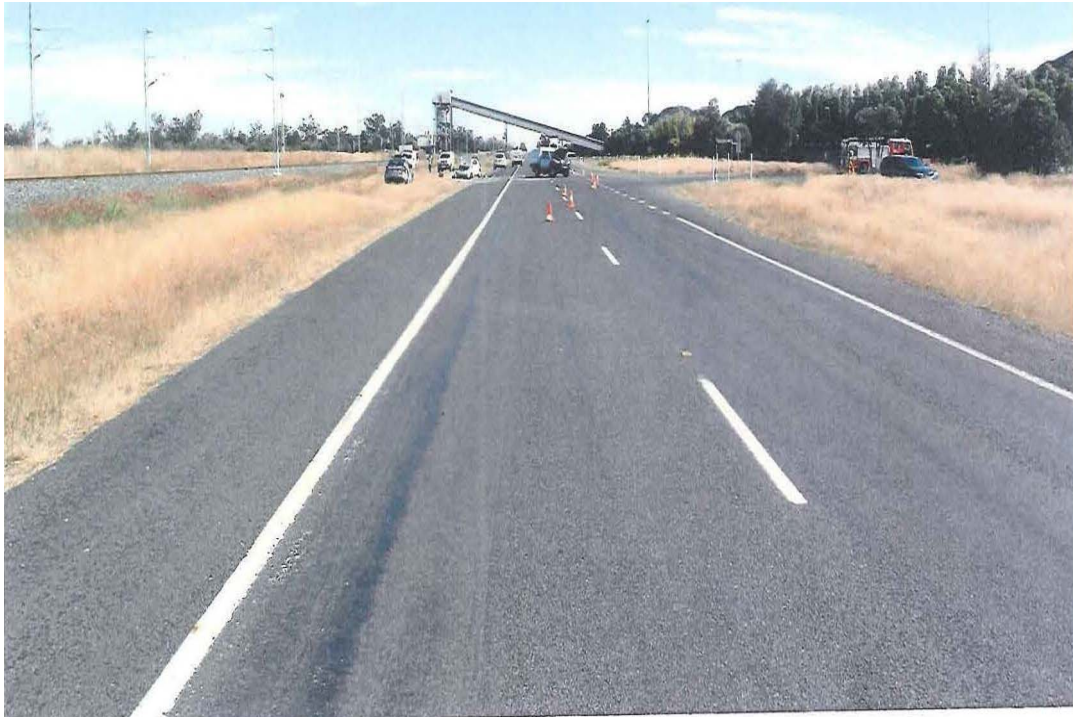
Photo 1. ¹¹

[20]. The police reconstruction of the incident approximately one year later is of some interest¹⁰. What they re-created, and did show, was that at around 7:30 AM a vehicle stopped at the intersection may be seen as partly obscured, or perhaps more properly stated, becomes superimposed, on the background structure of the Boonal coal loader which is located quite some distance away from the intersection. The Coal Loader is shown in the below photo:-

- [21]. In addition the fact that the vehicle in front of her was grey in colour would not have assisted in its' differentiation against the Boonal coal loader background. Accordingly whilst I cannot say that she suffered from inattentive background distraction I am unable to exclude it as a possible cause of the incident.

right. A photograph of this ‘alleged’ slip-lane is shown in Photo 1 in these Inquest Findings.

- [28]. Whilst the Department of Transport & Main Roads personnel might consider it a slip lane, I am an experienced road user and merely view it as a widened road shoulder because there is no dedicated slip-lane indicated by any line markings. In fact the fog-line is marked as a continuous, or unbroken, white line and even has audible lane markers¹⁶, which two features clearly do not direct a driver to go to the left of any driver turning right. Further the road shoulder is just 3.0 metres wide before reaching the grass verge, whereas a proper traffic lane is 3.6 metres wide. It is only too easy to see a calamity occurring if a B-double semi-trailer configuration travelling at 100 km/h attempted to try and thread its’ way through on the road shoulder to try and pass a stationary vehicle turning right¹⁷.

- [29]. Accordingly I find that the present configuration of the intersection did contribute to the accident occurring because its present configuration does not direct a driver to the left, to move around the driver who is stationary and turning right.

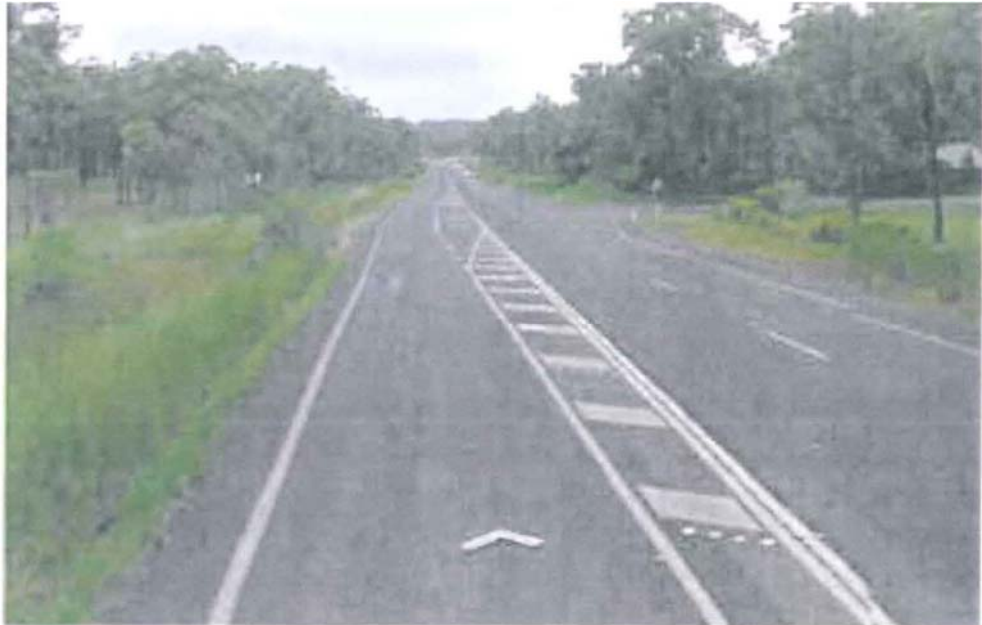
Photo 2. ¹³

[25]. What a CHR intersection achieves is to provide a dedicated right turn lane for vehicles which need to stop on the road and give way to other traffic before turning right. An example of a CHR intersection treatment is shown below:-

- [47]. It was recommended to me, and was supported by the Department of Transport & Main Roads, which was a very sensible position to take, that for westbound traffic the intersection should be altered to be a CHR style intersection. This type of intersection will allow the through traffic to be guided to the left of a dedicated lane where motorists turning right can be stationary awaiting their opportunity to turn right without being exposed to a rear-end collision. The present intersection treatment is 5200%²³ more likely to result in a rear end collision than a CHR style intersection. The intersection treatment has already had detailed design work undertaken, and is costed in the order of \$800,000. For an intersection on a highway it is not a cost prohibitive solution.

- a. that the intersection be upgraded to a CHR (channelised right-hand turn) style intersection for westbound traffic;
- b. that the Department of Transport & Main Roads take all steps necessary to assist in the early implementation of the CHR intersection upgrade; and
- c. that the Department of Transport & Main Roads nominate for the benefit of external parties, a single, dedicated, contact person, within the Department, to co-ordinate and progress, the intersection upgrade.
